**IHO CSMWG 16
IHB Monaco 29-31 May 2006**

**REPORT by IC-ENC on S-57 E3.1.1 tests conducted with various
ECDIS.**

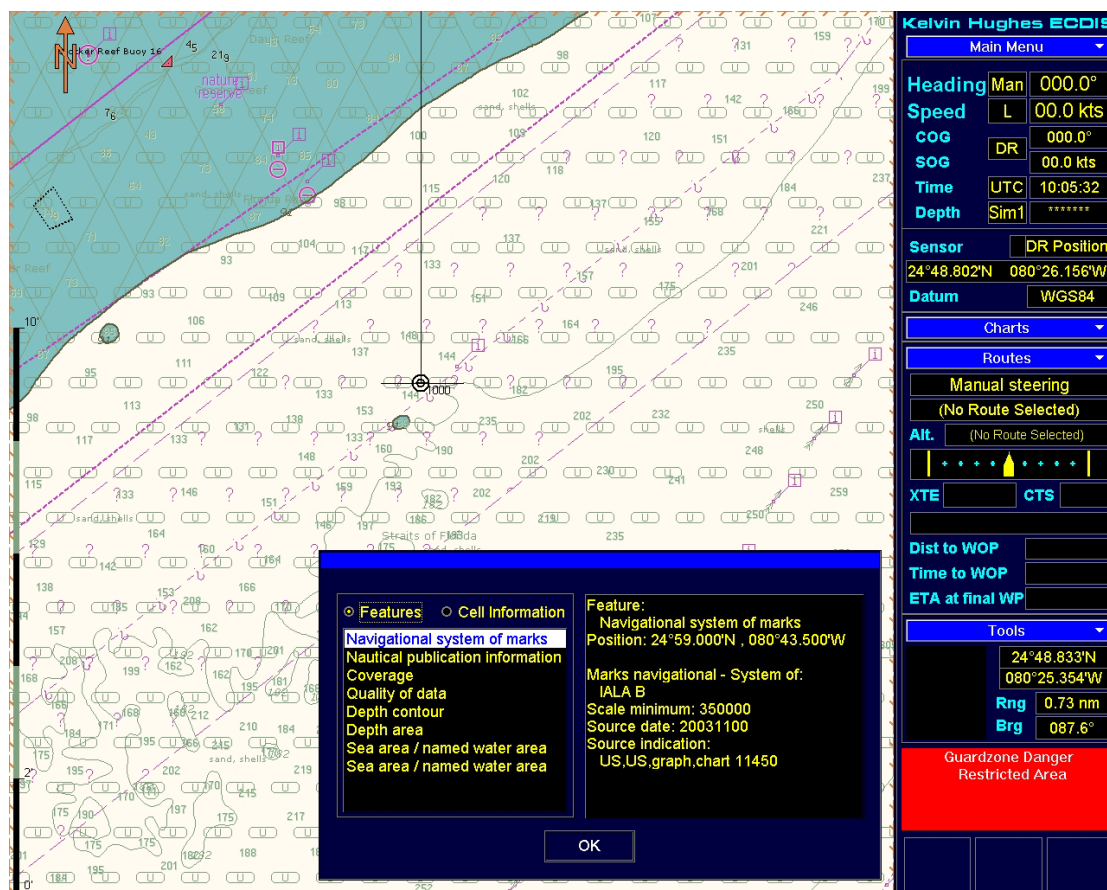
KELVIN HUGHES ZM1816 V3.2

ARCSLN - Displayed as area bounded by magenta pecked lines and with floating '?' area fill. When interrogated no object reported.

Display of proposed S-57 E3.1.1 object **ARCSLN**: feature displayed with question mark symbology, but no object was reported and accordingly the attribute INFORM was not displayed.

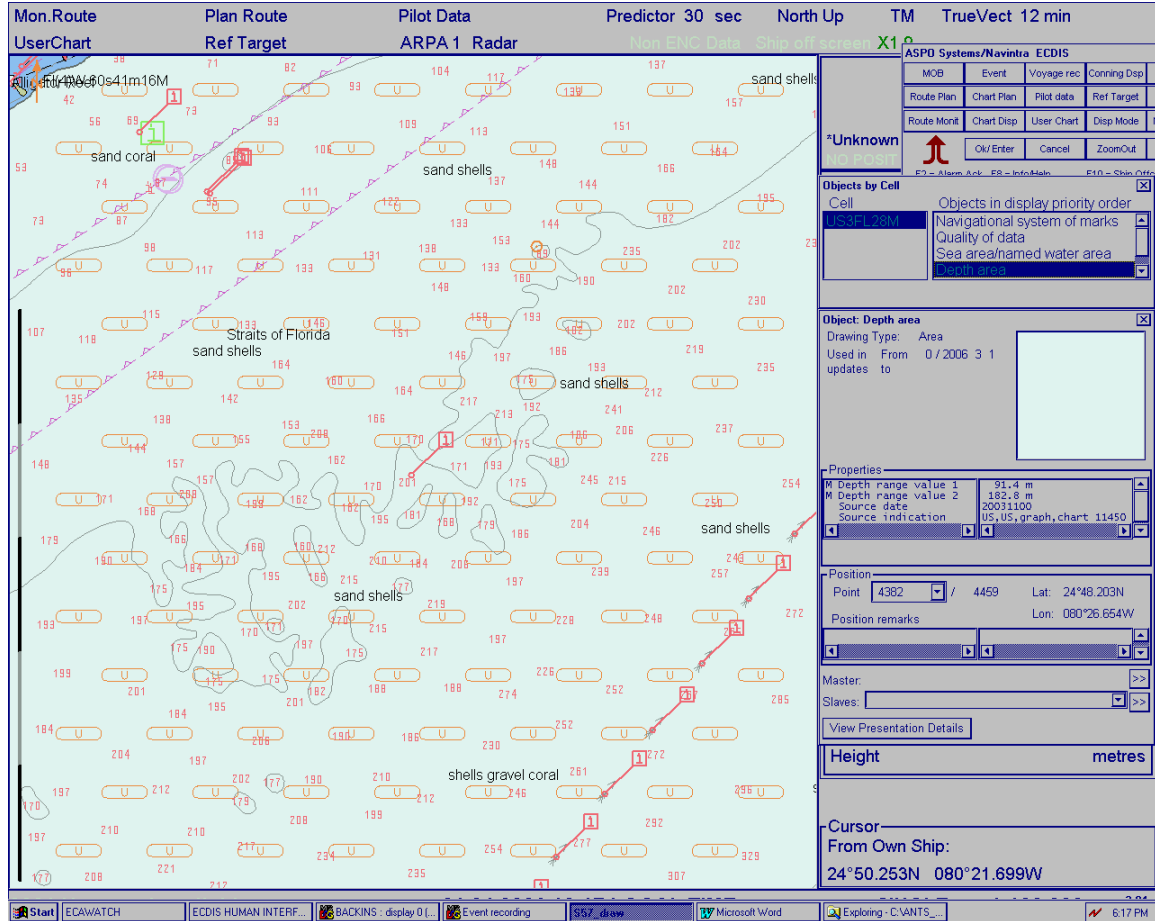
ASPO SYSTEMS/NAVINTRA EC1000 03.00

ARCSLN - Nothing displayed. When interrogated no object reported.

Display of proposed S-57 E3.1.1 object **ARCSLN**: no object was displayed nor reported and accordingly attribute INFORM was not displayed.
