## Cyclone Winston, Fiji

### A preliminary Satellite Imagery Analysis of Navigation & Coastal Damage (Imagery available to 25<sup>th</sup> February 2016)

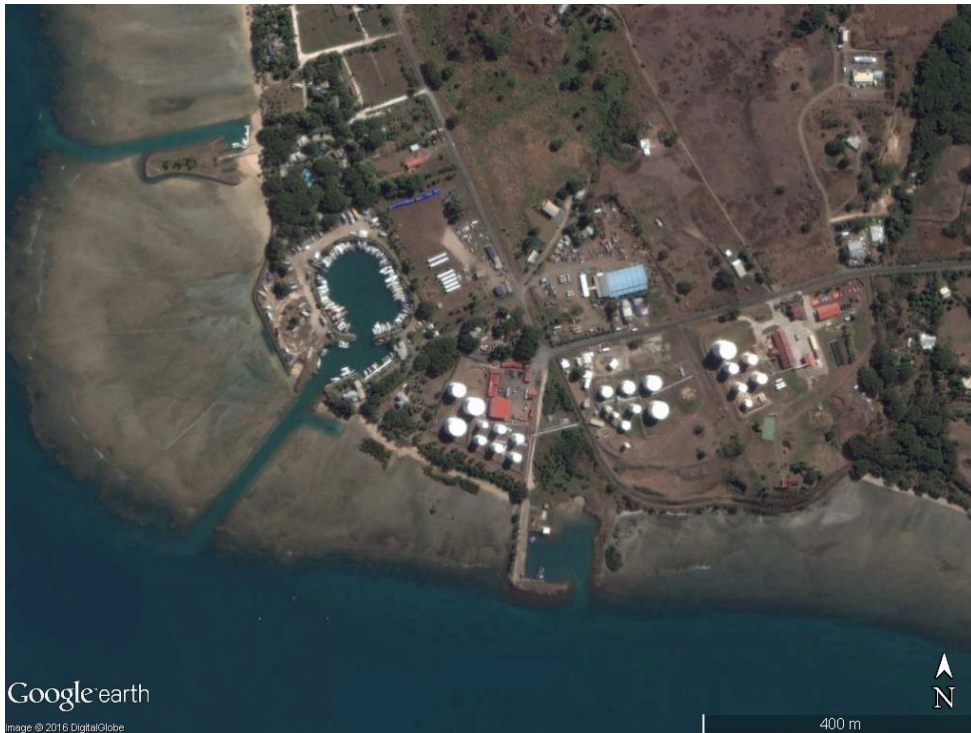
**Vuda Point, centred on 17°41'4.75"S, 177°23'14.49"E**

Jetties, Tanks and marinas show no visible signs of damage. Note marina developments in this area not depicted on current BA chart.

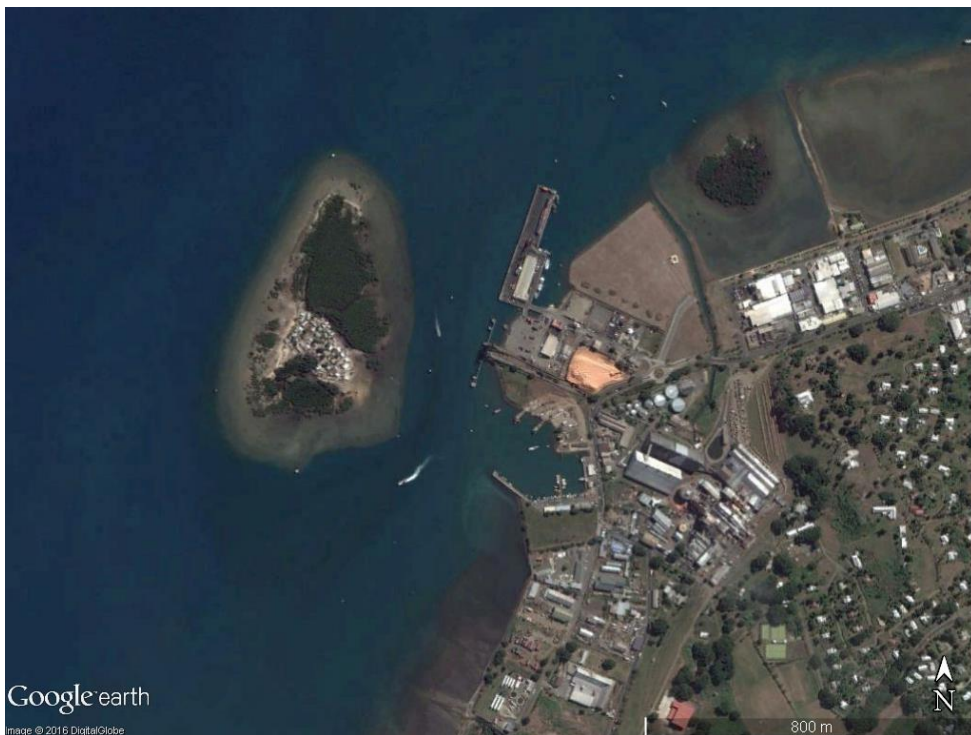
**Lautoka Harbour, centred on 17°36'18.79"S, 177°26'18.11"E**

Jetties in Harbour show no visible damage and buoys and nav aids appear intact.

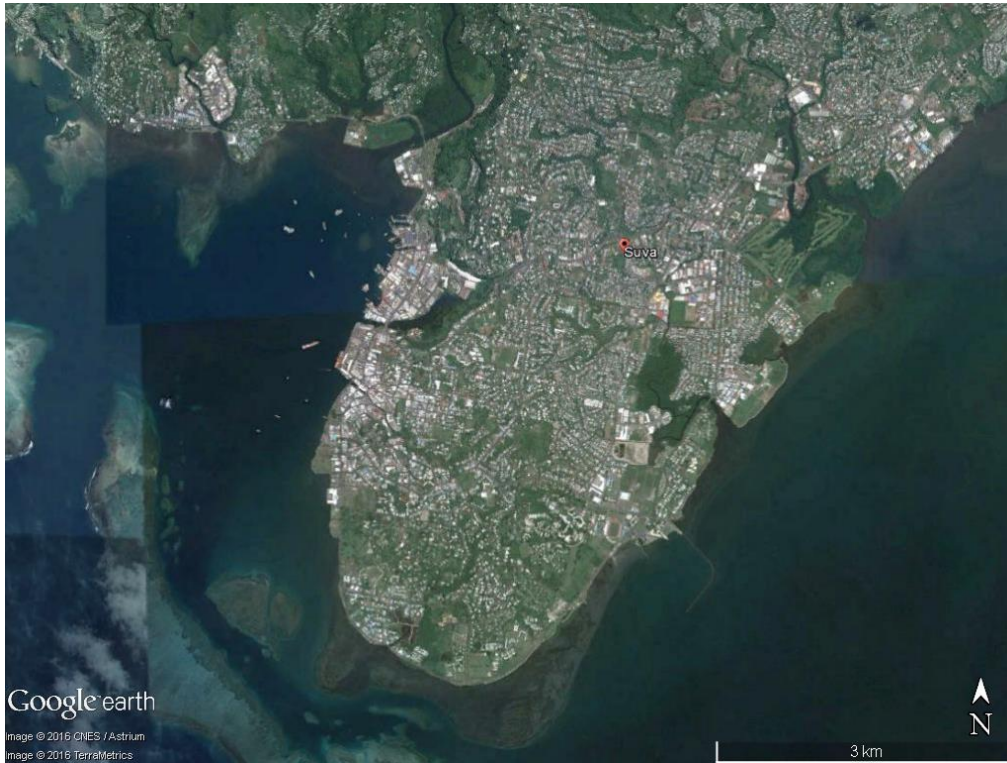
**Suva, centred on 18° 9'28.25"S, 178°26'23.63"E**

Dwellings, Jetties and other maritime infrastructure show no visible signs of damage.

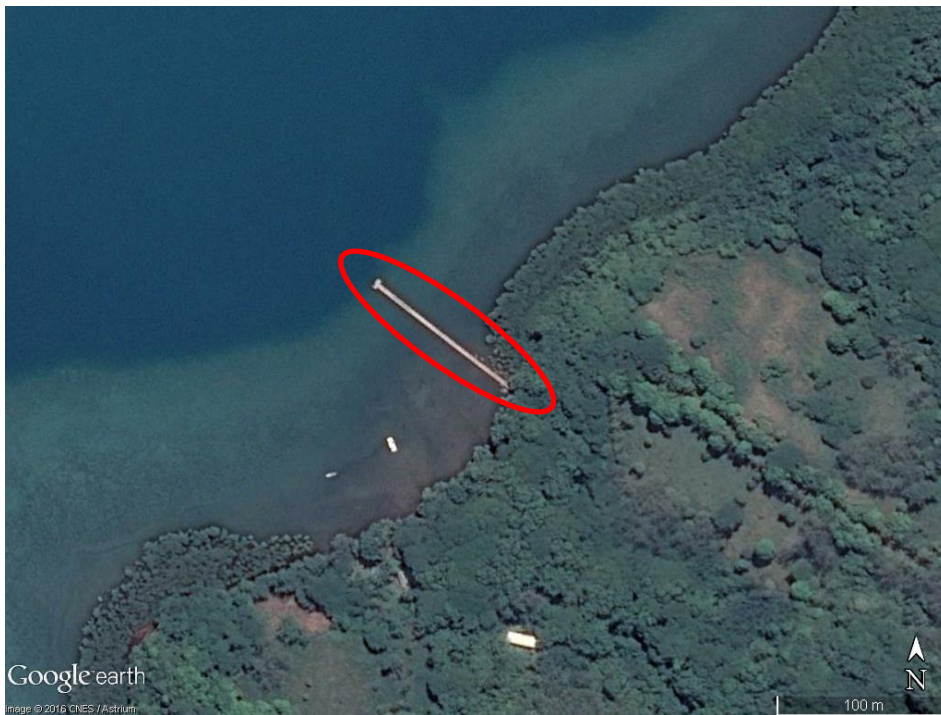
**Nanunu-I-Cake island , centred on 17°19.25'S, 178°13.45'E**

**Jetty destroyed** on Nananu-I-Cake island at 17°19.25'S, 178°13.45'E

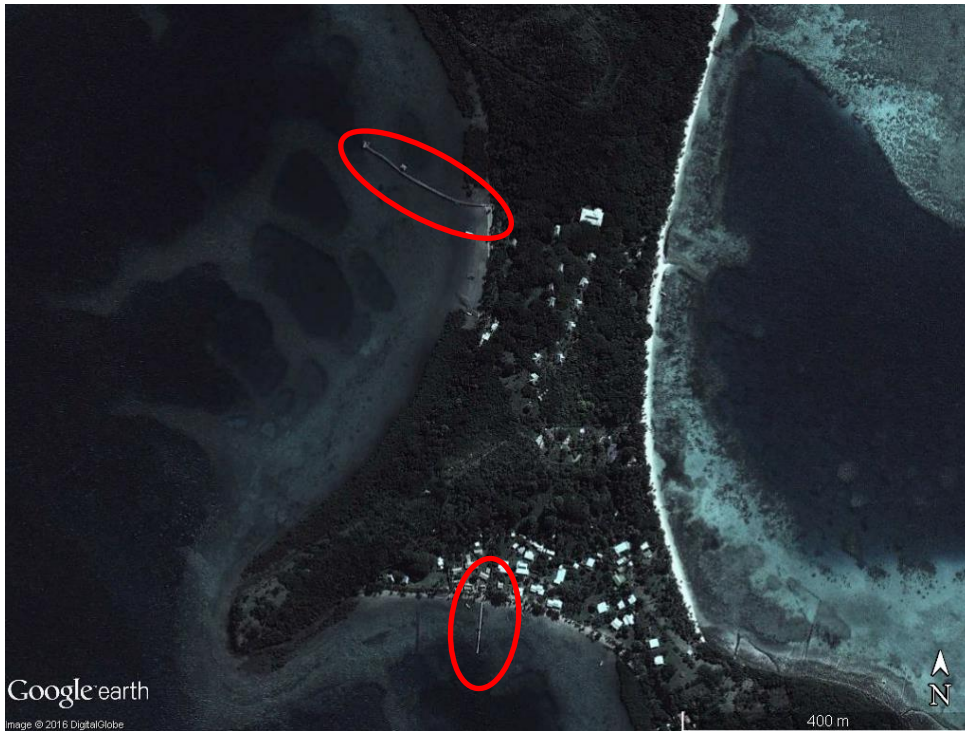
**Nananu-I-Ra island , centred on 17°17.78'S, 178°13.00'E**

**Two jetties destroyed** on Nananu-I-Cake island at 17°19.25'S, 178°13.45'E
