Paper for Consideration by NCWG
Marine Incidents: Grounding of “Nova Cura”

Submitted by:	Netherlands Hydrographic Office
Executive Summary:	Lessons learned from the grounding of the Nova Cura
Related Documents:	Report Dutch Safety Board
Related Projects:

Digital navigation: old skills in new technology

Lessons from the grounding of the Nova Cura

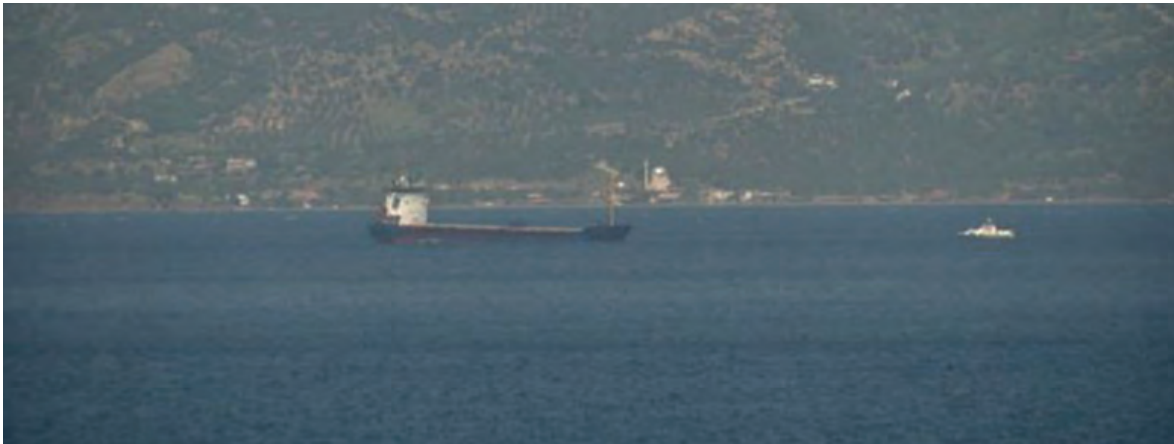
Figure 1: The *Nova Cura* grounded in Mytilini Strait (Greece). Source: Dutch Safety Board

The digital chart in the ECDIS (Electronic Chart Display and Information System, see blue box on page 6) indicated that the sea should be 112 metres deep at the ship's position. However, the ship appeared to have run aground in shallow water at Lamnas Reef.

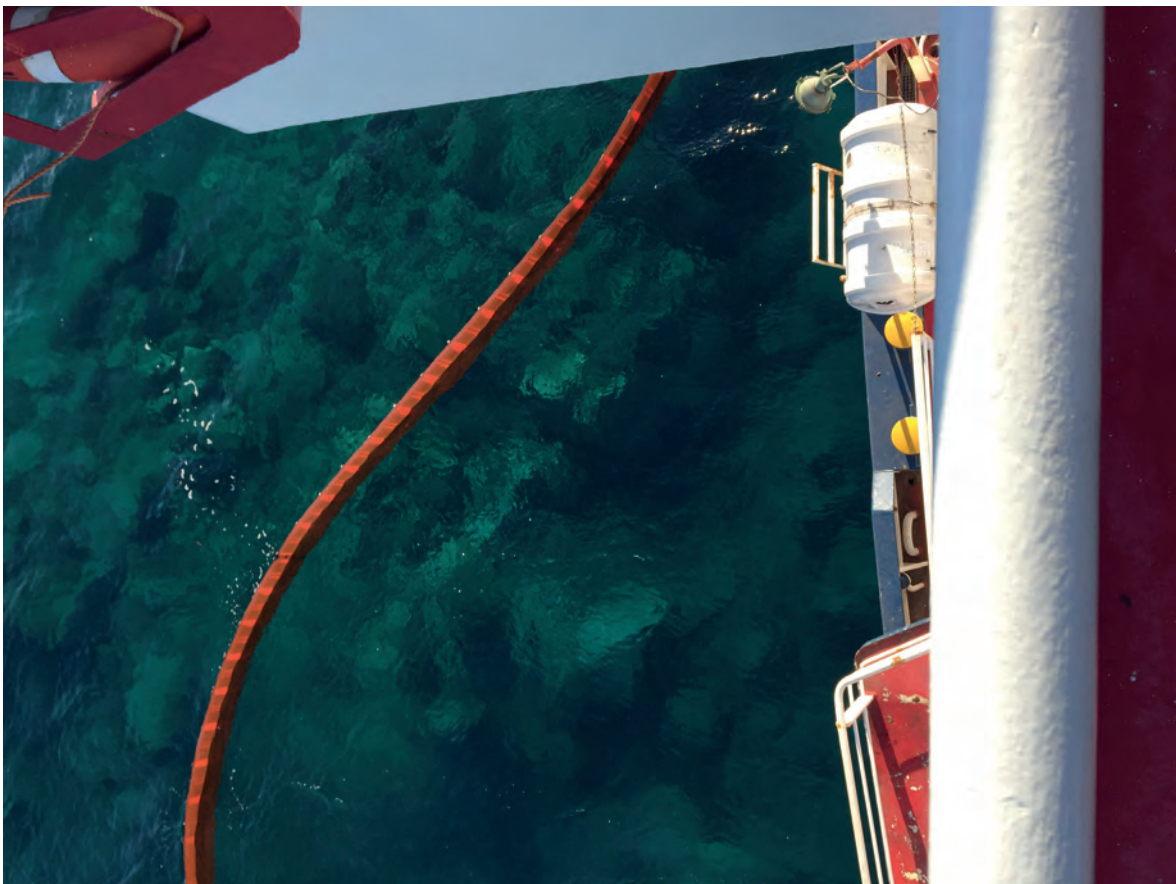
Figure 4: The rocks were visible from the bridge wing of the Nova Cura. Source: Crew Nova Cura

The fore of the Nova Cura extended beyond the shallow water, but from the midship to the stern the Nova Cura was sitting on top of a rock. The ECDIS still indicated that the water depth in that location had to be 112 metres and that the shallow water was about 0.2 nautical miles – about 400 meters - further north (port side) of the vessel.

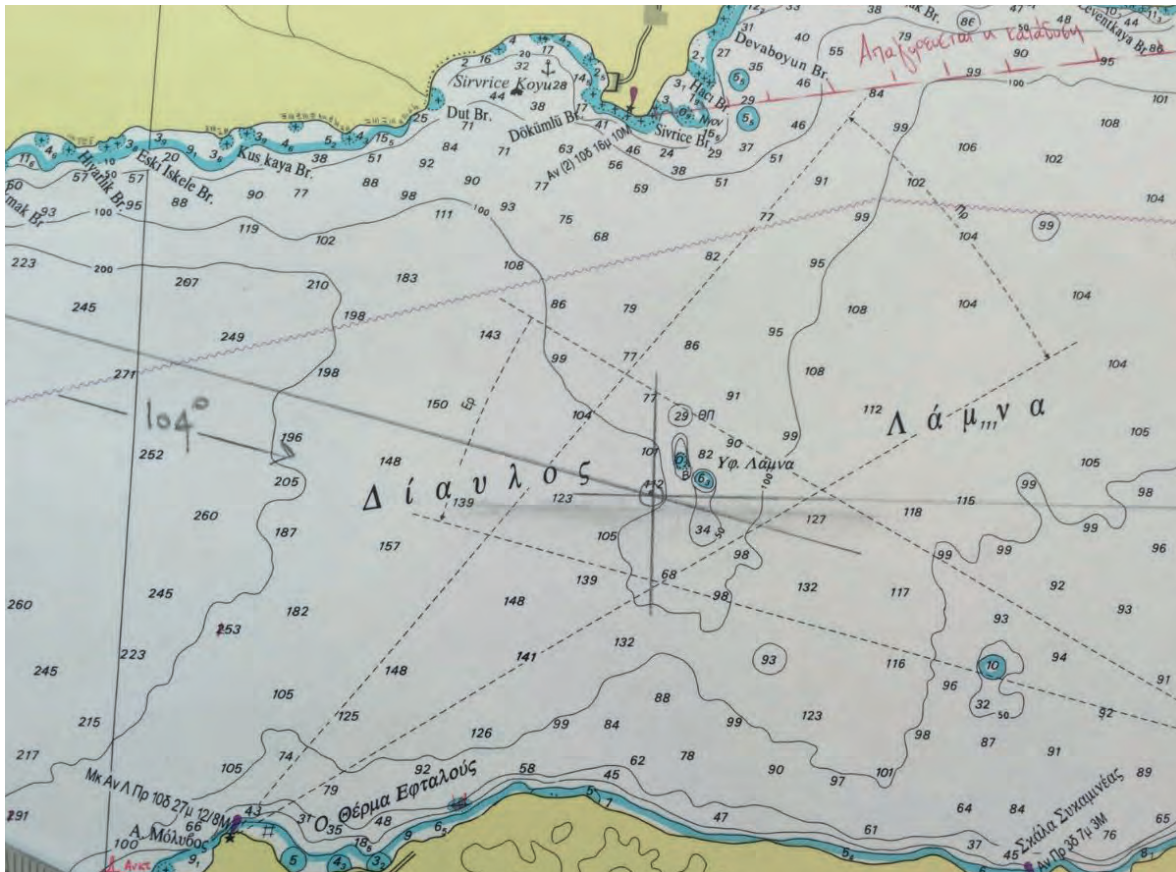
The HNHS has published a paper nautical chart and an ENC for Mytilini Strait, see Figure 7. The survey of the area was performed in 1967 with the equipment available at that time (analogue). Due to the emerging use of ECDIS and the demand for ENCs, the HNHS produced the first ENC of the area in 2004, based on 1967 data.

Figure 7: Greek paper nautical chart of the accident site. Source: Crew Nova Cura

Due to the age (1967) of the data that was used for the original paper nautical chart (and therefore the ENC), the ENC was designated as CATZOC 'U'. This means that the reliability of the data used has not been determined.

1. Impose conditions for the age and reliability of the data used to compile ENC's and stimulate the decrease of ENC's with CATZOC U.

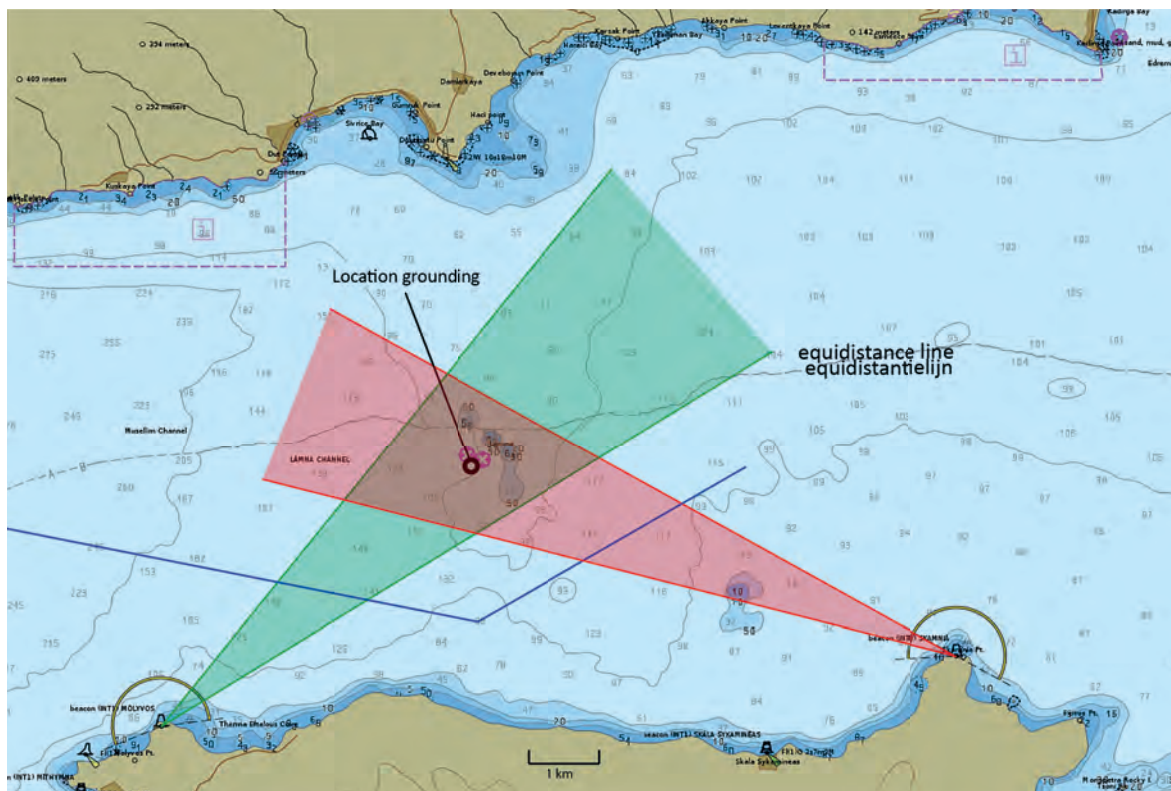
Figure 8: Sector lights in Mytilini Strait. Source: GR4APP01

The sector lights Ák Mólivos (on the left in Figure 8) and Ák Skamniá (on the right in Figure 8) are both intended to warn of the danger of Lamnas Reef. In this case, the danger is located in the area illuminated simultaneously by both the green and the red sector lights. For the passage south of Lamnas Reef, coming from the west as the Nova Cura had intended (on the left of Figure 8), the vessel should approach in the left white sector of Ák Skamniá (see blue line⁹ in Figure 8). Only when the vessel has passed the green sector of Ak Mólivos, can it go to the port side; in this case both sector lights are white. After that the vessel passes the red sector of Ak Skamniá and has passed Lamnas Reef. The coordinates of the area covered by the sector lights were also stated in the Pilots for the area (NP48). It is not forbidden to sail in the green or red sector of sectorlights.

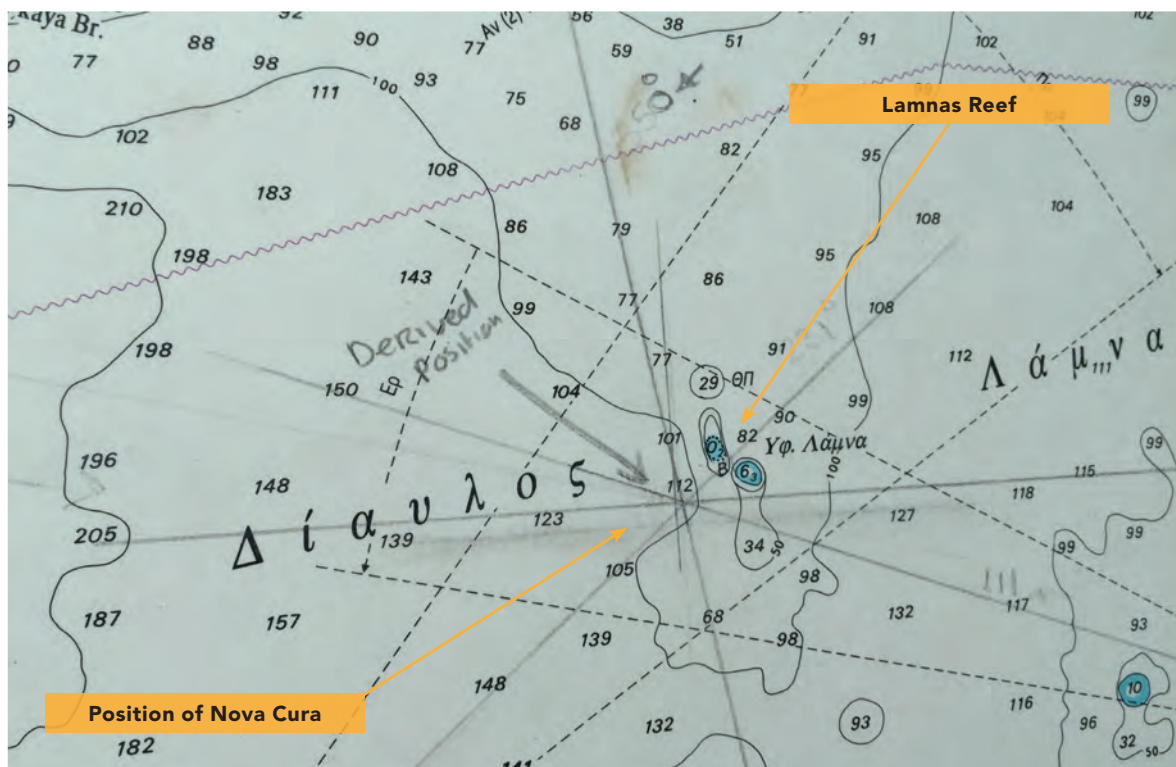
The position of Lamnas Reef was found to be incorrectly stated on the Greek charts.

Figure 10 shows the position of the Nova Cura in relation to Lamnas Reef. The GPS position of the Nova Cura was verified by taking cross bearings. The position where the Nova Cura ran aground is 0.2 miles more south than the charted shallow area.

Figure 10: Result of cross bearings showing the position of the Nova Cura on the Greek paper nautical chart.
Source: Crew Nova Cura

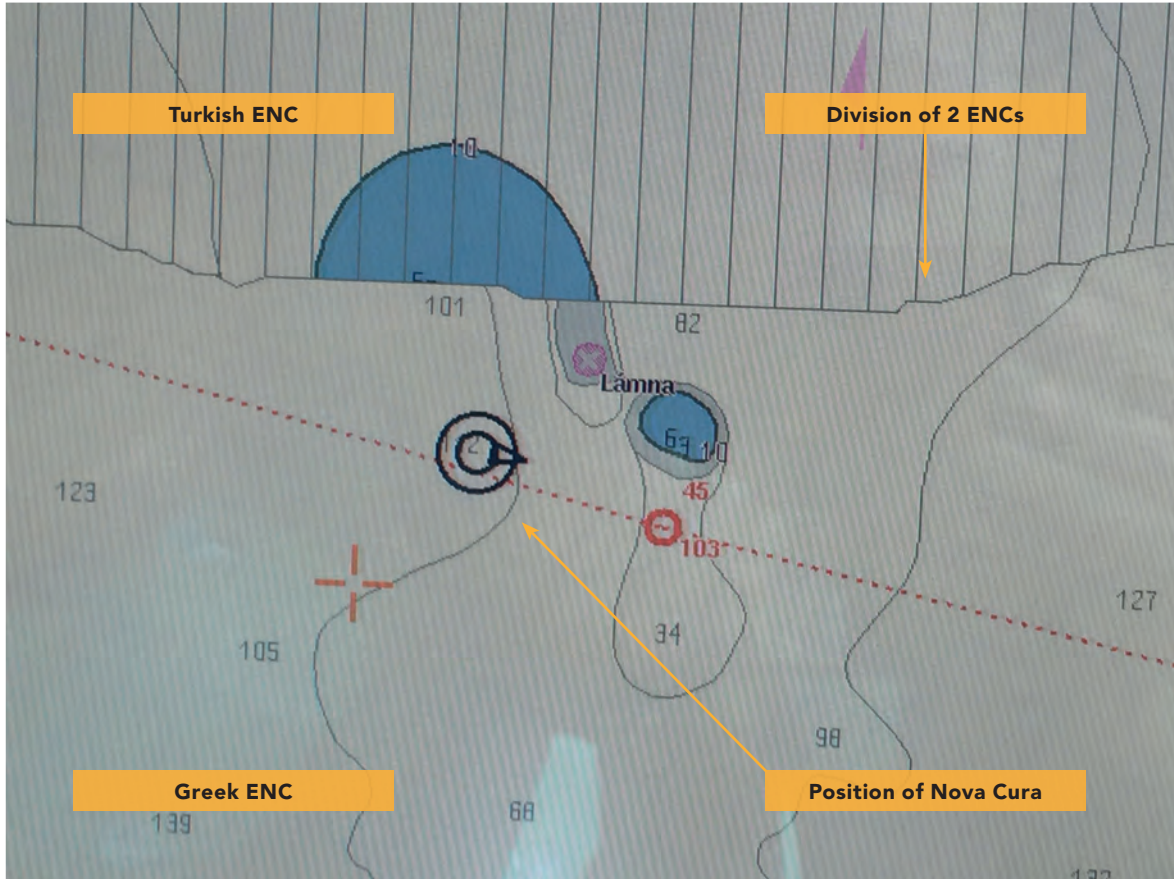
ECDIS was used on board the Nova Cura for navigation and not paper nautical charts. Figure 11 shows the position of the Nova Cura on ECDIS; it shows the same image as the Greek paper nautical chart. Figures 10 and 11 both show that the depth of the water at the location where the Nova Cura ran aground should be 112 metres, according to the Greek nautical charts.

Another striking point in Figure 11 is the division between two ENC's. The scale of the bottom ENC differs from that of the top ENC (illustrated by the vertical lines) and the shallow water in the top ENC (blue area) ends abruptly on the division between the ENC's. The division between the two ENC's corresponds to the location of the border¹² between Turkey (top section) and Greece (bottom section).

Figure 11: ECDIS image of the accident site. Source: ECDIS Nova Cura

The position of the shallows of Lamnas Reef on the available ENC deviated from their actual location. According to the ENC, the shallows were supposed to be 0.2 nautical miles (about 400 metres) further north. Because of unfamiliarity with the concept of CATZOC to assess the reliability of the ENC, the crew were unaware that major deviations could be present on the ENC. In addition, their impression that the shallows ended abruptly at the transition between two ENCs gave the crew no cause to keep a greater distance from Lamnas Reef. The distance to the shallows chosen in this case (± 400 metres) appeared to be insufficient to prevent the ship from running aground.

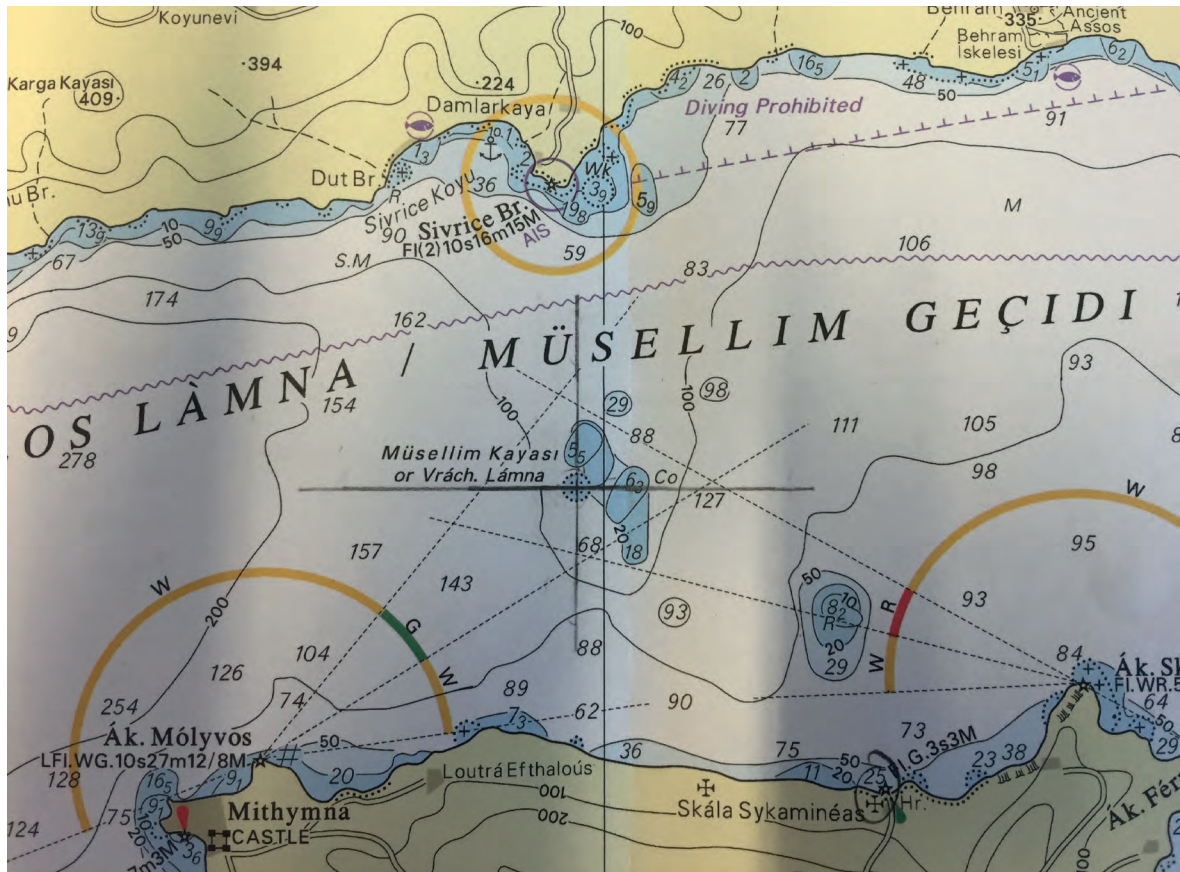
As stated earlier in this report, only countries whose waters are involved, may create and publish ENC's. Or let other hydrographic offices do this on their behalf. This is in contrast to paper nautical charts. The UKHO's chart, BA 1061, incorporates information from various countries and information sources. Figure 12 shows that BA1061 therefore provides a more complete picture of the accident site. It shows that the shallow water where the Nova Cura ran aground was actually visible.

Figure 12: The accident site plotted on BA1061.

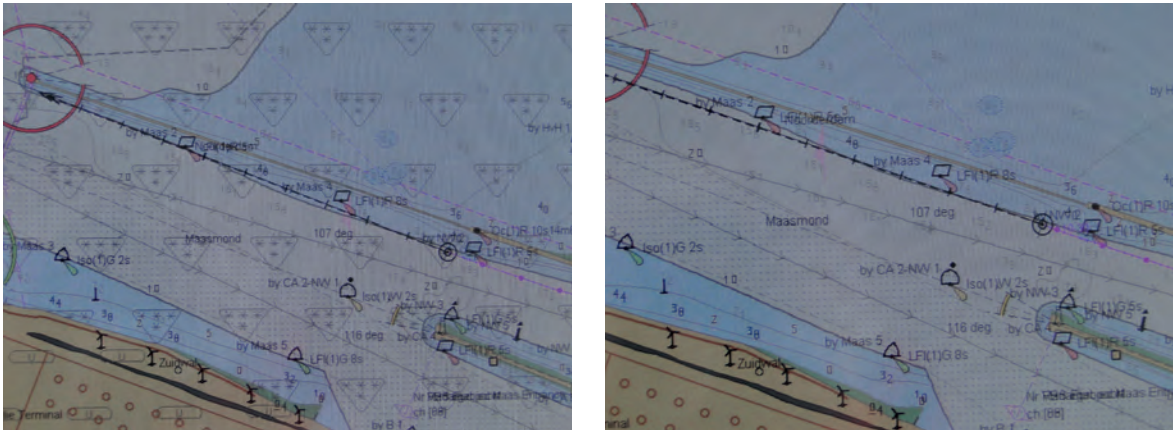
Apart from being unaware of the CATZOC, the setting in ECDIS is not very user friendly. The layer which makes the CATZOC visible in ECDIS can be 'enabled' or 'disabled'. If this layer is constantly 'enabled', the image becomes contaminated, as shown in Figure 13. Therefore it is good practice to 'enable' the layer for a while during voyage preparations to verify the different CATZOCs located on the route. It is equally important to check the CATZOC of the new route in the event of deviating from the planned route, particularly if it is the first voyage on that route.

Figure 13: ENC displayed, left with CATZOC 'enabled', right with CATZOC 'disabled'.

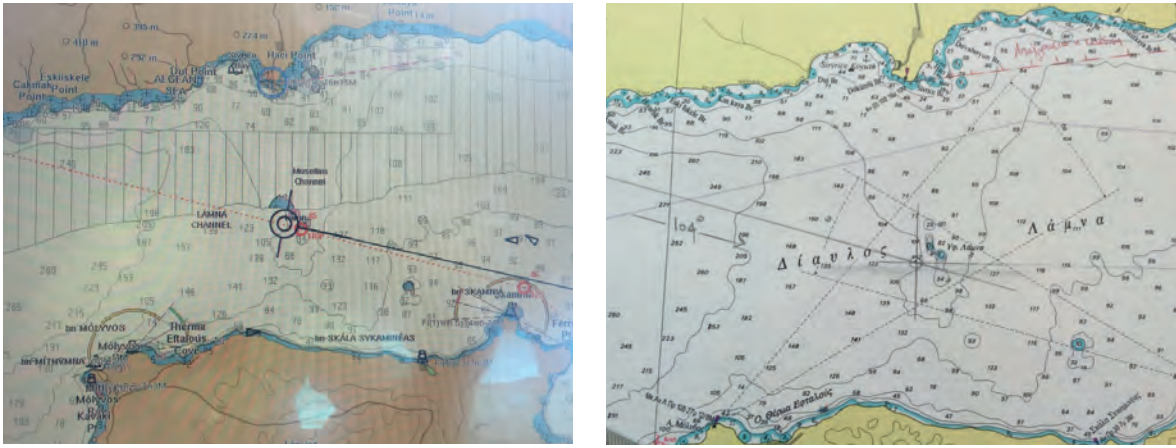
Nevertheless it is striking that the sector boundaries do not extend to the danger they are covering. This in contrary to the sector boundaries on paper charts. This is why the sector lights on paper charts work more intuitive than on the ENC's.

Figure 14: Left: Sector lights in ECDIS, right: sector lights on the Greek paper nautical chart.
Source Dutch Safety Board

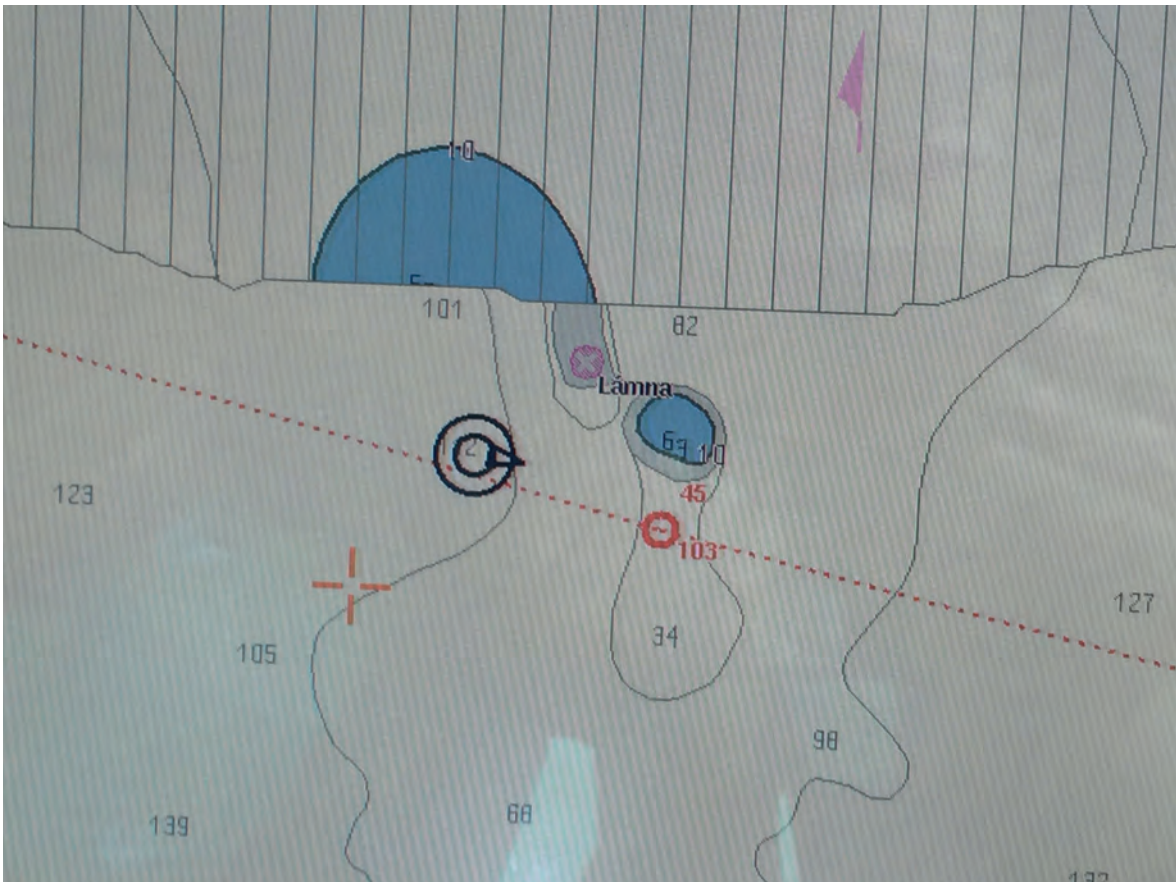
The possibility of zooming in on an ENC may create the feeling that highly accurate navigation is possible. In Figure 15, the *Nova Cura* appears to be at a reasonable distance from Lamnas Reef. Partly due to the high accuracy of GPS equipment, the ship's own position can be indicated very accurately. If, however, the ENC used to project this position is unreliable, positioning down to one metre does not count for much.

Figure 15: Zoomed in position of *Nova Cura* on ECDIS. Source: ECDIS *Nova Cura*
