Paper for Consideration by NIPWG

Grounding of Bulk Carrier Muros—Lessons Learned from Improper Use of ECDIS

Submitted by:	United States (NGA)
Executive Summary:	A look at an “ECDIS-assisted” grounding and how it may affect NIPWG and Hydrographic Offices.
Related Documents:	United Kingdom Marine Accident Investigation Branch Report No. 22/2017 of 19 October 2017 (https://www.gov.uk/maib-reports/grounding-of-bulk-carrier-muros)
Related Projects:	None

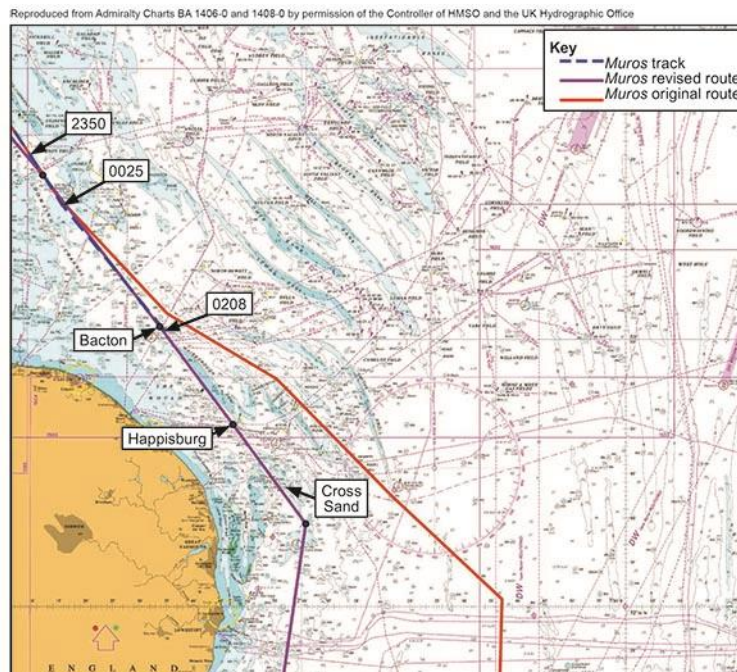
Figure 2—Comparison of Muros’ original Passage Plan and amended Passage Plan

The proximate cause of the grounding was an unsafe Passage Plan resulting from changing the vessel transit from via North Hinder Junction to via Sunk Traffic Separation Scheme.

1. Depth at LW = 5.0 meters.
2. Depth at HW = 6.2 meters.
3. Vessel draft = 6.03 meters (forward) and 6.16 meters (aft).
4. Depth of water too shallow for transit.
5. At best, vessel had an underkeel clearance of 0.04 meters (1.6 inches) only during a very short time at maximum High Water.

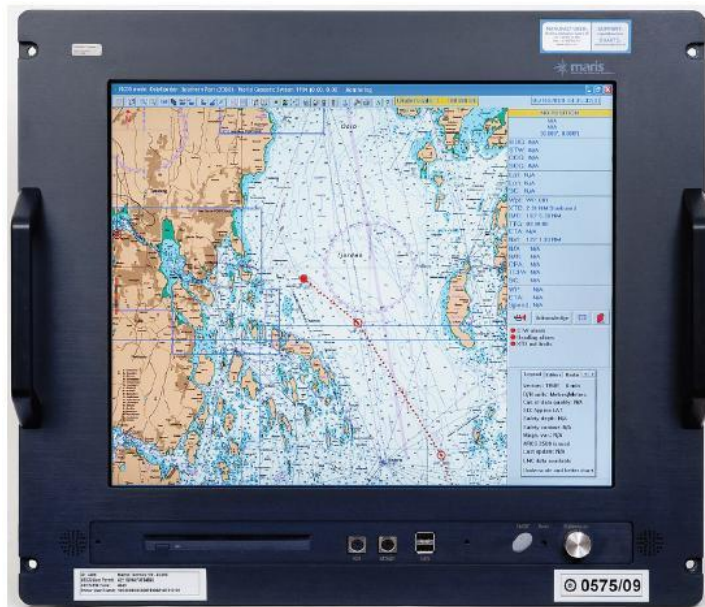
1. ECDIS (Marine Navigation System AB Type ECDIS 900 (MARIS ECDIS900) Mk 10)—Functioning correctly (Figure 3).
2. Vessel navigated on Electronic Navigation Charts supplied by PRIMER, operated by the Norwegian Hydrographic Service.
3. The vessel did not carry paper charts.
4. Radar—Functioning correctly.
5. Bridge Navigational Watch Alarm System (BNWAS)—Functioning correctly. Set to alert at 3-minute intervals.
6. Echo sounder—Switched off after departing Teesport.

Figure 3— Marine Navigation System AB Type ECDIS 900 (MARIS ECDIS900) Mk 10

1. ECDIS system and procedural safeguards intended to prevent groundings overlooked, disabled, or ignored.
2. Visual check of amended Passage Plan by 2/O did not identify the unsafe track over Haisborough Sand.
3. The track of the amended Passage Plan not planned or checked on an appropriate scale chart.
4. The use of the “standard” chart view limited the display of information and allowed the reliance upon visual checks when passage planning to be prone to error.
5. Audible alarms were disabled and the guard zone removed.
6. The ECDIS not used as expected by the regulators or the equipment manufacturers
