ECDIS Display and Alarm Issues

Tim Lewis, Head of International Partnering (America)
XII th MACHC - BASSETERRE, ST.KITTS & NEVIS
Dec 2011

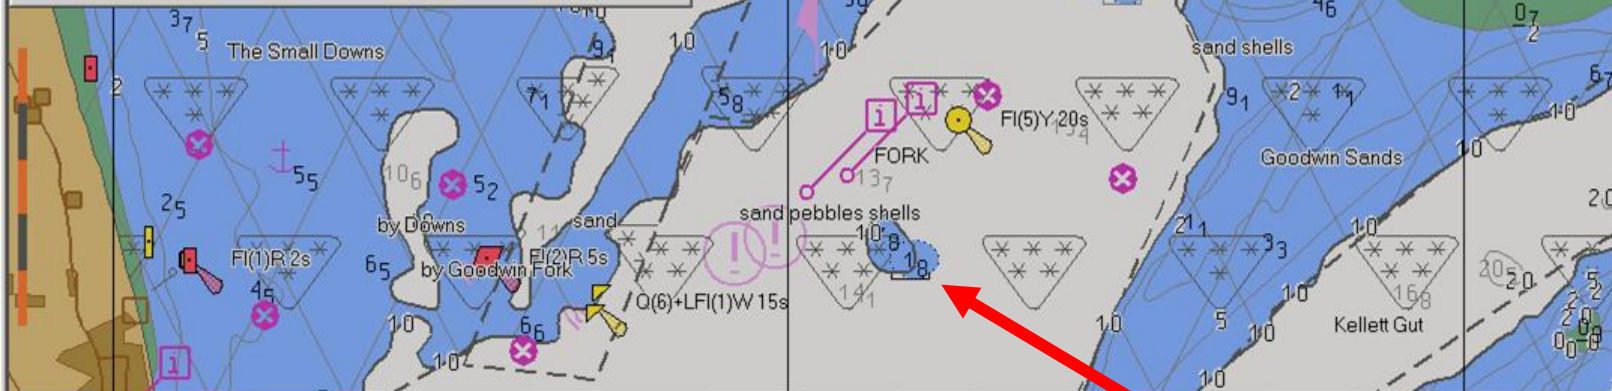
**All display mode
on a coastal scale band ENC
1.8m Wreck displays fine**

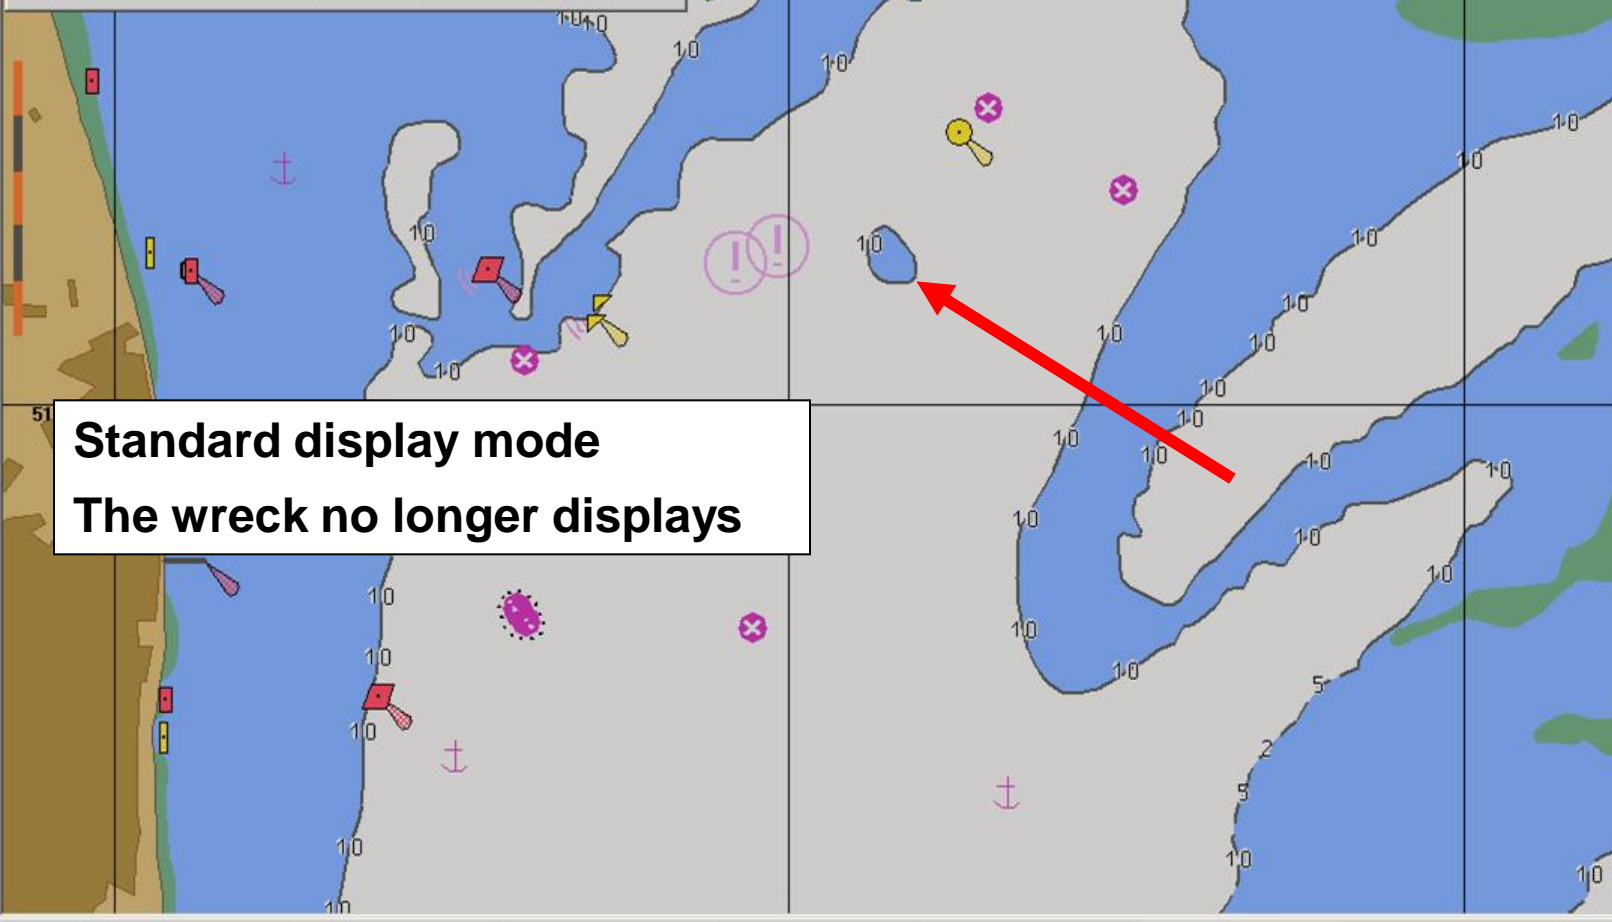
Standard display mode
The wreck no longer displays

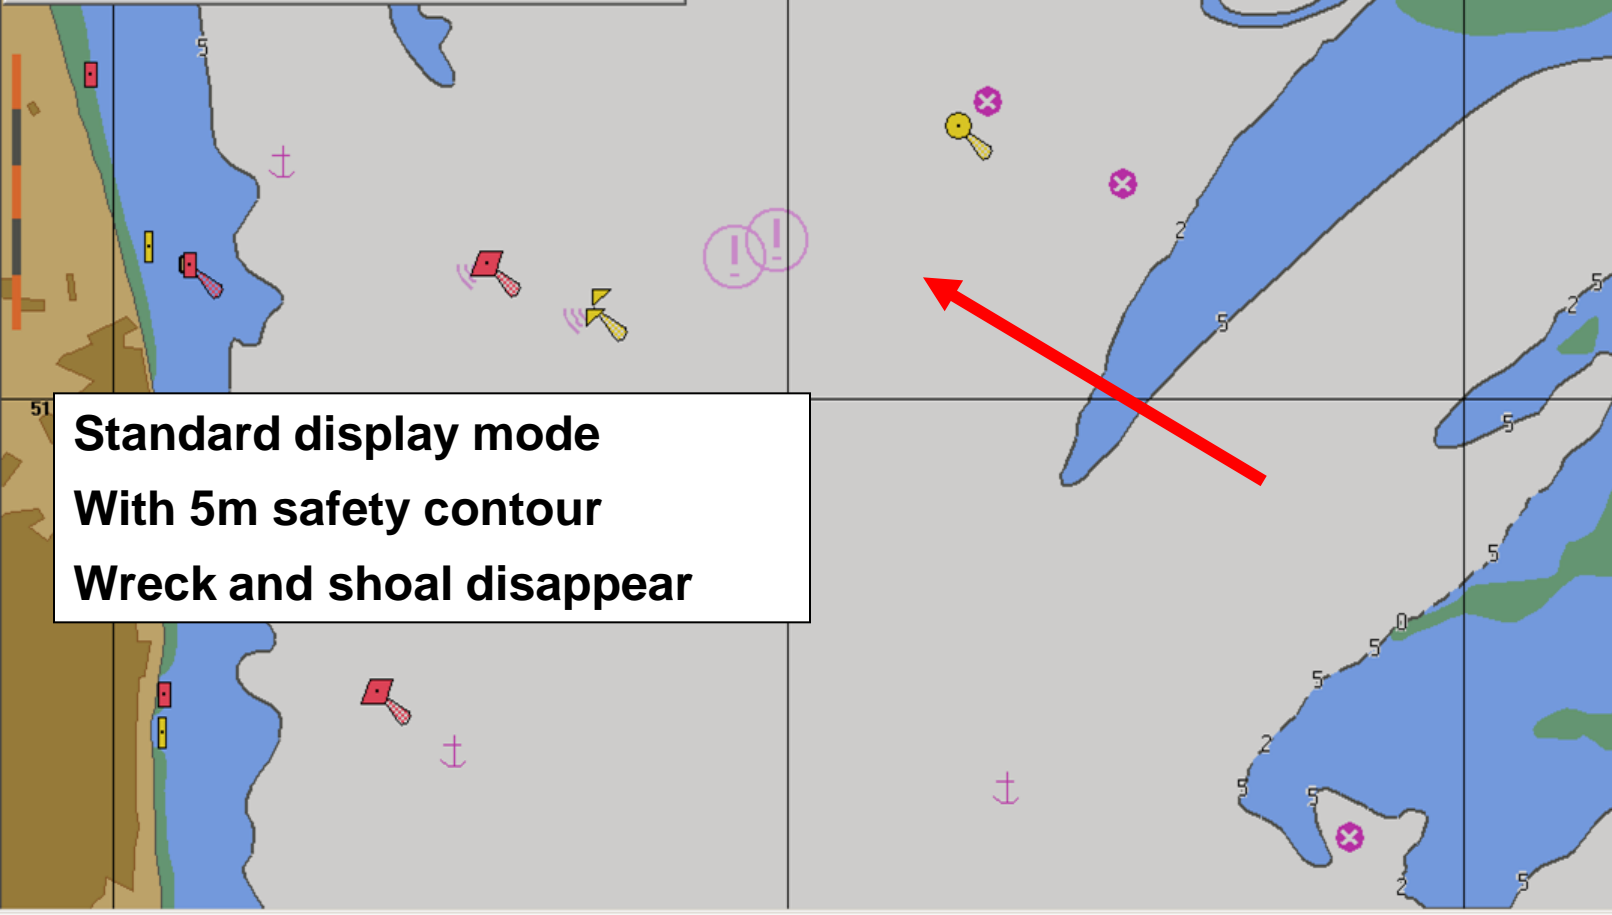
Standard display mode
With 5m safety contour
Wreck and shoal disappear

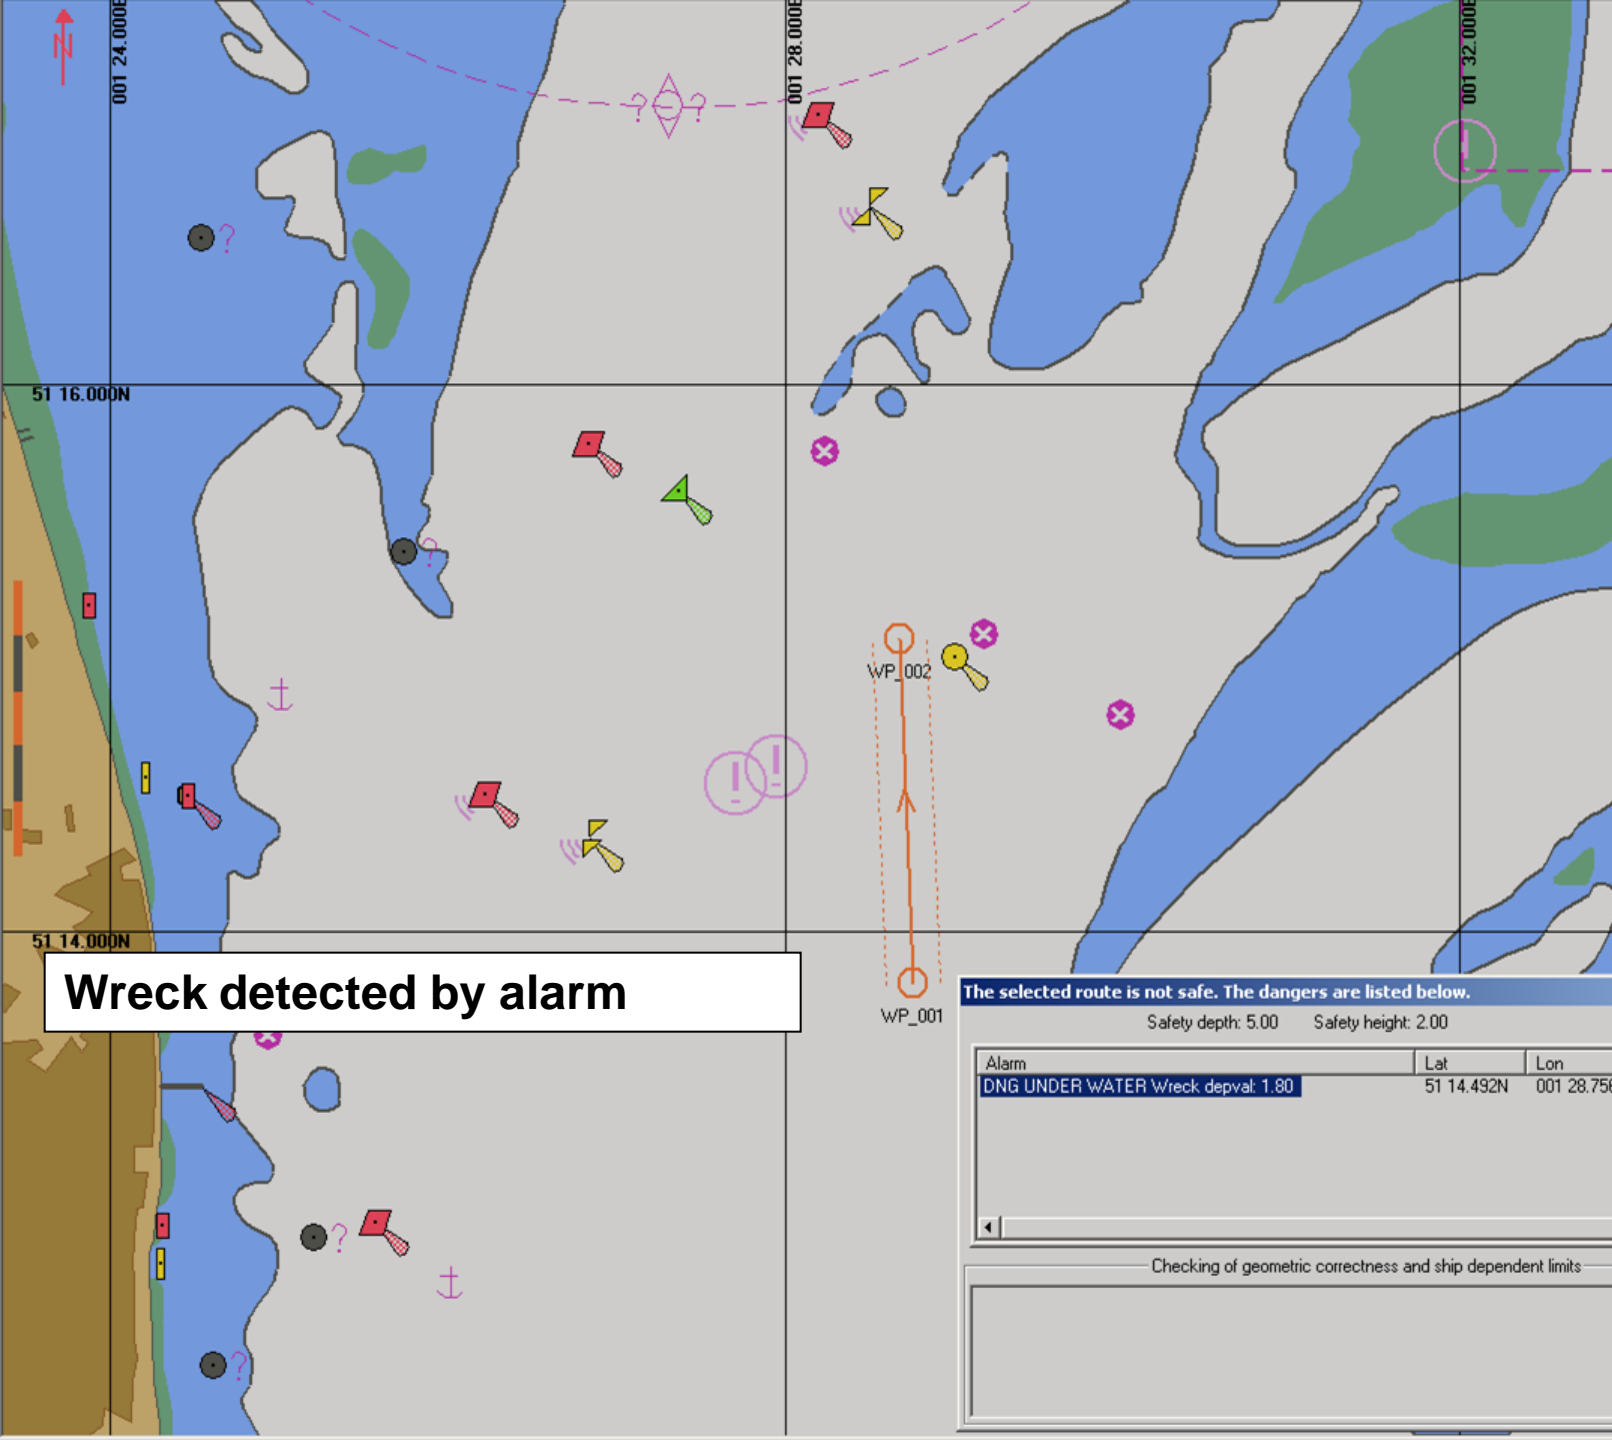
Wreck detected by alarm

| Alarm | Lat | Lon | Leg |
|---|---|---|---|
| DNG UNDER WATER Wreck depval: 1.80 | 51 14.492N | 001 28.756E | WP_001...WP_002 |

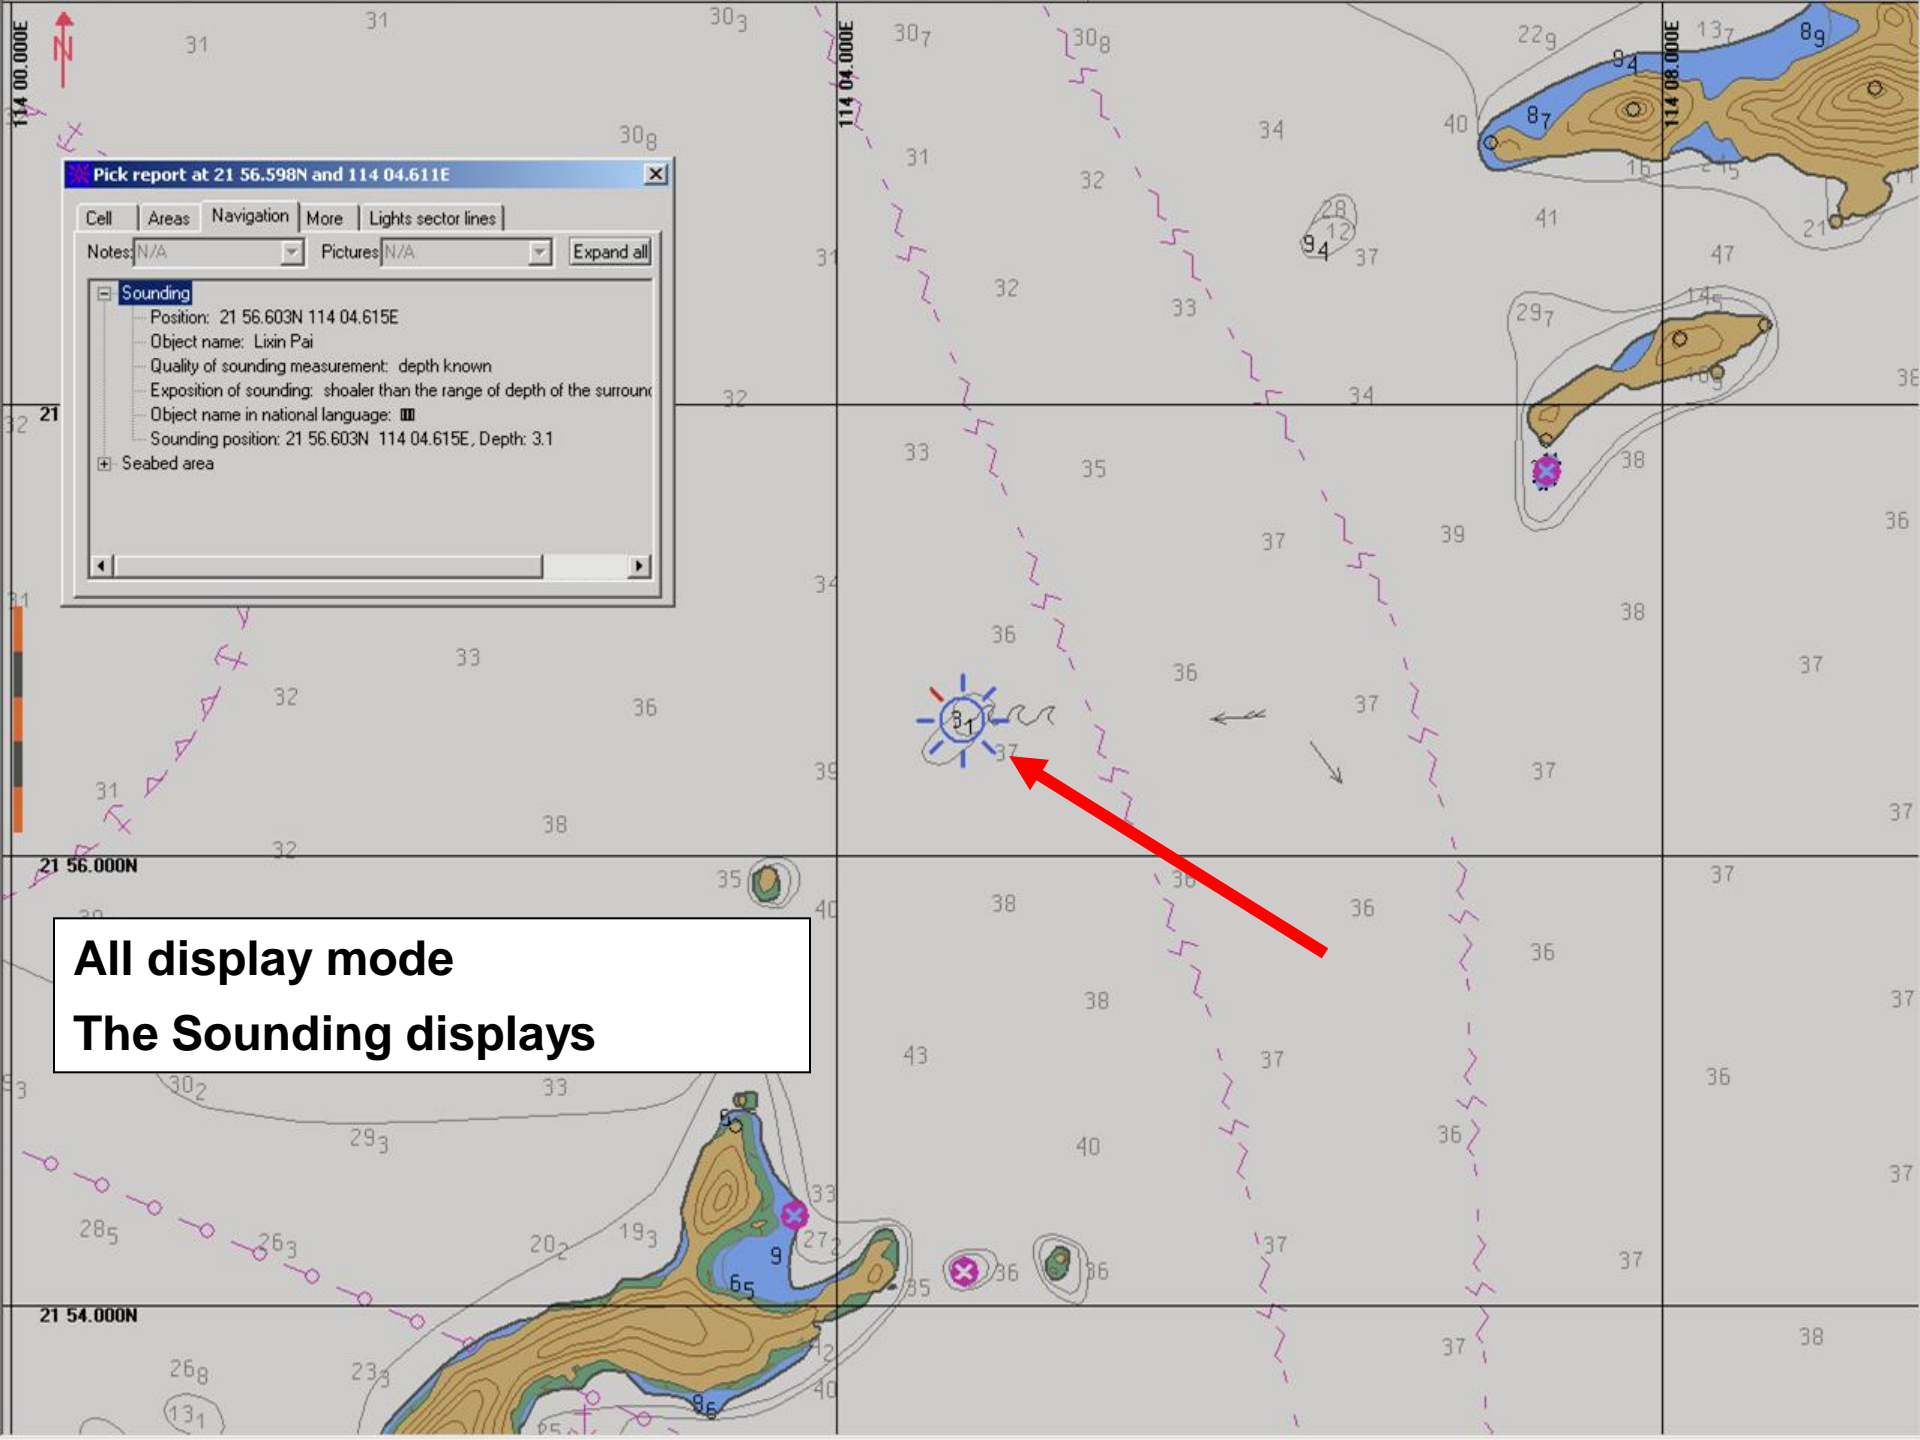
All display mode
The Sounding displays

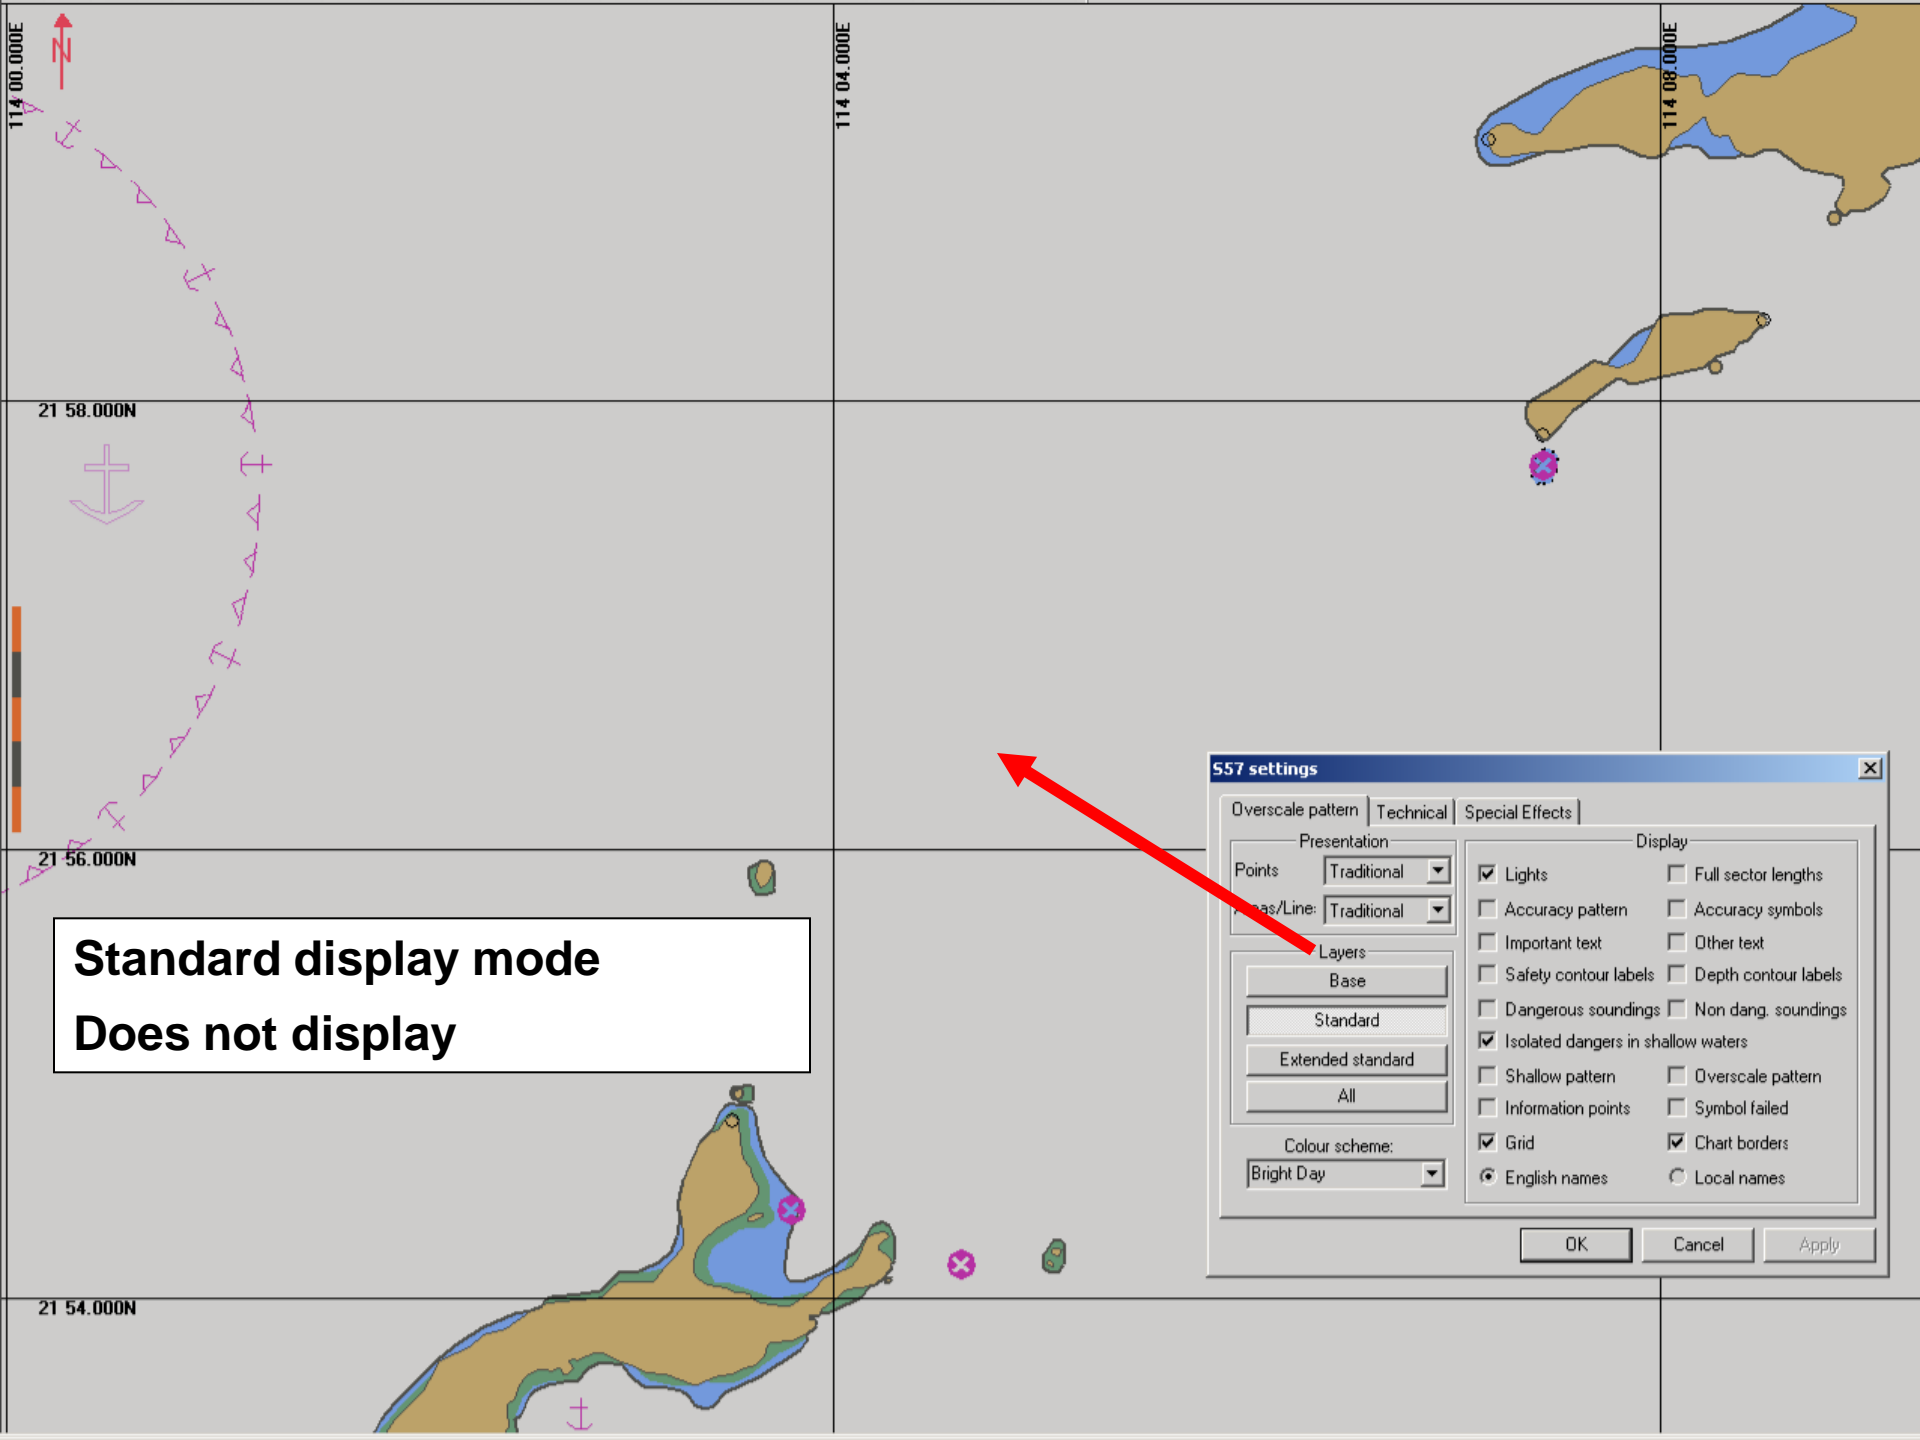
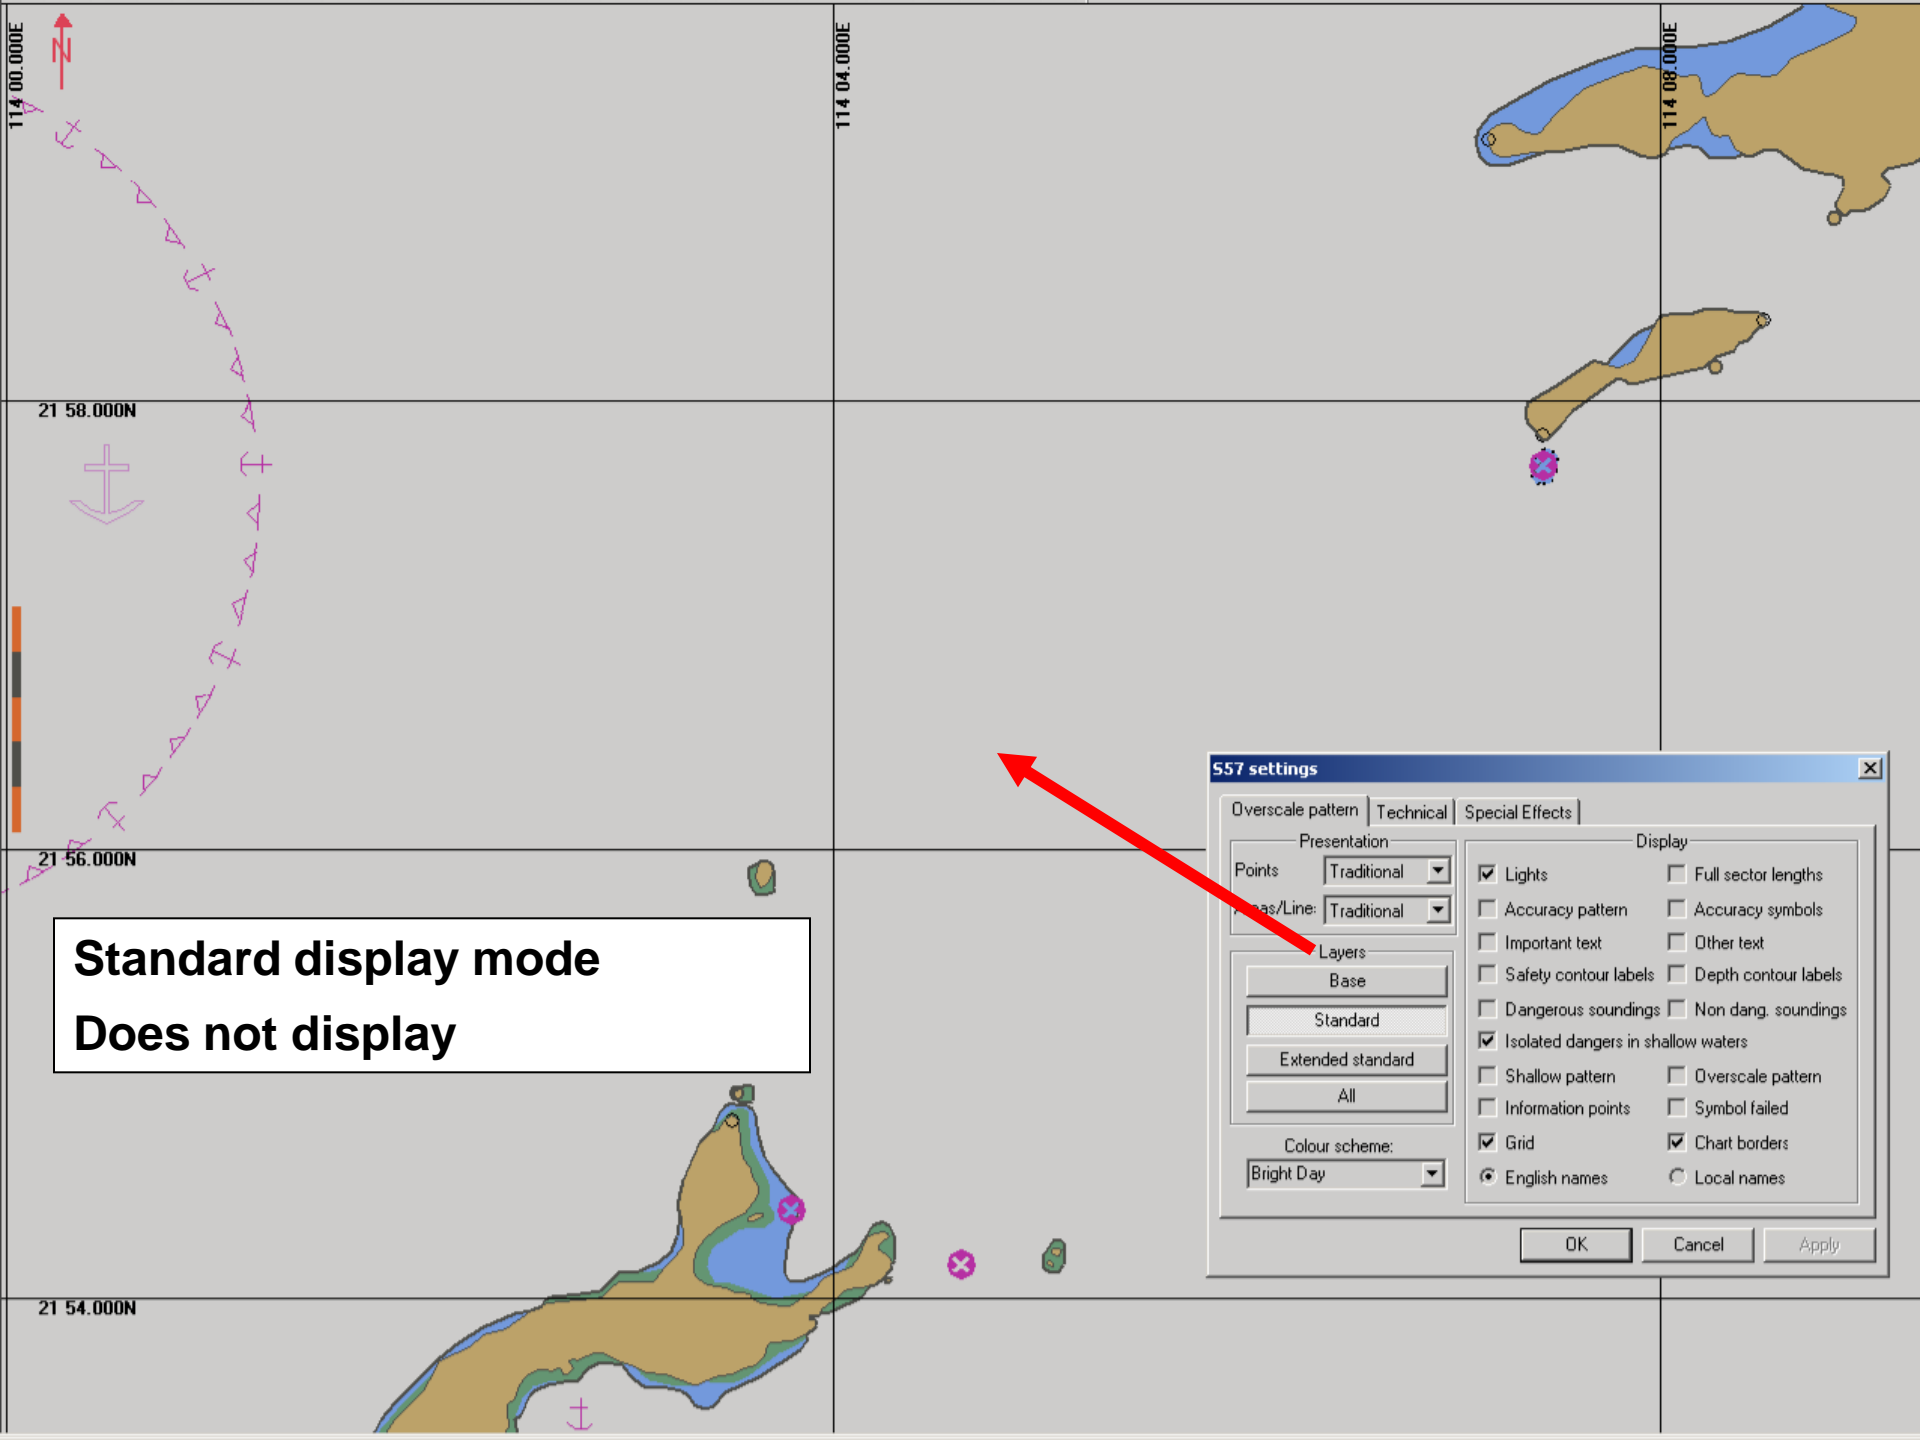
**Standard display mode
Does not display**

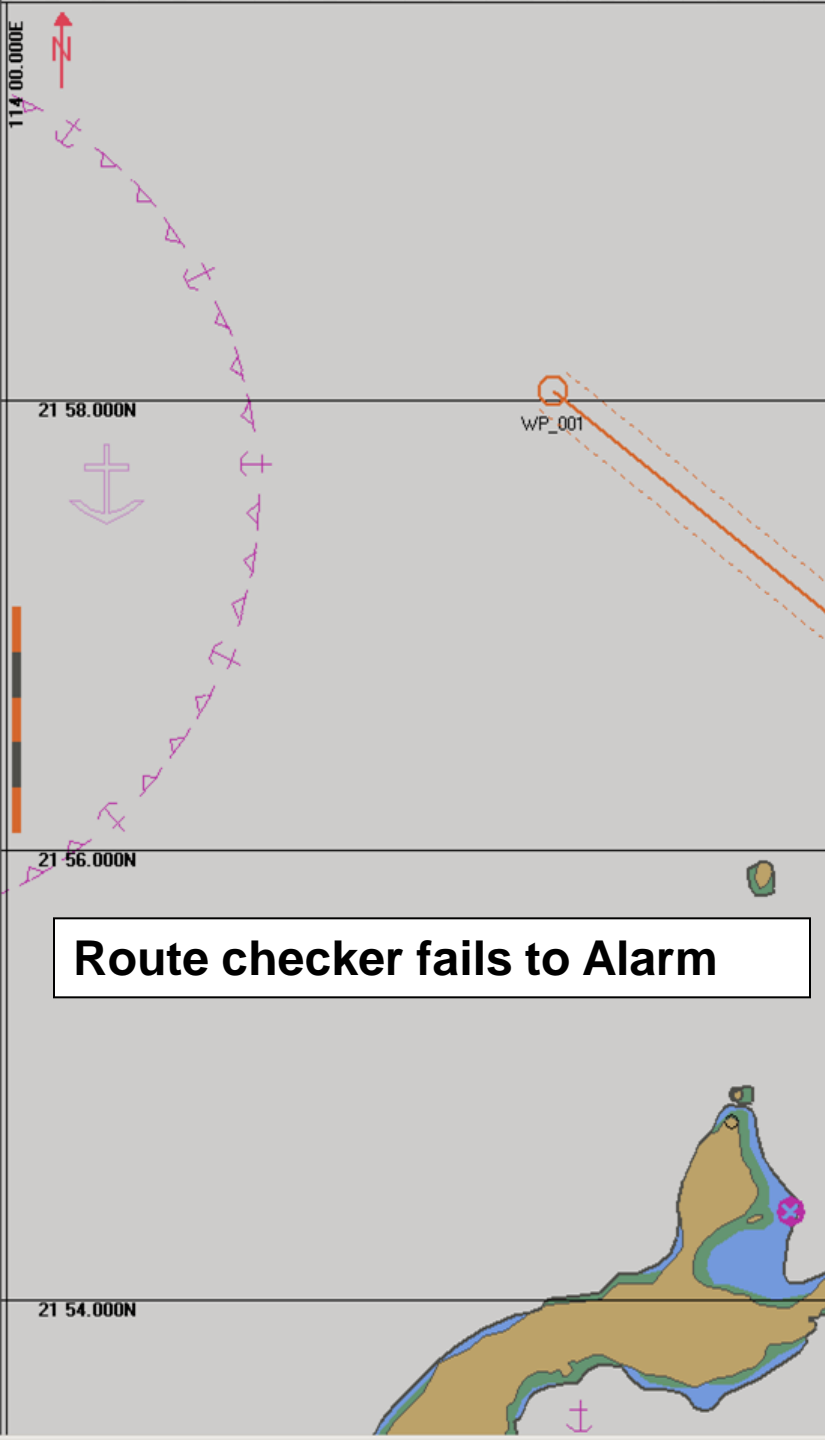
Route is safe

| Alarm | Lat | Lon | Leg |
|---|---|---|---|
| No alarms | N/A | N/A | N/A |

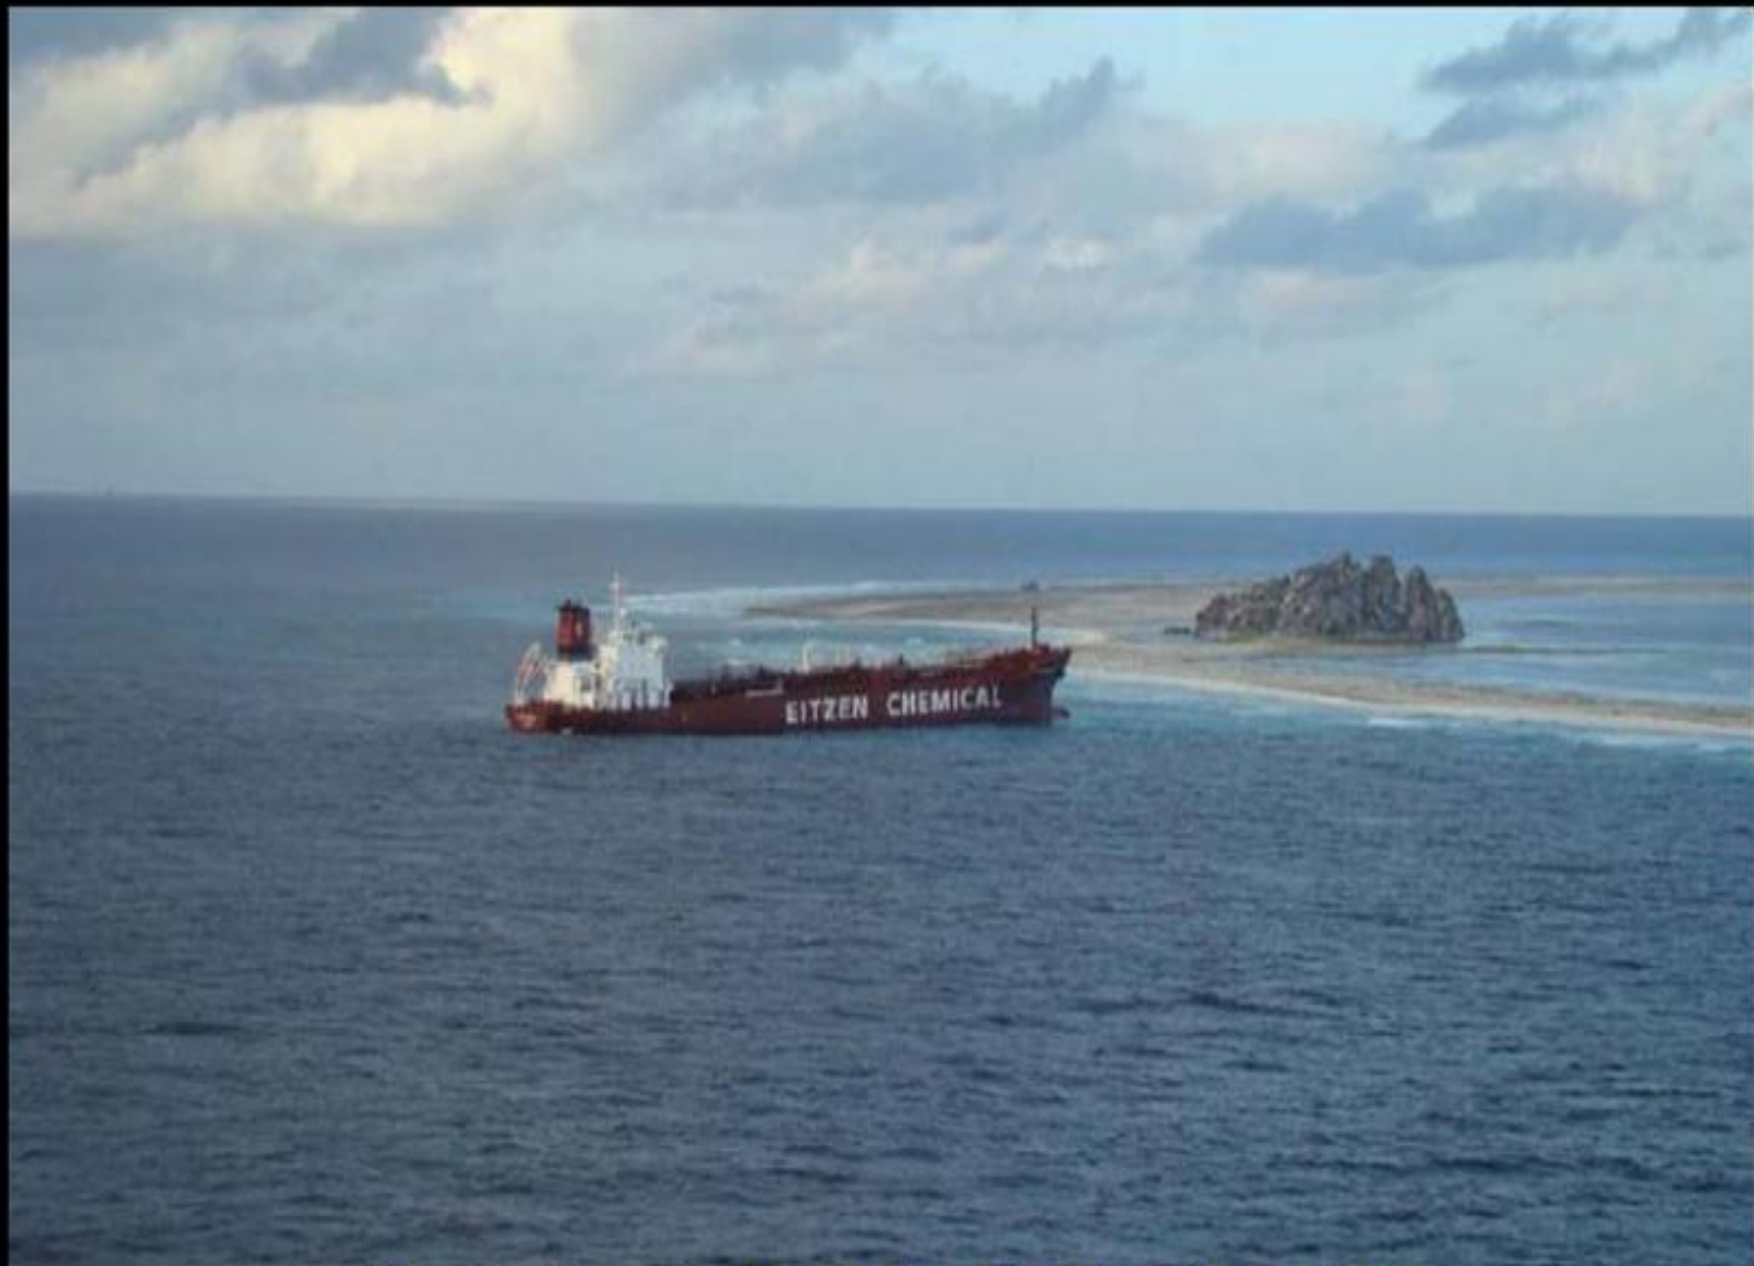
Sichern Osprey aground on the reef at Clipperton Island near Clipperton Rock

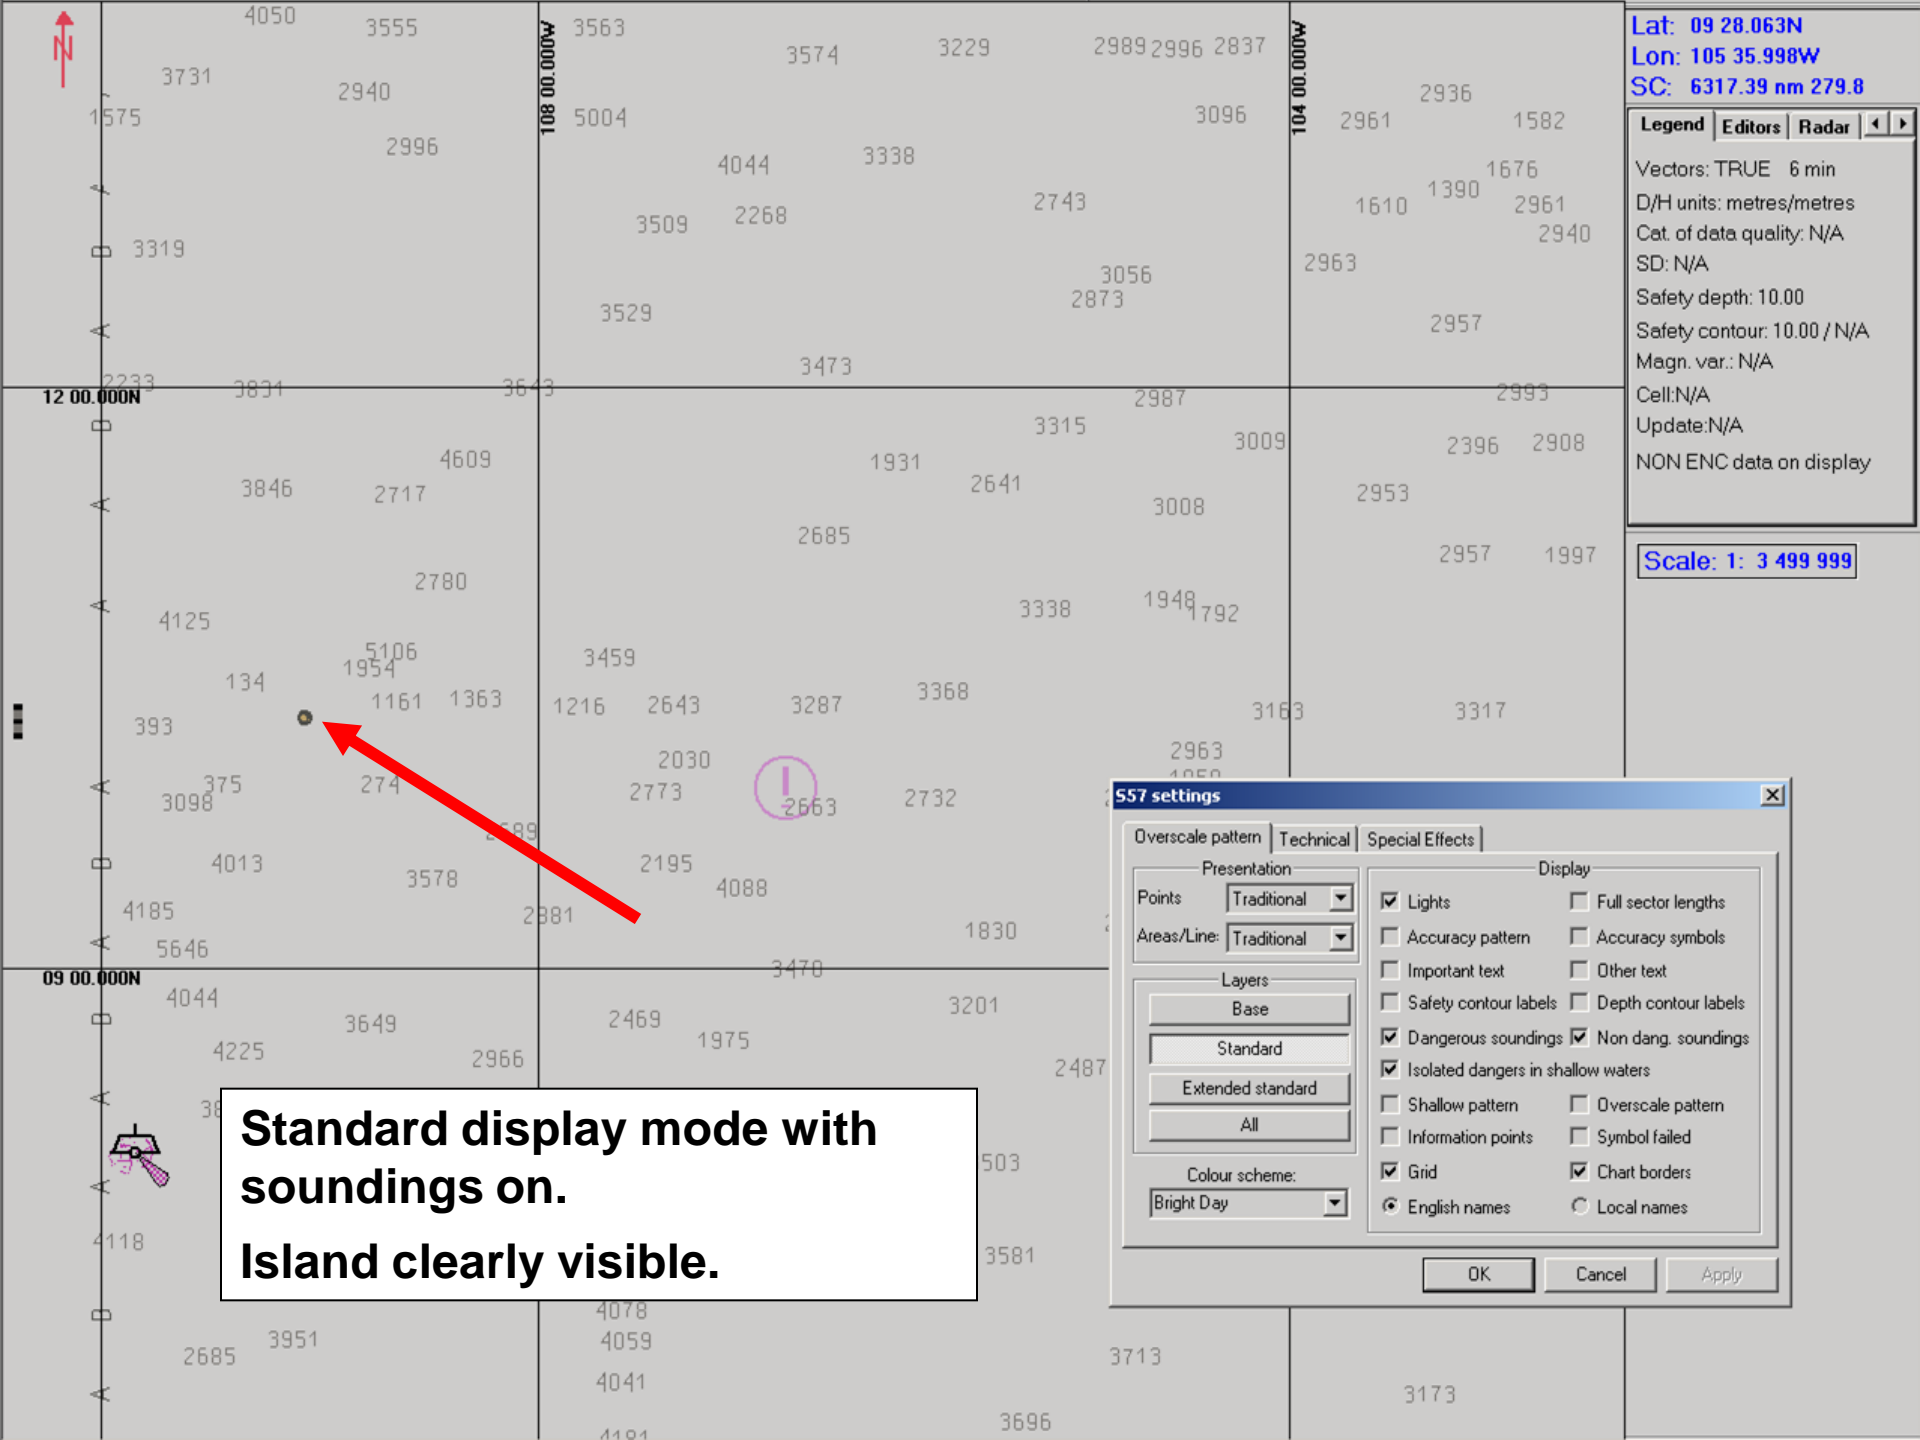
Standard display mode with soundings on. Island clearly visible.

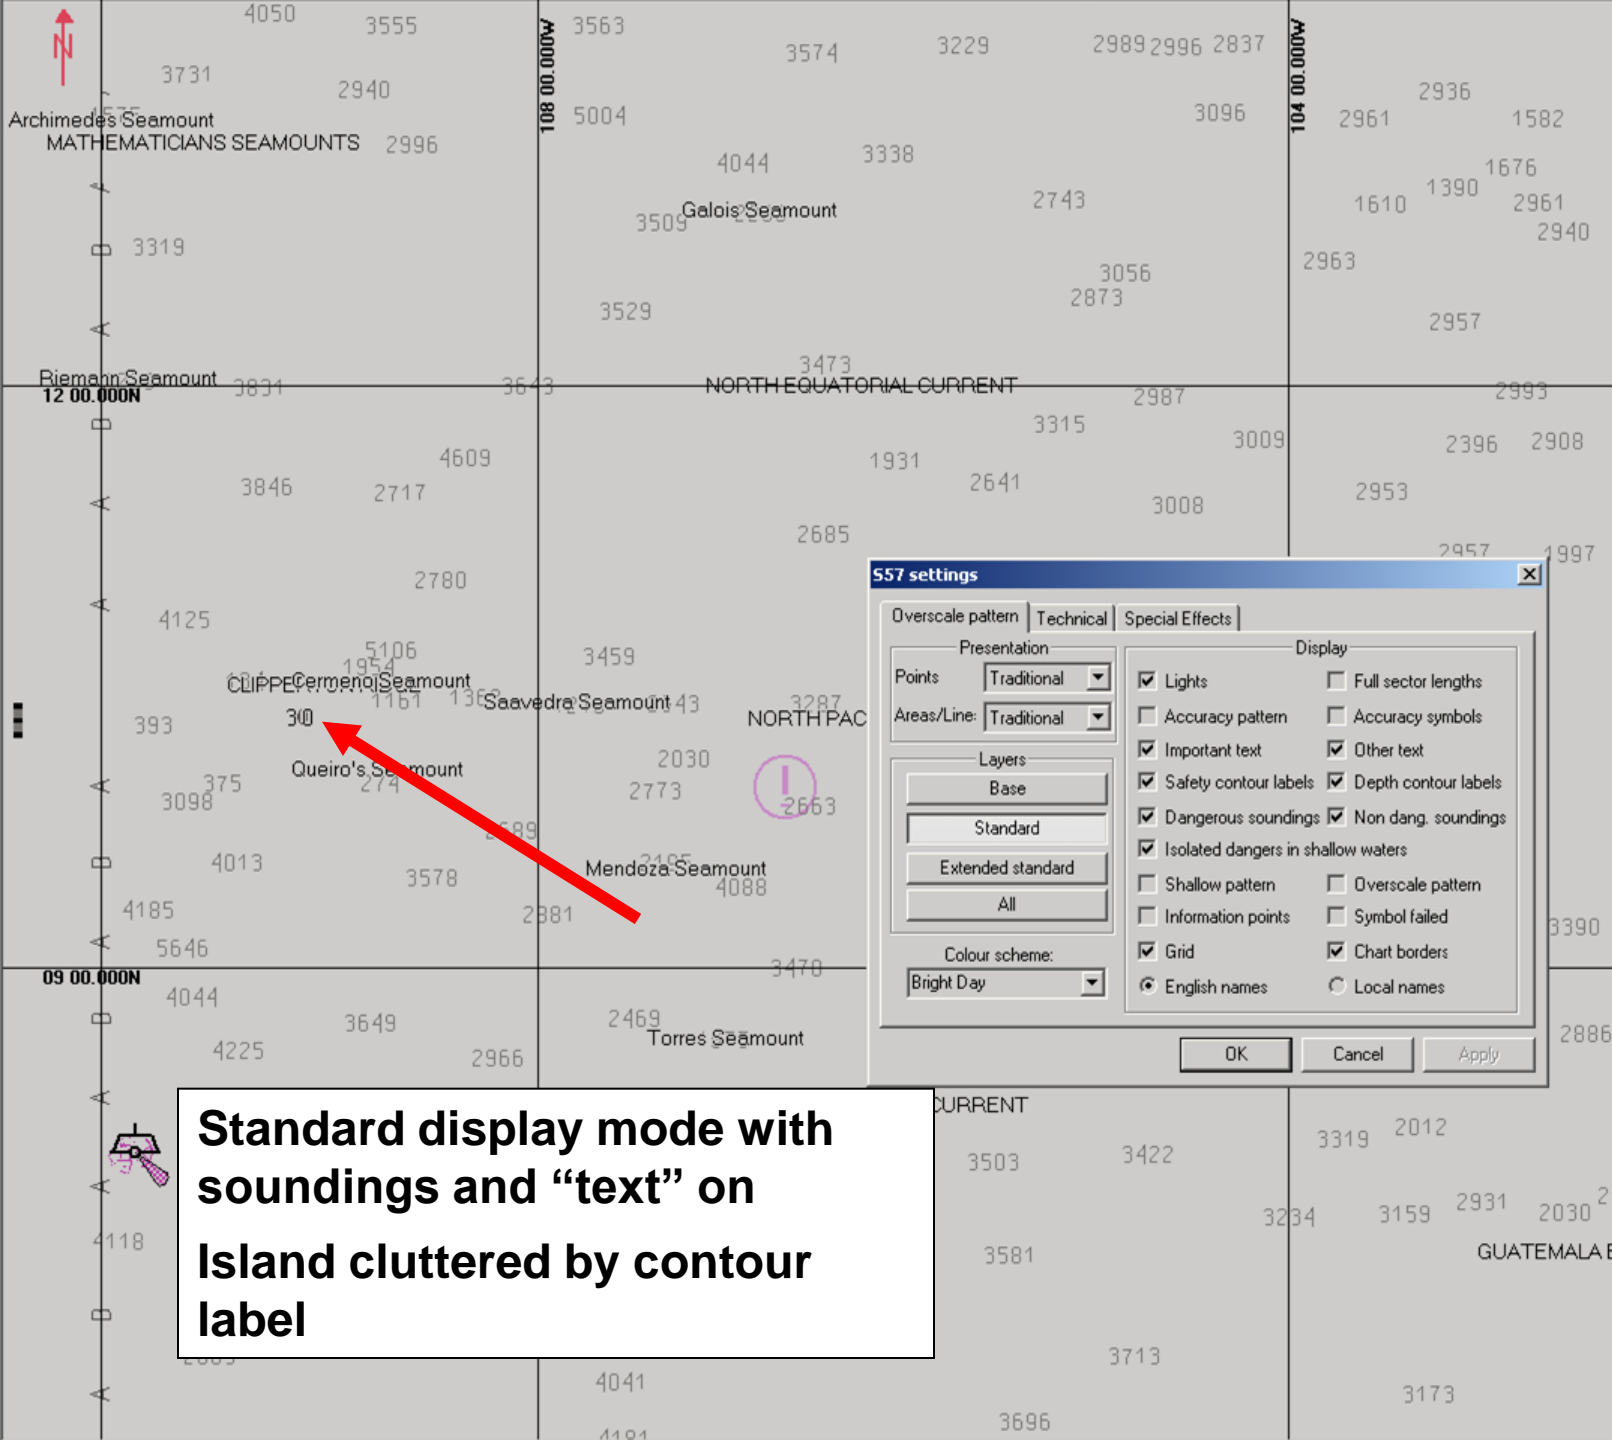
Standard display mode with soundings and "text" on Island cluttered by contour label
