ECDIS Display and Alarm Issues

Tim Lewis, Head of International Partnering (America)
XII th MACHC - BASSETERRE, ST.KITTS & NEVIS
Dec 2011

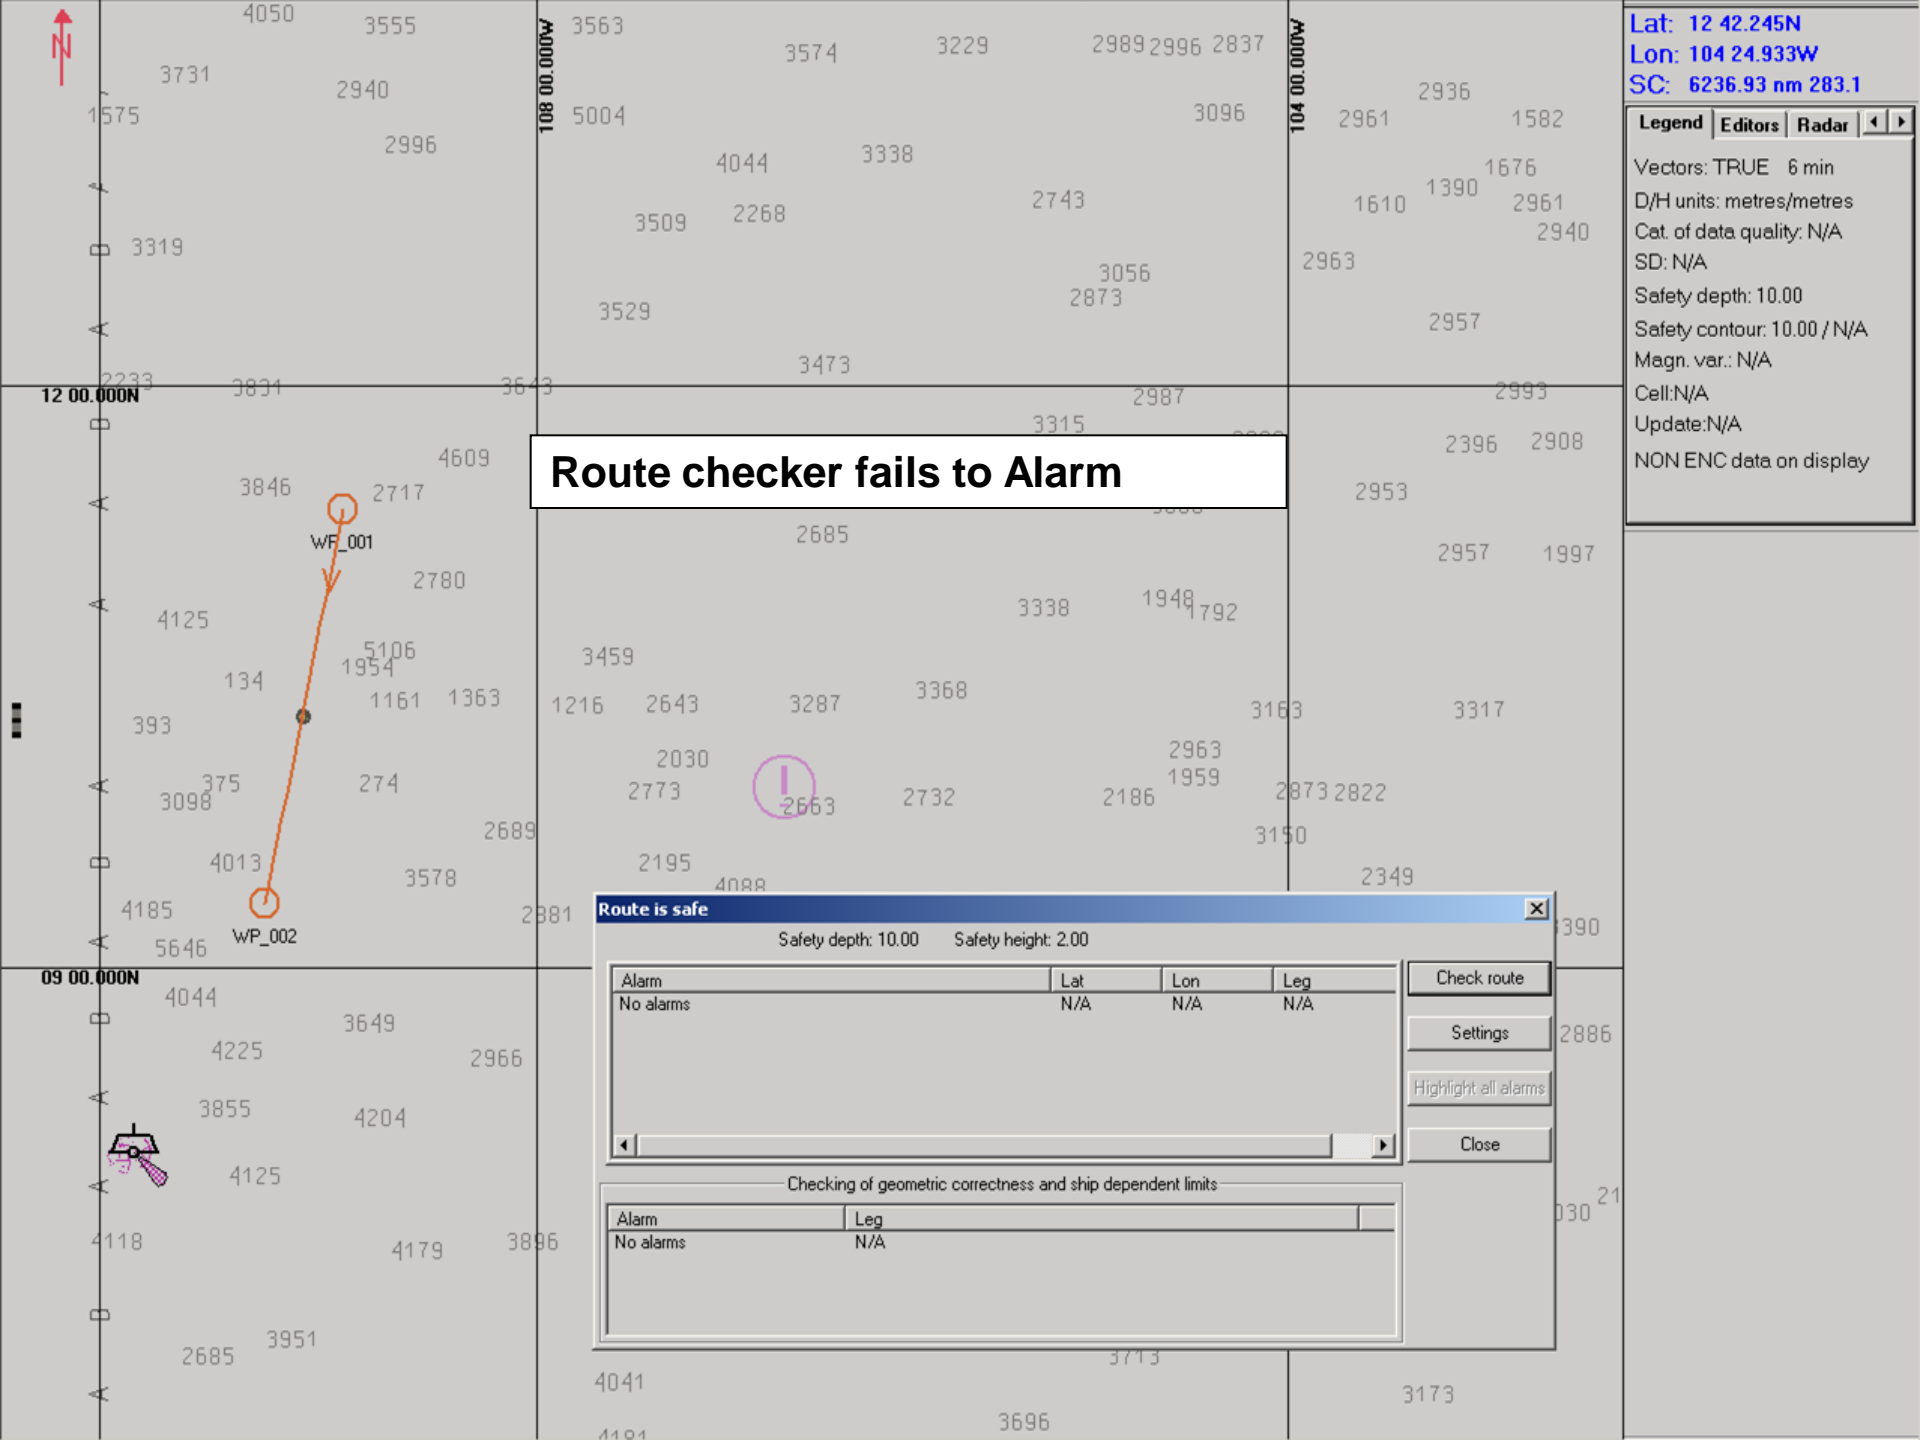
Route checker fails to Alarm

Route is safe [X]

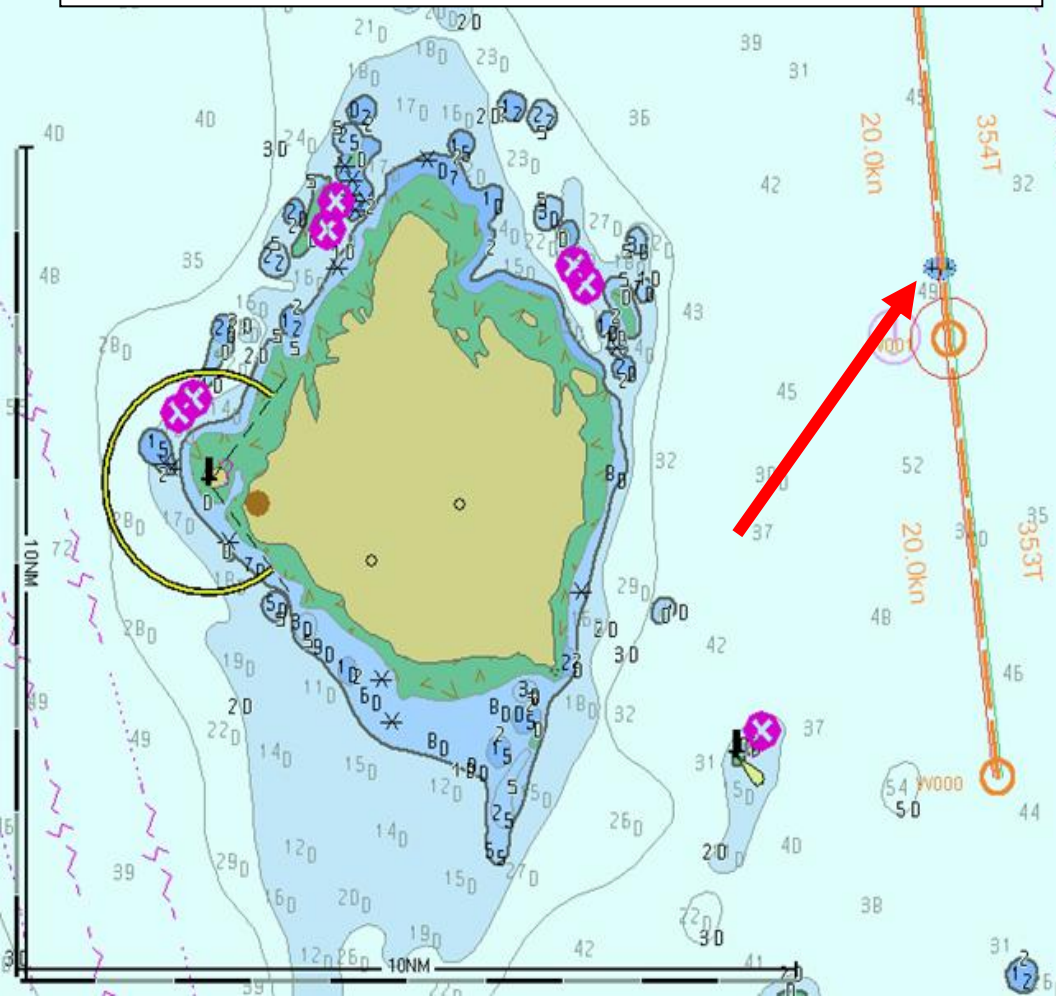
Issue: Doesn't always display and doesn't alarm

**Safety Contour and Safety Depth=10m
Dangerous Wreck, depth unknown
Display Mode = OTHER**

This ROUTE cross neither safety depth nor dangerous area.

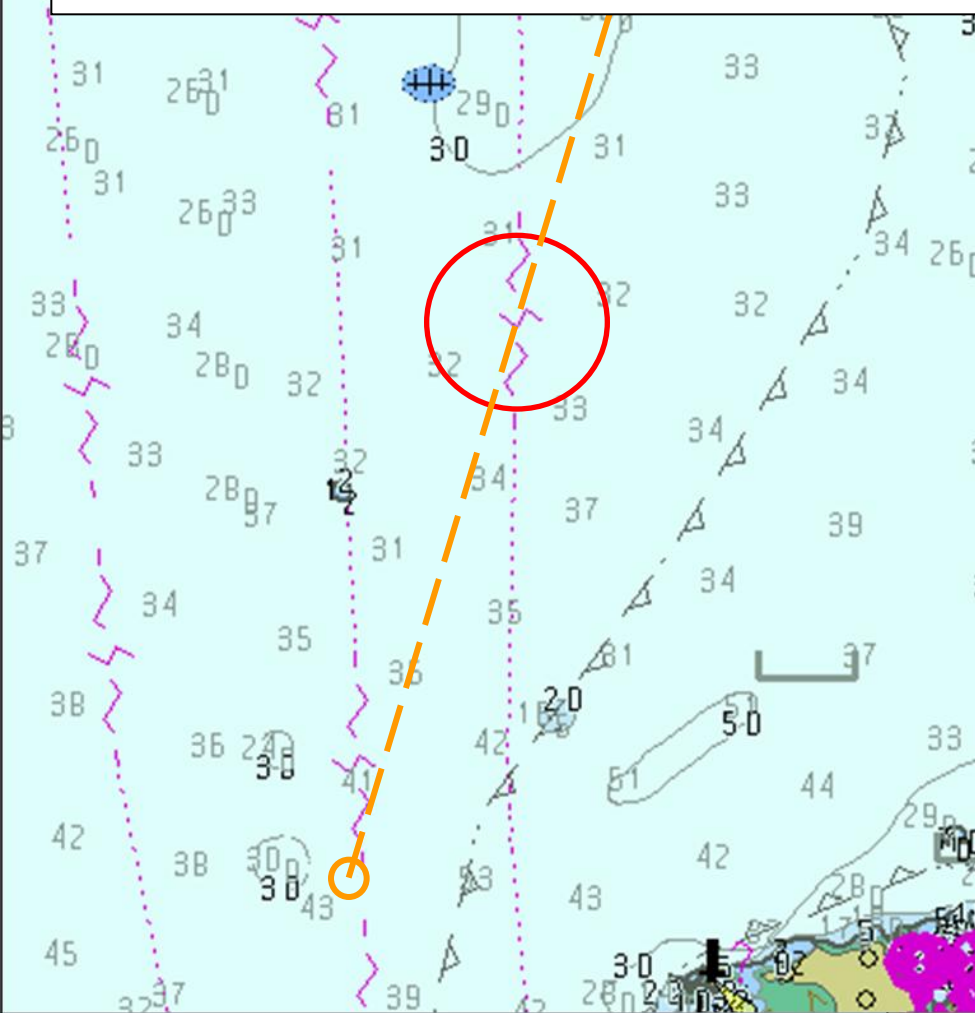
Issue: Doesn't display but does alarm
Stranded Wreck
