Wärtsilä SAM Electronics GmbH · P.O. Box 50 03 29 · 22703 Hamburg

United Kingdom Hydrographic Office
Mr. Thomas Mellor
Admiralty Way
TAUNTON
Somerset
TA1 2DN

Issues experienced during implementation & test of new Ecdis IHO standards

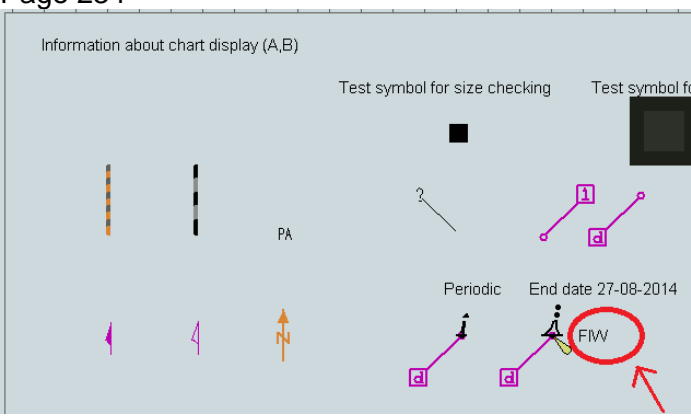
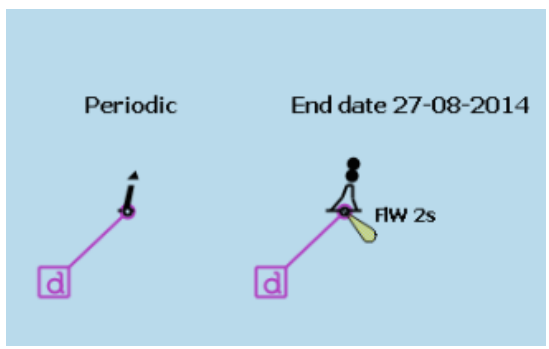
<p>Page 234</p>

<p>The number of the signal period '2s' in the light characteristic label is missing.</p>

<p>With the Pick-Report the signal period of the light object may be displayed and verified that the display of the light characteristic label is correct.</p>
---	---

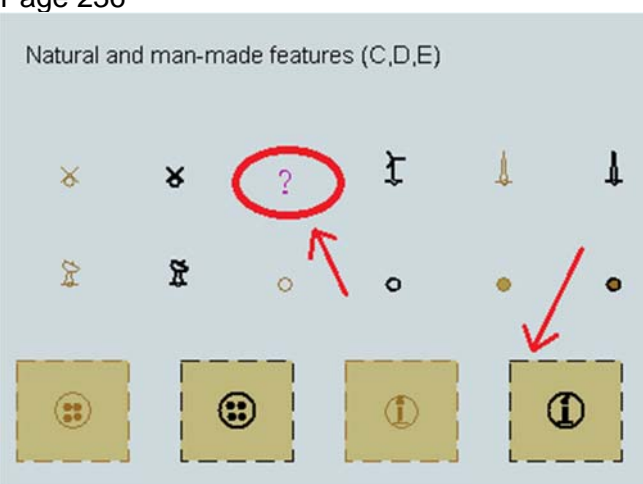
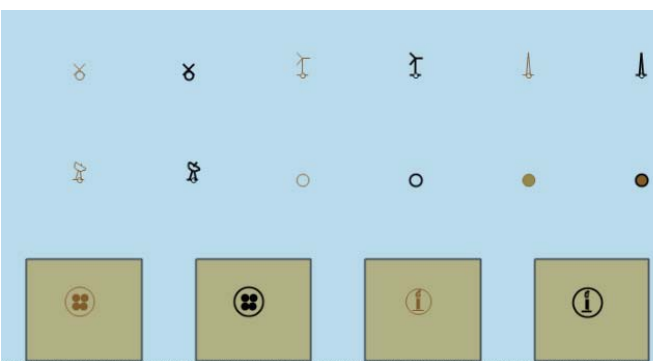
<p>Page 236</p>

<ol style="list-style-type: none"> The symbol "WNDMIL02" is missing. (Symbol "?" is wrong.) The borders of the Land areas are not drawn as "Safety Contour".

<ol style="list-style-type: none"> The Pick-Report at 15°06.433' N 005°03.452' W tells there is a 'Landmark' object with category 'windmotor', not visual conspicuous. (show symbol WNDMIL02) According to the 'Safety Contour' detection procedure the border of 'Land area' has to be drawn as "Safety Contour".
--	---

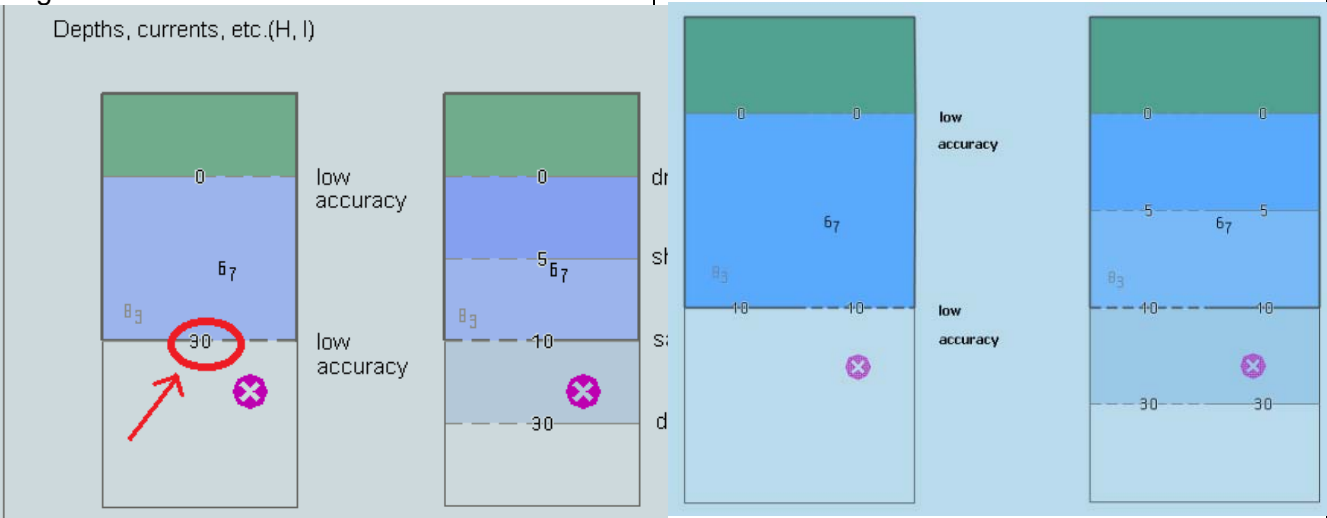
Page 238

The label '30' at the Safety contour is wrong. The label must be '10'.

With the Pick-Report at the Safety contour the value of the depth contour may be displayed and verified.

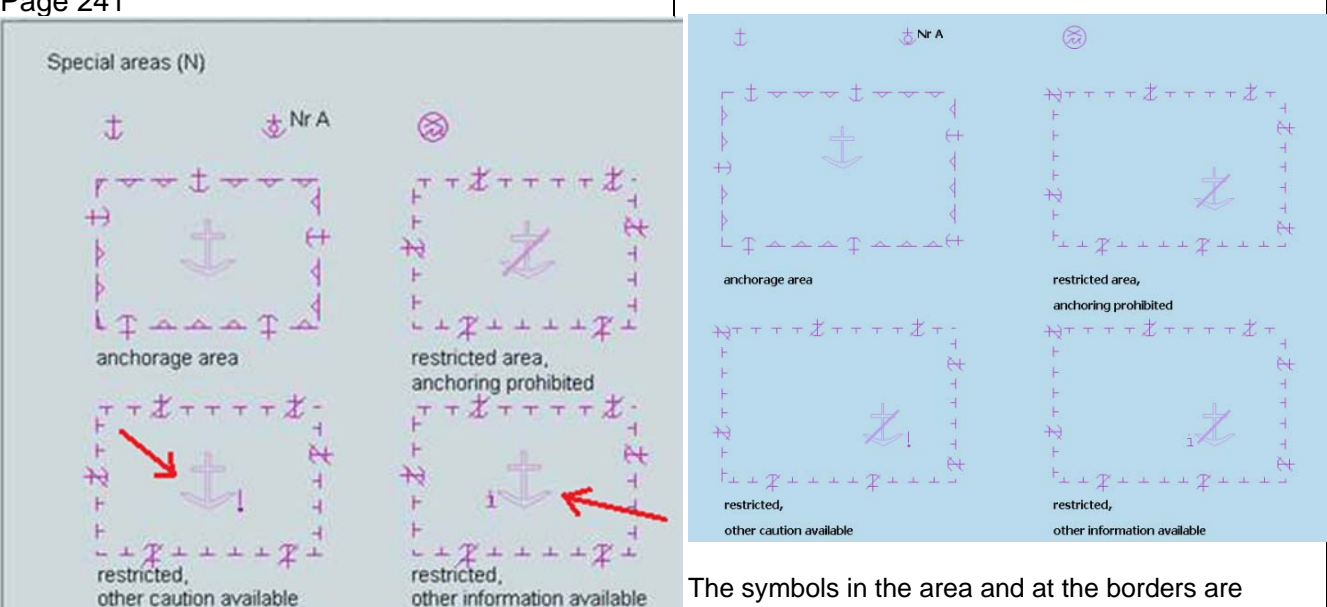
Page 241

These 2 areas are of type 'Restricted area' with attribute 'anchoring prohibited', so the symbol in the area is wrong, but the symbols at the borders are correct.

The symbols in the area and at the borders are correct. (Same as with older Chart1.)

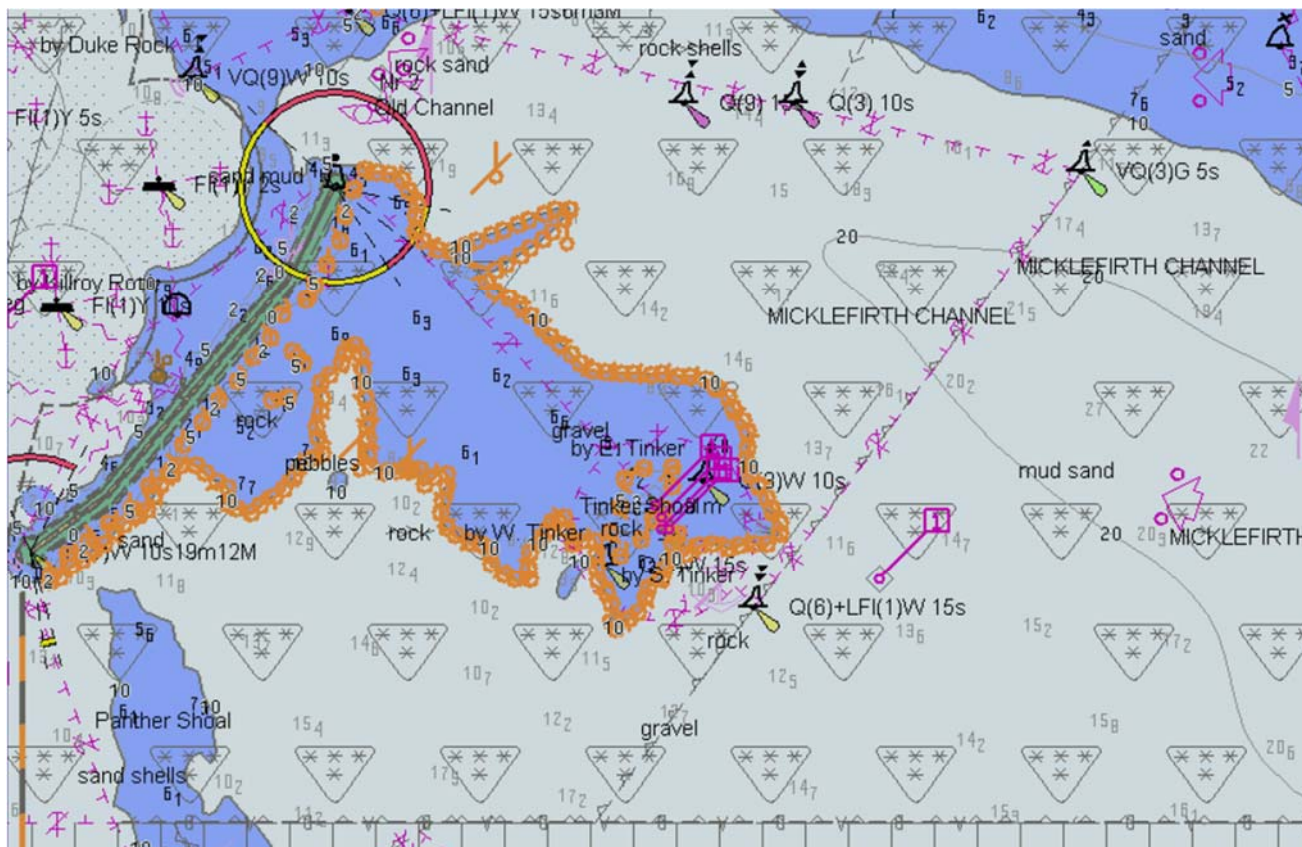
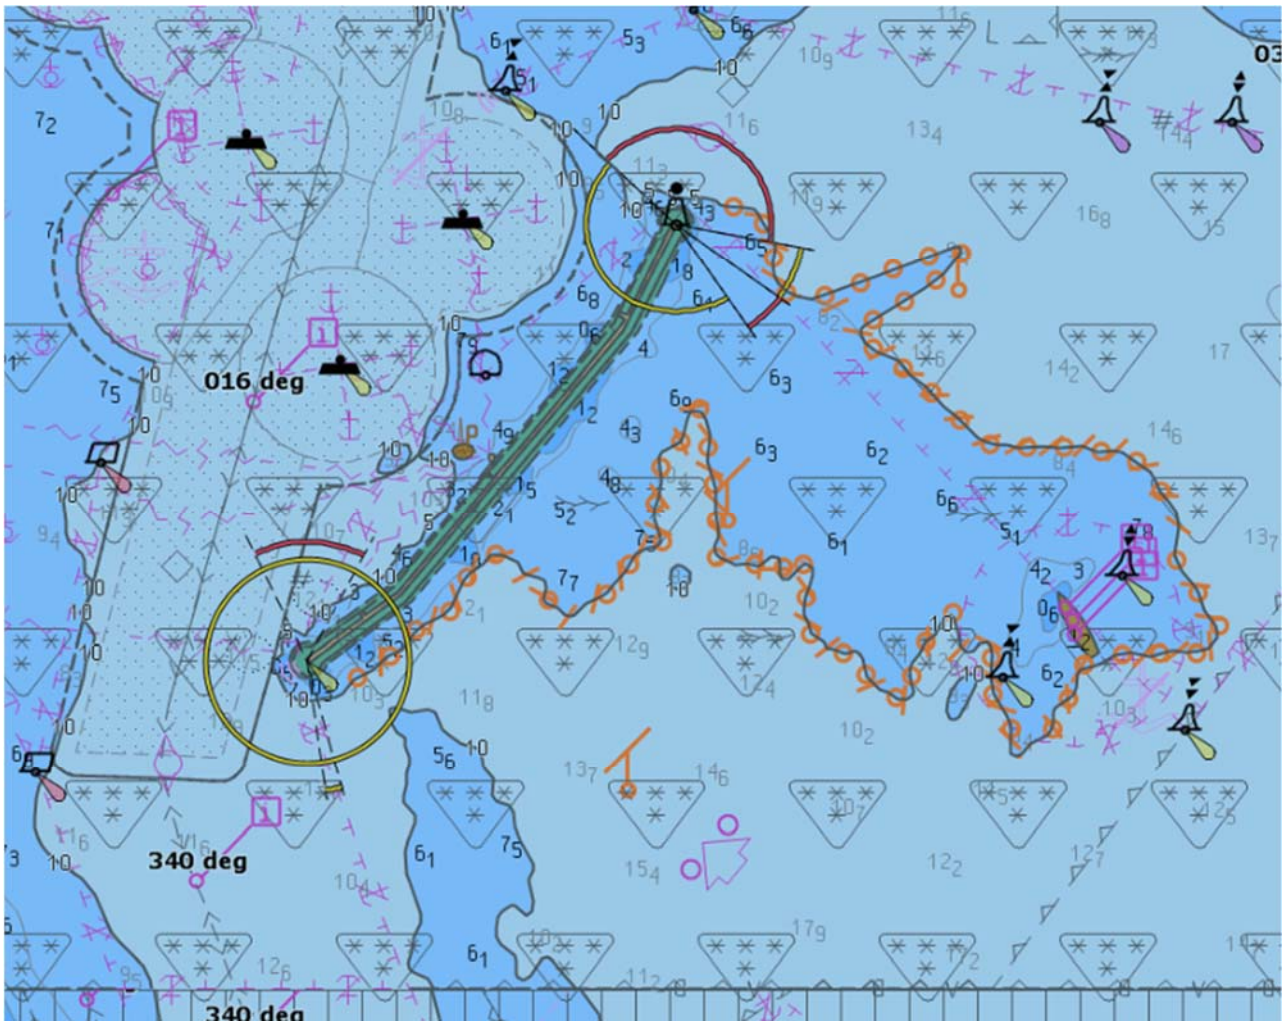
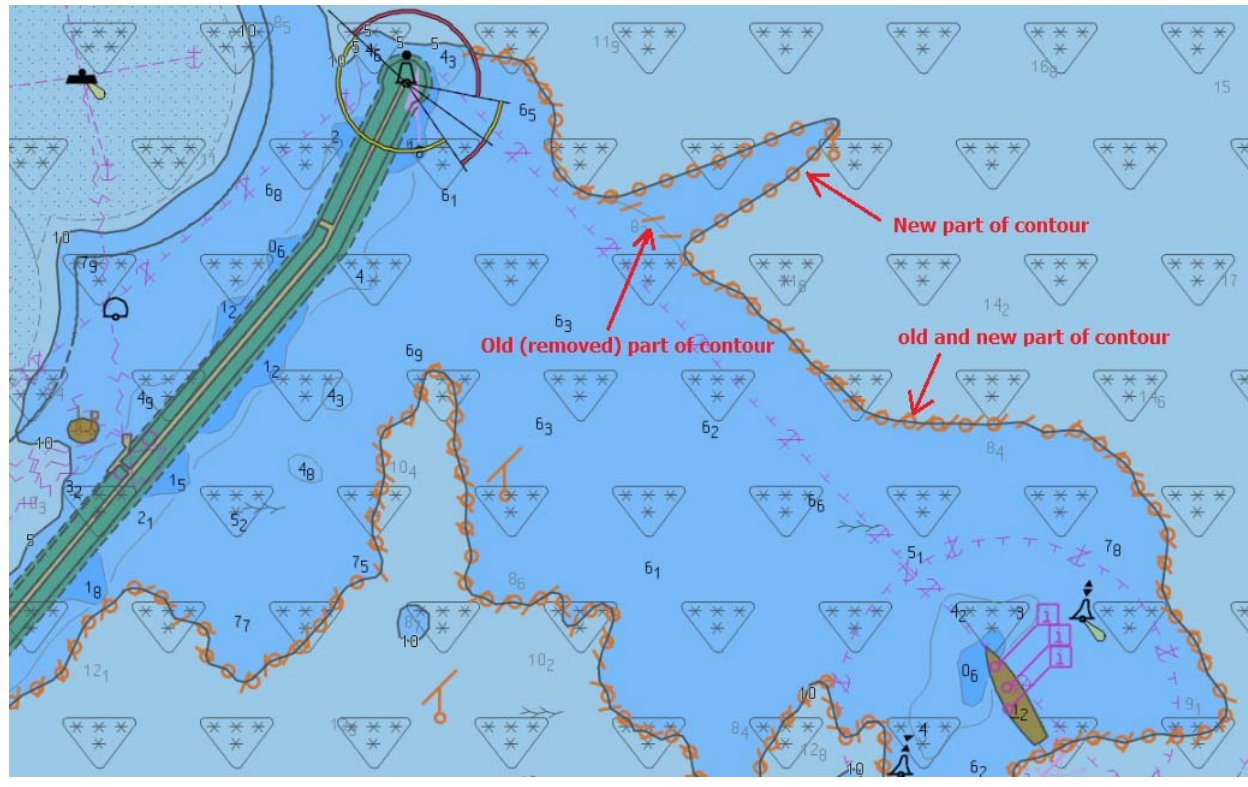
a) From the document “S-64_e3.0.0_ENC_TIM_December_Final.pdf”, Page 18: ‘Review Updates’

During this update the sounding of 12.8m at 32°31.75'S 060°56.85'E is replaced with a 9.4m Sounding and a part of the 10m depth contour is deleted and inserted with some new additional geographic points.

This part of the 10m depth contour is a part of the border of the 5-10m depth area, the 10-20m depth area, a harbour area and a meta navigational system of marks.

If the user has activated now the “Review Update” mode and has selected the date range including 03 Nov 2005, then the updated parts should be marked with the appropriate orange symbols.

Because the modified ‘edge’ of the 10m depth contour belongs to 4 different areas, all those areas have the status ‘modified’, there is no priority.

According to “S-52 PresLib Ed 4.0.1 Part I.pdf” 10.7.2 ‘Identifying Automatic Chart Corrections On Mariners Demand’, all the modified areas should be marked with overwriting the area boundaries and a centred symbol.

This is not the case in the picture above (10-20m depth area borders are not marked) and it would also definitely clutter the screen, and indeed confuse the user.

If instead only the modified part of the area borders should be marked, then the picture above is also not correct, because the north-west border part was not modified.

In order not to confuse the user and only mark the parts of the geometry which have really been modified, the Ecdispilot Platinum will overwrite only the parts of the modified geometry lines and the modified areas only in such cases with the centered symbol.

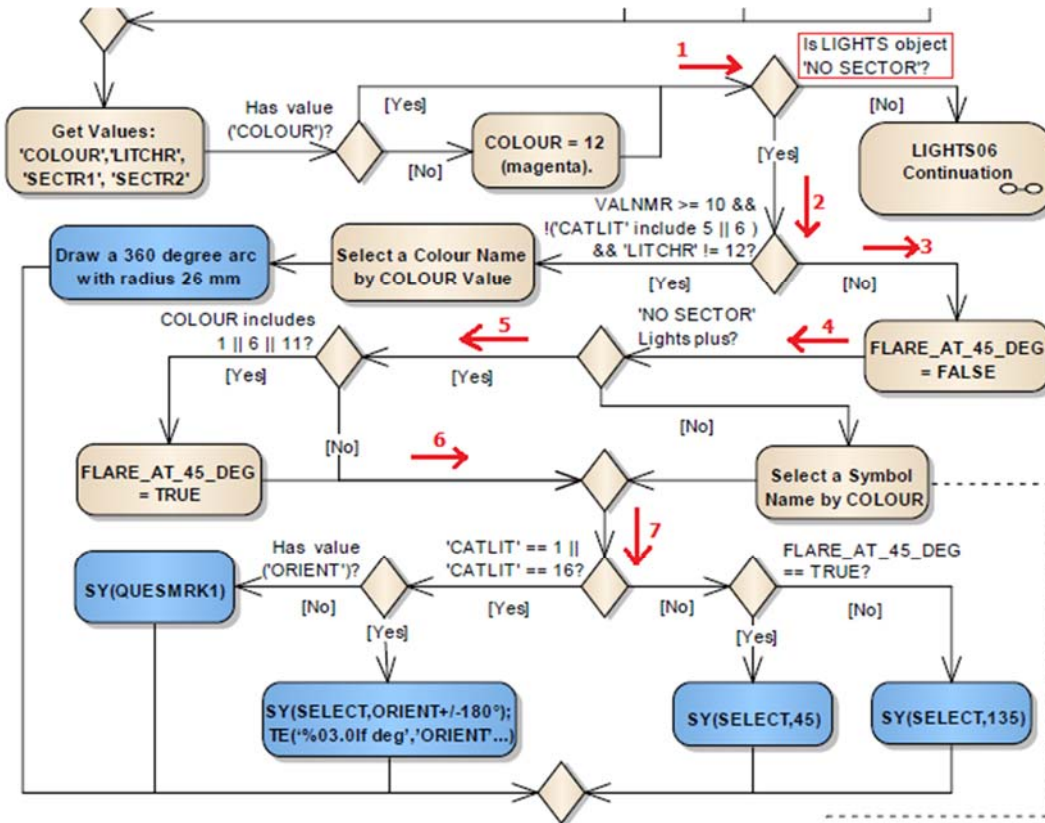
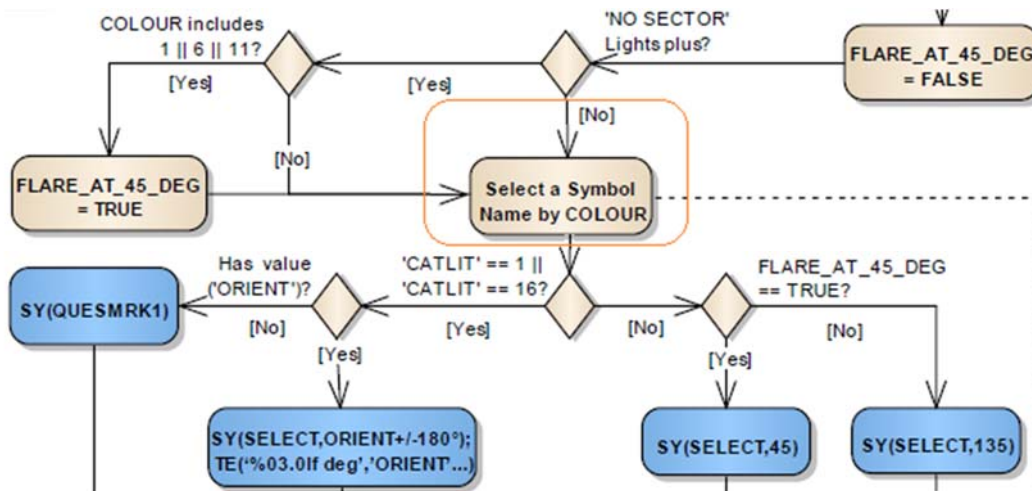
Figure 7 LIGHTS06 conditional symbology procedure (Page 124, middle part):

Problem 1: If the decision path is following the red arrows, then after arrow 7 there is no symbol selected for using. Next picture shows SAM Platinum ECDIS behaviour:

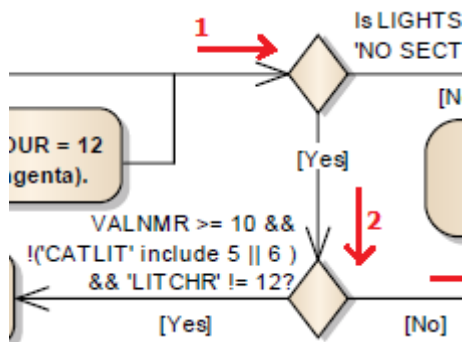
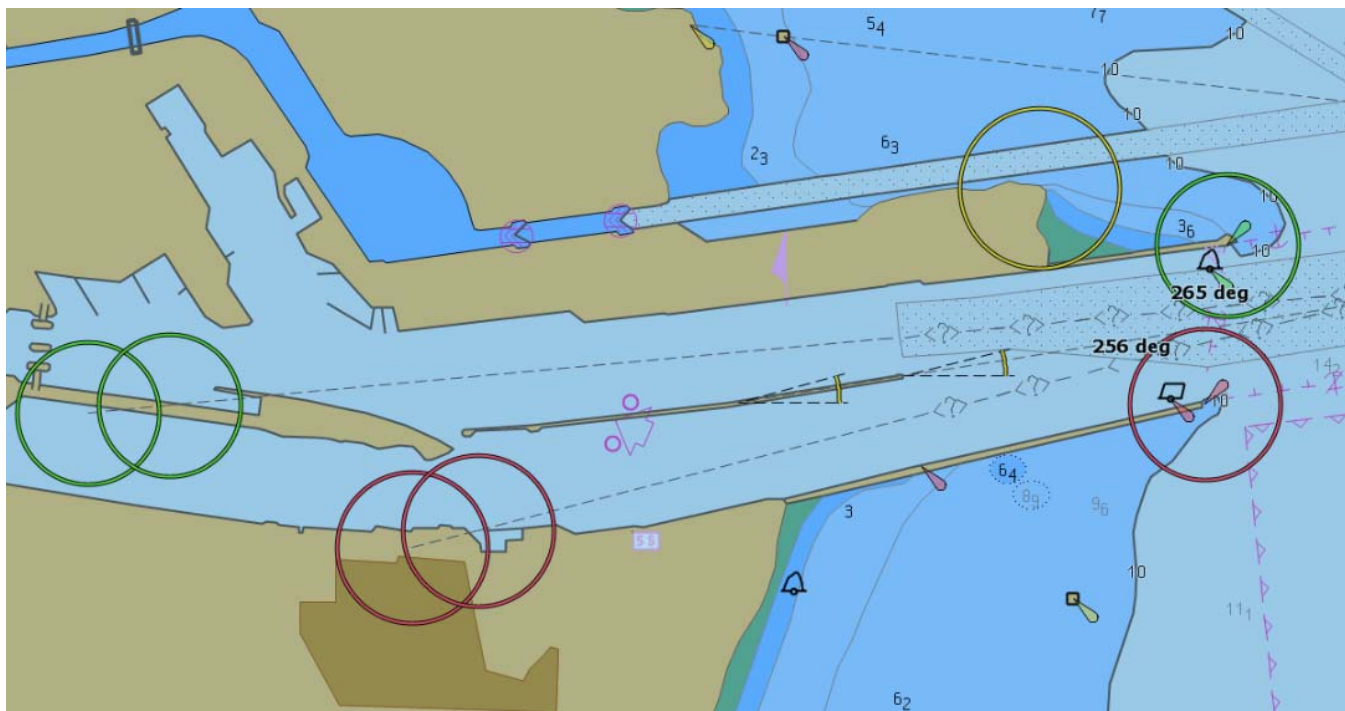
Problem 2: After the decision "Is LIGHTS object 'NO SECTOR'?" is answered with "Yes" the next check is for VALNMR >= 10 && !('CATLIT' include 5 || 6) && 'LITCHR' != 12?

If this is implemented accordingly, then a lot of lights will be displayed with a fixed 360° arc:
(S64 Test Data Set, Pos 32°36,3' S 060°53.0' E)

Following exactly the "Conditional Symbology Procedure" of Lights then some of them are drawn with the fixed size 360° arc and there is maybe no symbol at the position of the light.

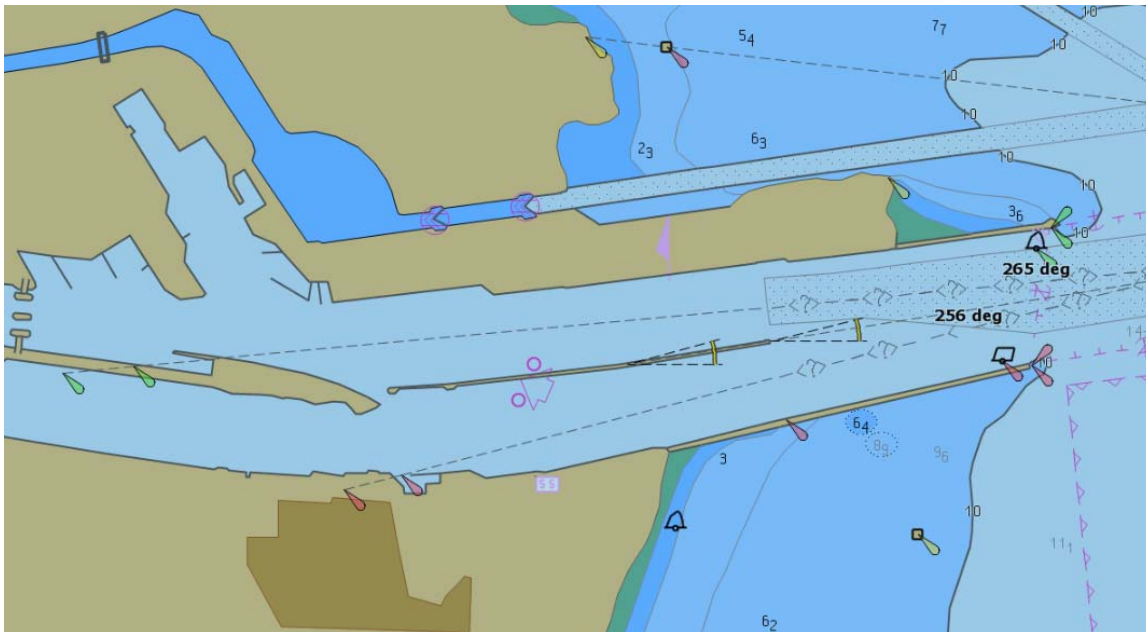
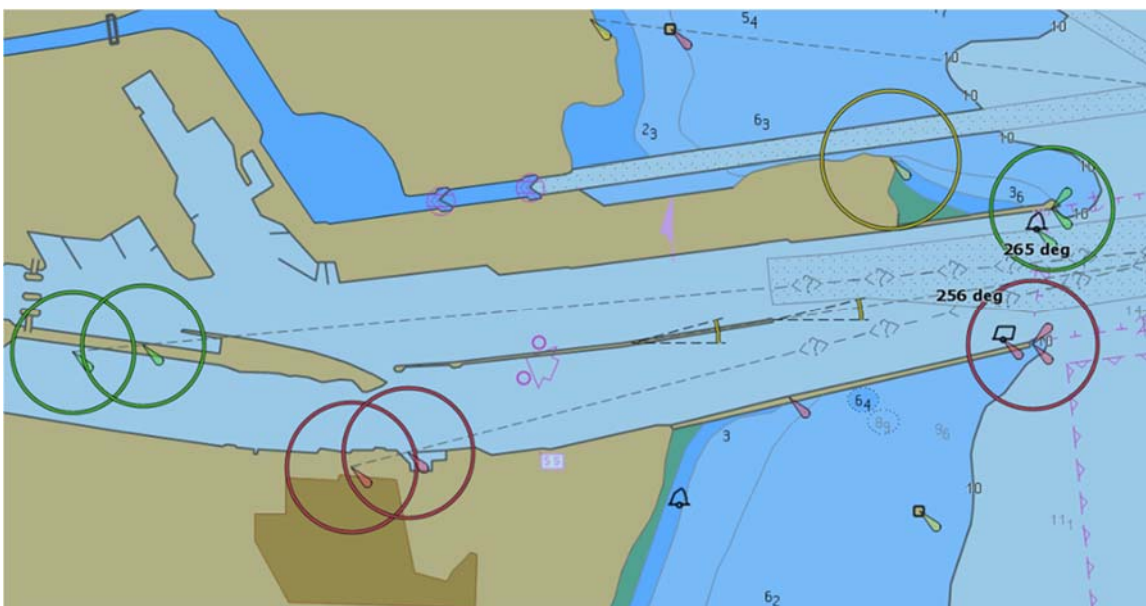
The picture below is created with the procedure for lights from the “old” PresLib 3.4:

The following picture is created with a **combination** of the procedure for lights from the “old” PresLib 3.4 and the new PresLib 4.0:
 Now the fixed 360° arc is an additional indication for the mariner that the light has an attribute “Value of nominal range” VALNMR with a value ≥ 10 m.

Question: What is the wanted and “right” solution?
