Depiction to delimit the area surveyed adequately after a disaster

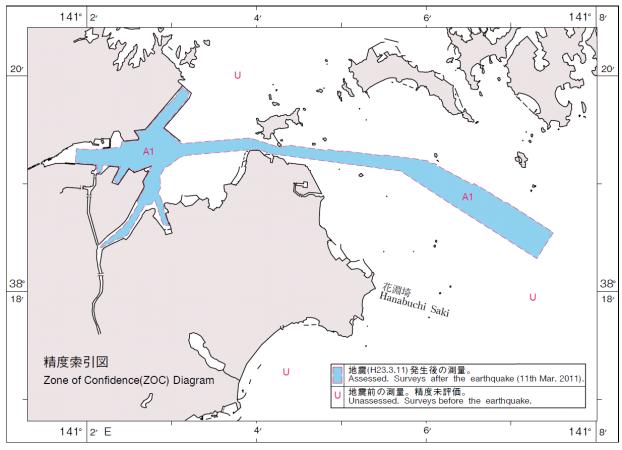
Use of ZOC Diagram

- filled the area surveyed after the earthquake with solid blue
- provided two ZOC categories meaning survey "before" and "after" the earthquake on the chart: other meanings of ZOC categories are provided in JHOD's website and NMs.

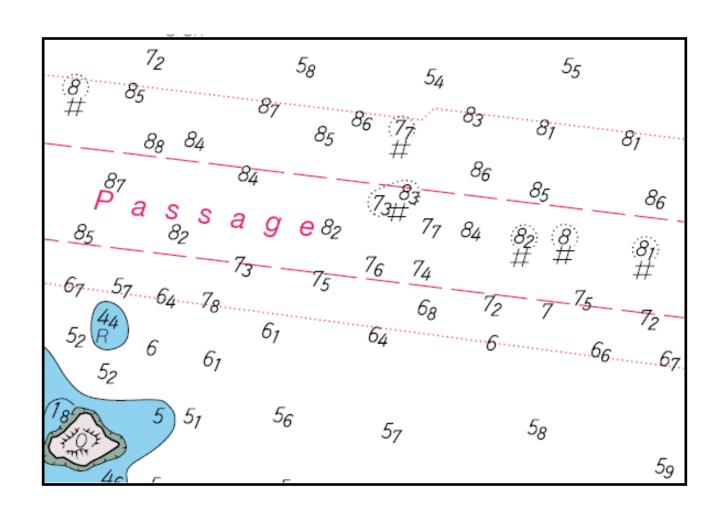
Proposal for new symbol

- Dotted line in magenta to delimit new survey area
- User's voices were considered in defining this symbol

Add 'dotted line in magenta' which delimit the area surveyed after a great disaster.

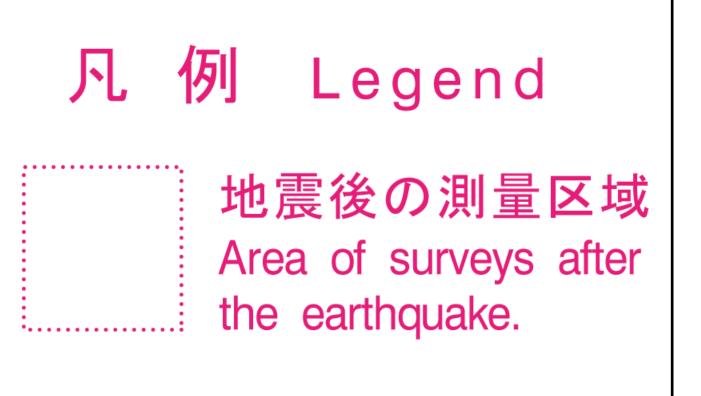
Addition of a legend

- This symbol is not an international symbol and not included in INT 1
- Combination with ZOC Diagram
