16th Meeting of the Southern African and Islands Hydrographic Commission

Lesson Learnt from Cyclone IDAI - Mozambique

[Mozambique - Member State]

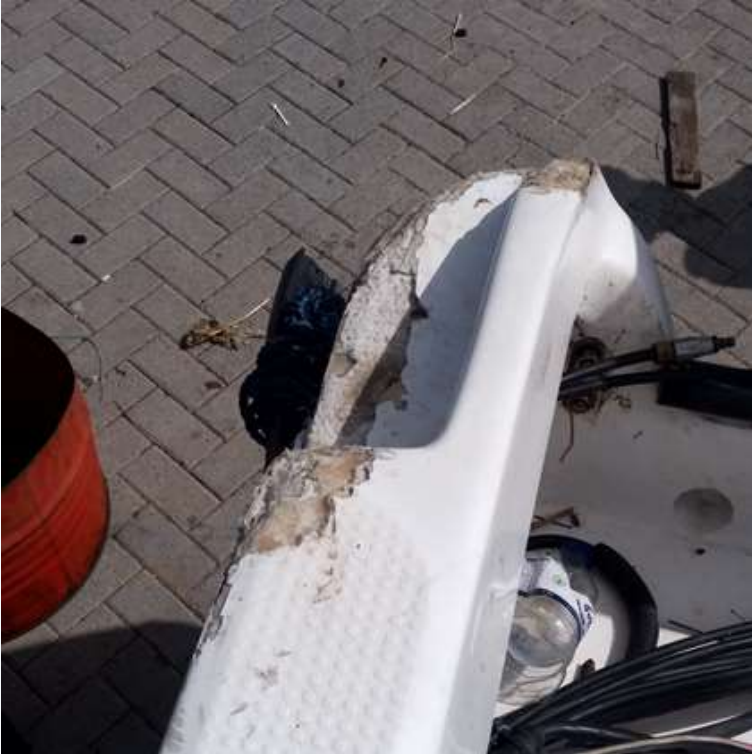
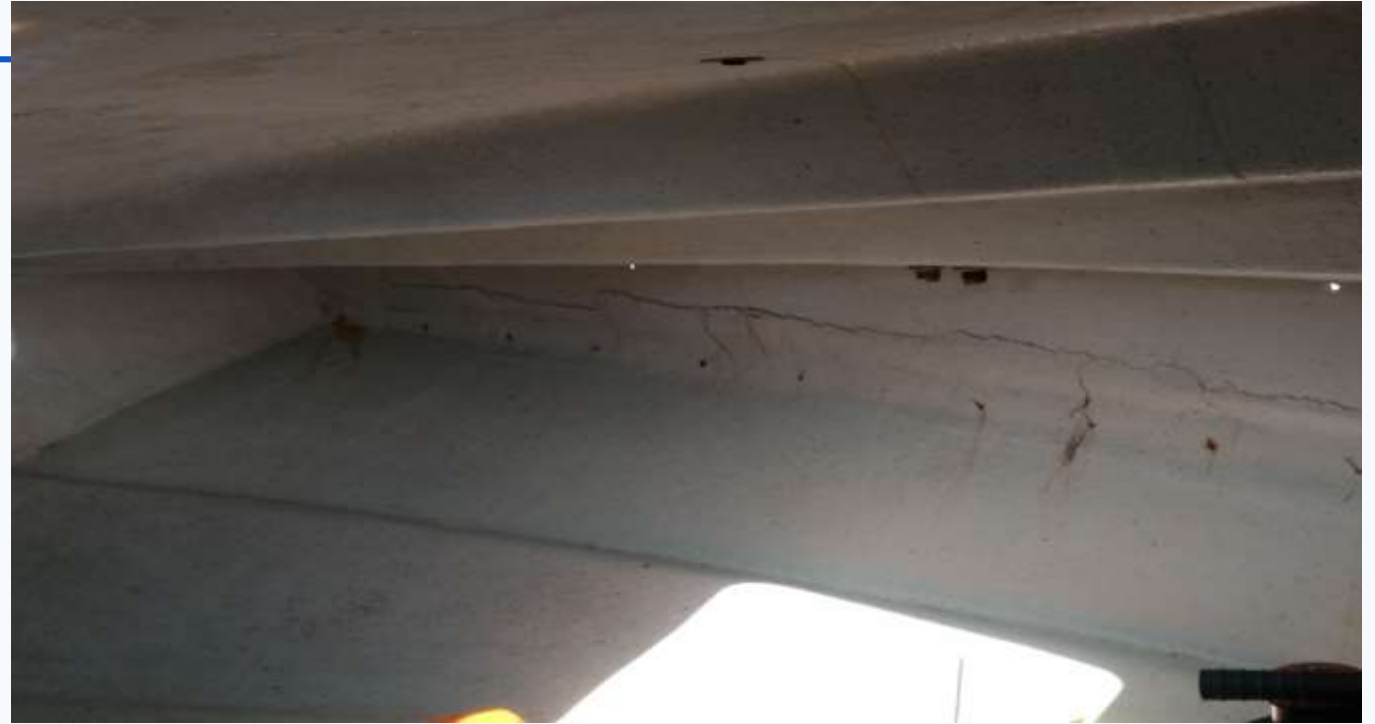
The **access door to the cabin broken**

Several breaches inside the boat

Failures on the operation of the starboard engine

Some of Hydrographic Survey's equipment's damaged

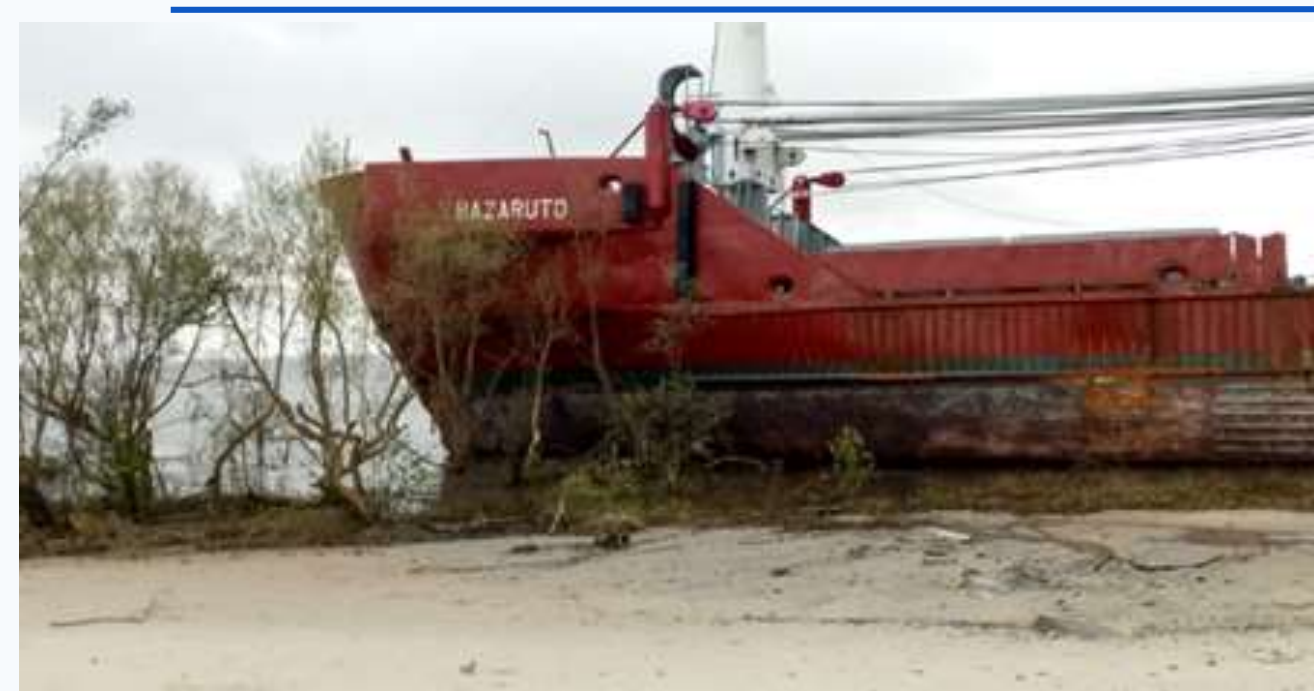
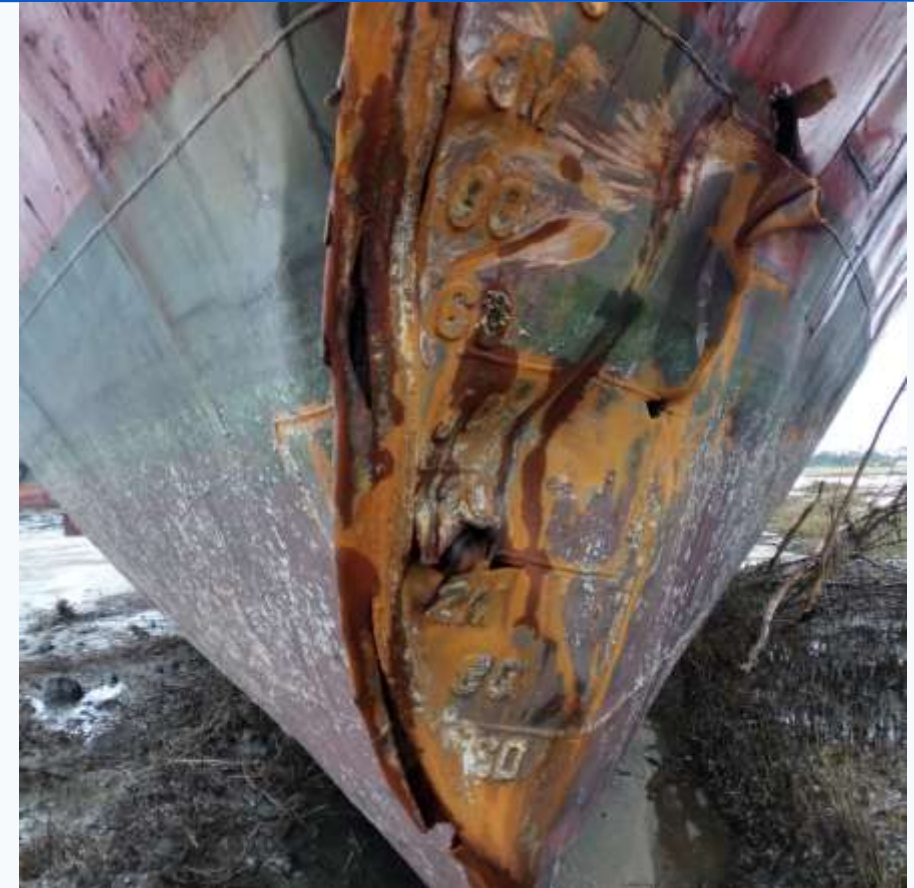
Buoy Tender – Bazaruto

- ❖ A Breach in the Collision-tank
- ❖ A Tear on the Bow

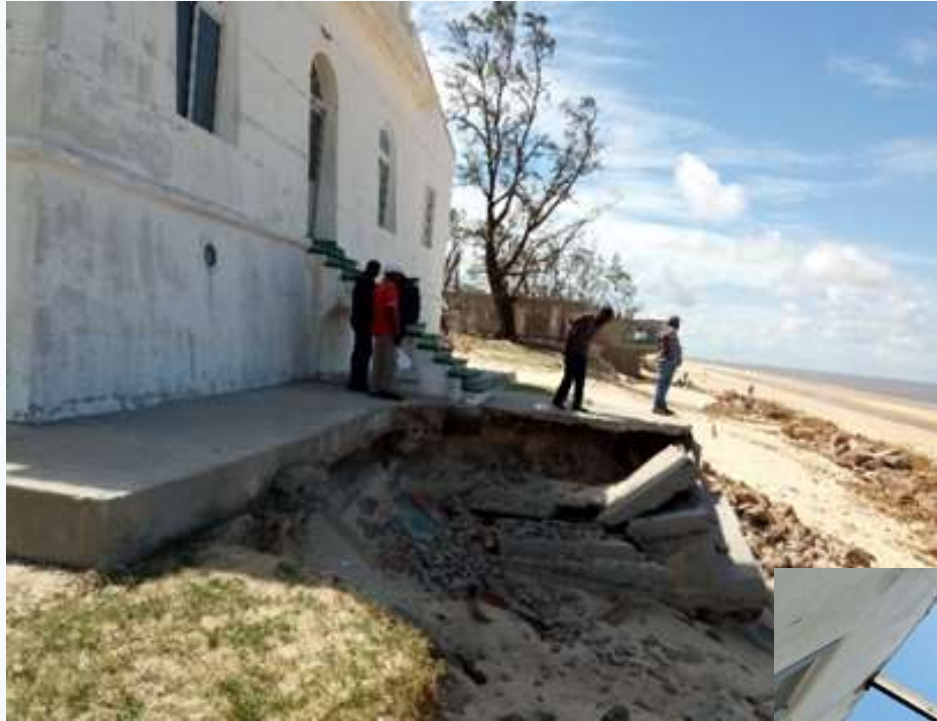
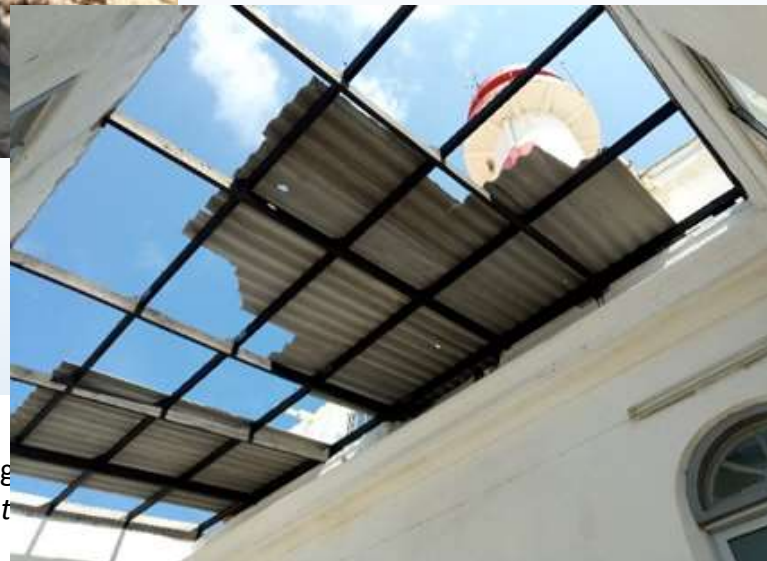
Assessment of the Beira Lighthouse

Findings in the lighthouse were as the followings:

- The protection wall was destroyed
- The sand material around the lighthouse had moved, exposing the underlying lighthouse structure to salt water, and leaving the steps to access the lighthouse at risky to collapse.

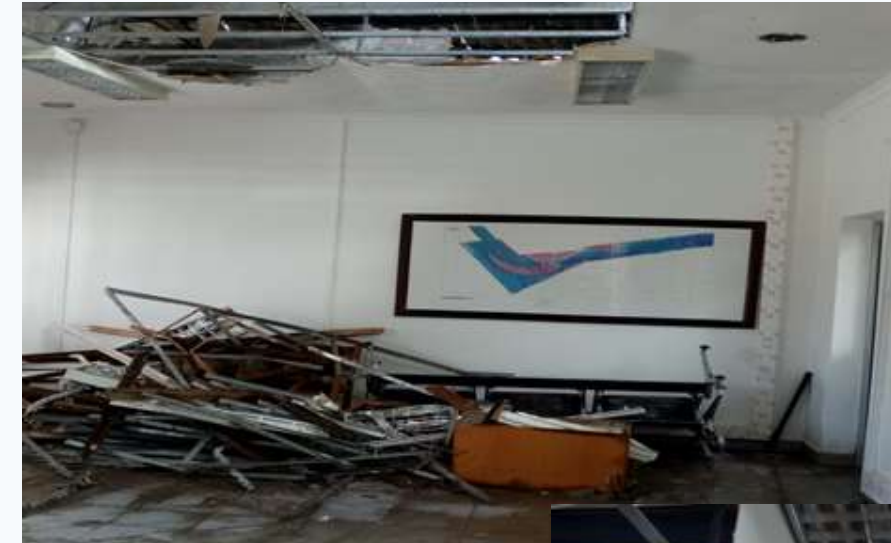
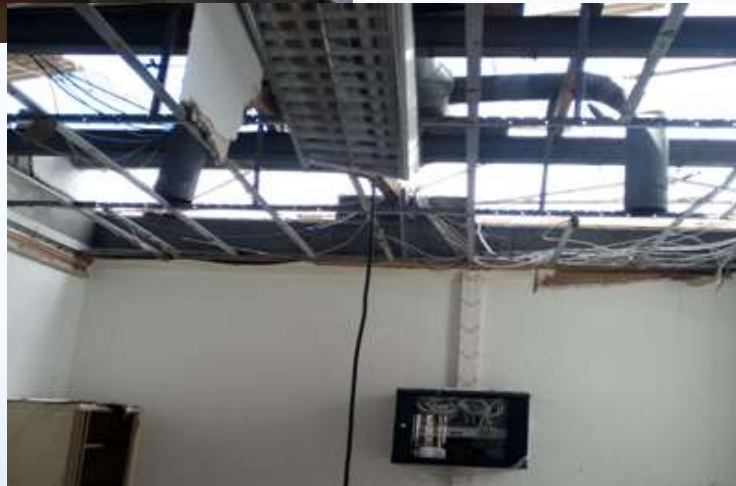
Effects on the INAHINA's Office in Beira

- The **removal of the ceil** of the INAHINA's office in Beira.
- Furniture **destroyed**
- **Computer equipment damaged** as the raining and wave waters have entered into the office
- Documents and **archives were wet** as result of water entering into the offices
