Trip Report:
Gulf of Honduras Project
Phase 3 Hydrographic
Training Mission to Belize

14 March 2011

Subj: Trip Report for Gulf of Honduras Project Phase 3 Hydrographic Training Mission to Belize

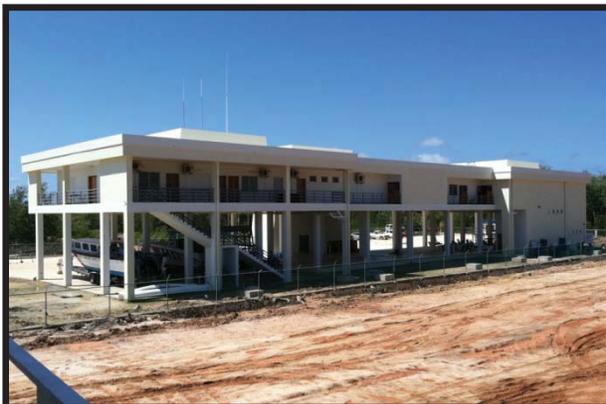
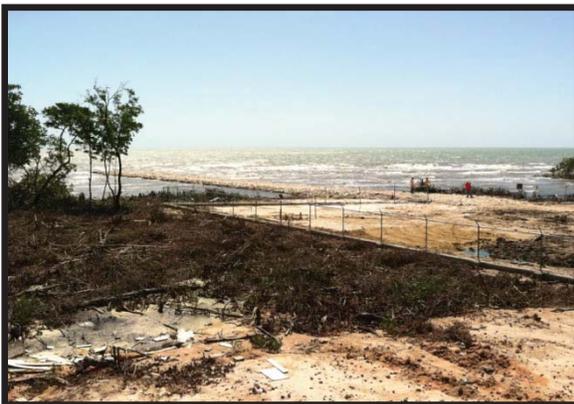
New BNCG Facility (left) – Land adjoins BPA Port Operations Base. A new jetty and pier structure from the new Coast Guard facility is under construction (right) and may be available for BPA use in the future.

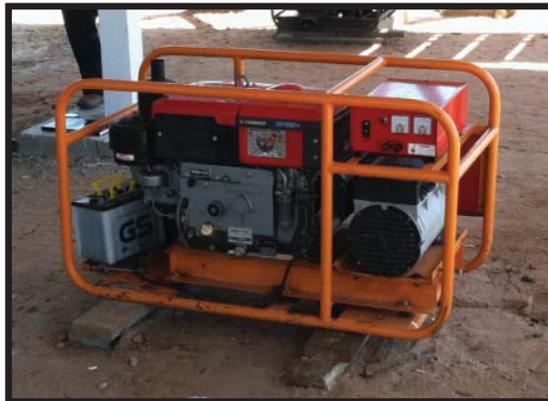
- a. **Electric Generator** – In addition to suffering from numerous mechanical problems, the vessel’s original generator (from 2009-2010) did not meet the power requirements for all electrical systems (including survey equipment) to operate simultaneously. Following several attempts to salvage the old generator, a new generator was purchased following the 2010 training session. While this generator is not marine-grade (designed to be mounted inside a vessel’s engine compartment), it does meet power requirements for survey.

New Generator used
aboard R/V SEA
KING

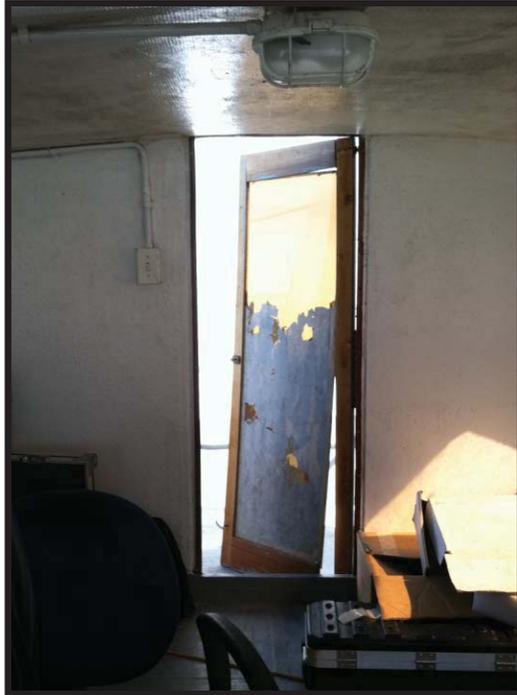
Cabin Door shows serious signs of neglect and should be replaced with a more marine-grade door.

- a. **BPA Action Items (Short Term)** – To succeed in the short term, BPA personnel must accomplish the following:
 - i. Repair R/V SEA KING for hull integrity, engine operation, and electrical operation/connectivity following recent vessel sinking / engine breakdowns.

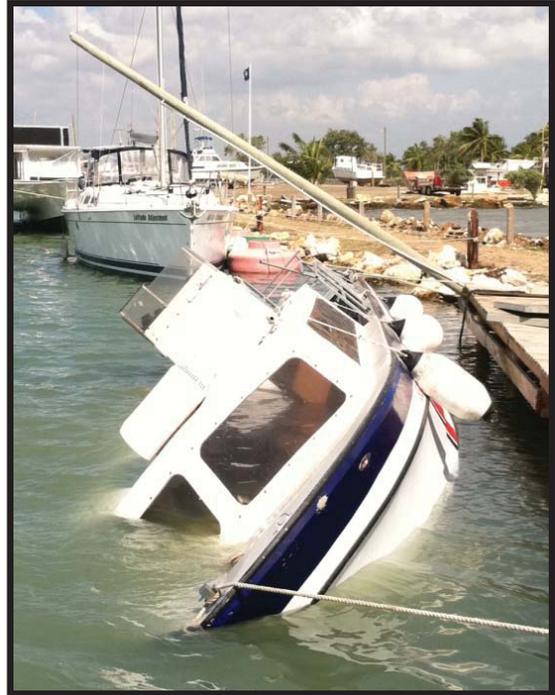
- b. **Vessel Integrity / Maintenance** – Several engine breakdowns prevented SEA KING from conducting any hydrographic survey acquisition following the 2010 training session, but the vessel remained in the water throughout this period. SEA KING was subsequently lifted from its mooring at Old Belize during a hurricane storm surge and deposited further into the marina on top of a pier; the vessel appeared to be spared from any major damage from this event. Upon my arrival in Belize, the decision was made to attempt hydrographic survey with only one of the two engines rather than continue to wait for parts and repairs on the second engine. On-the-water hydrographic survey days resulted in few mechanical difficulties while operating on the one engine, although the vessel showed several signs of relative neglect, such as the state of the cabin door (see image below). Presumably, numerous stresses from the aforementioned hurricane, combined with a relative lack of vessel maintenance over the past year, greatly reduced SEA

KING's seaworthiness and resulted in the vessel sinking at the end of the Phase 3 training. Fortunately no topside survey equipment was onboard during the sinking, so damage is limited to the engine compartment and vessel electrical system. It should be noted that the issues leading to the sinking are being addressed now, including patching the hull, replacing/repairing shaft seals, and repairing the existing engines.

Sinking at the Pier – R/V SEA KING at Old Belize on the last day of Phase 3 Training.

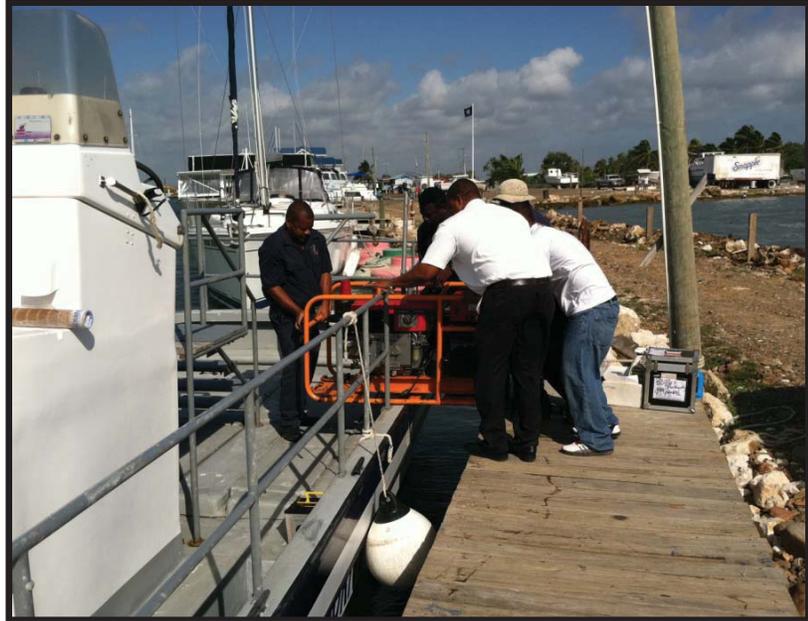
- i. The size and design of the new electric generator (approximately 1000 lbs) forces BPA personnel to place it on the boat's afterdeck, rather than inside the covered engine compartment. Additionally, since the survey vessel is located in a somewhat unsecured area at Old Belize, the generator must be loaded onboard and removed from the vessel each survey day. This procedure requires at least five personnel and presents significant injury risk to all involved (trip / burn / accessibility hazard).

BPA Personnel loading new electric generator onboard R/V SEA KING.

- iv. Modify current hydrographic vessel (SEA KING) to have generator-free shore power capability, safe generator placement, and overall safer vessel conditions (handrails, secured chairs, improved tow point accessibility, remotely operated mechanical SSS towing capability, etc)

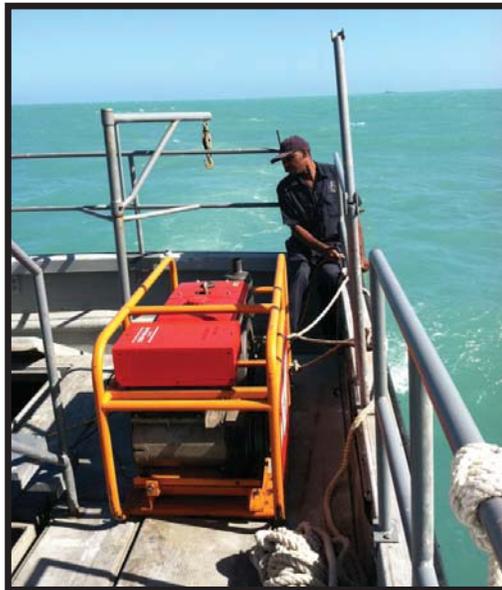
- ii. Side scan sonar towing is still done by hand with a deck-lain cable. Also, the new hand rails now block access to the towpoint from inside the vessel (trip, snag hazard).

Generator Placement & Hand SSS Towing present safety hazards to BPA hydrographic personnel.

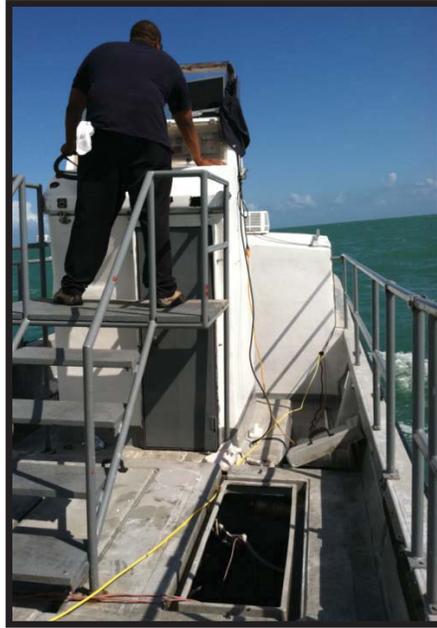
- iii. Engine compartment hatches continue to be left open during vessel operation to provide natural air cooling of the engines (fall / trip hazard).

Engine Compartment Hatches are left open during vessel operation.

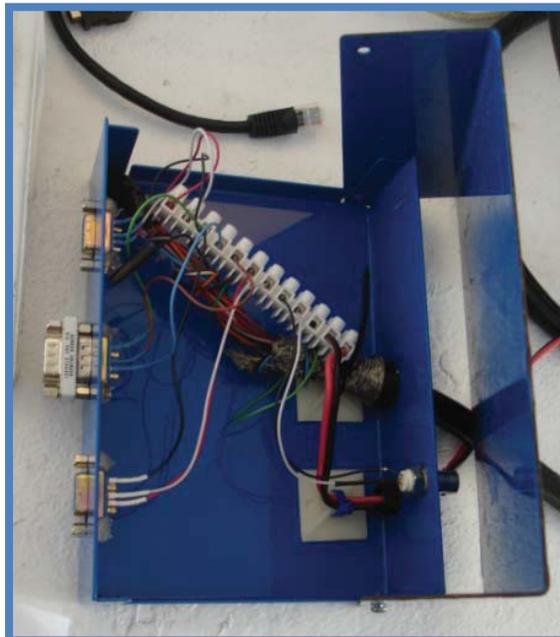
- a. **Kongsberg MRU Z** – The MRU-Z junction box remains the same from last year, with no 1A fast fuse protection (per MRU-Z manual). Due to a series of miscommunications between Kongsberg Seatex, BPA, and the GoH Project trainers and office, the MRU was delayed in being returned to Belize from calibration. However, it arrived during the first week of the Phase 3 training period and was installed and successfully operated from the first day of on-the-water acquisition (25 February). Issues encountered and/or corrected include:

BPA Junction Box for Kongsberg MRU-Z:
[picture from Phase 2 training] The current junction box contains no 1A fast fuse per the manufacturer's specifications. This fuse would prevent power surges from damaging sensitive electronics inside the MRU casing.

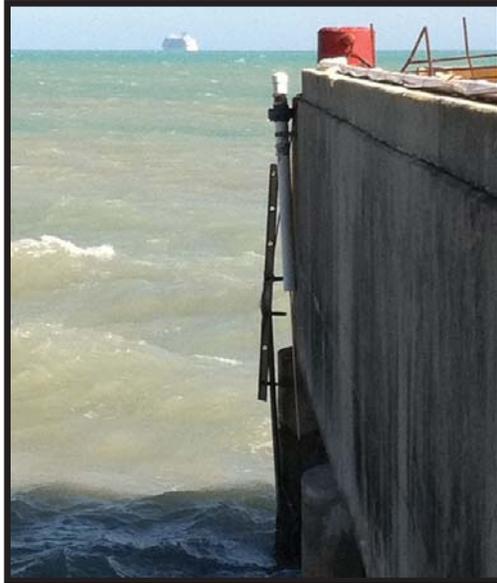
- i. Prior to Phase 3 training, BPA personnel verified with BNMS that the PBL tide station was operational but did not view or analyze the data stream. Upon commencement of training, the PBL gage data was downloaded with assistance from James Rizzo (TAMUCC DNR tide trainer from 2010) and analyzed for the resultant tide signal and accuracy. Analysis and a subsequent visit to the PBL tide gage revealed significant problems with the tide station that should be addressed by BPA, BNMS, and CCCCC jointly under the 2010 MOA. Further investigation suggests that BNMS personnel who co-signed the 2010 MOA have since retired and passed down little/no information on the tide gage or MOA to their respective reliefs.

PBL Tide Gage on 22 February 2011 – The Aquatrak system appears to have sustained significant damage from storm and/or shipping activity at the pier head. The lower mounting clamp and lower sections of the outer (well) and inner (sounding tube) PVC piping have been removed.

- vi. Repair and/or replace the existing UPS for survey battery backup capacity.
 - vii. Coordinate/train with CCCCC and BNMS to repair, relocate, and/or replace existing Aquatrak tide gage at PBL pier to have a primary tide gage.

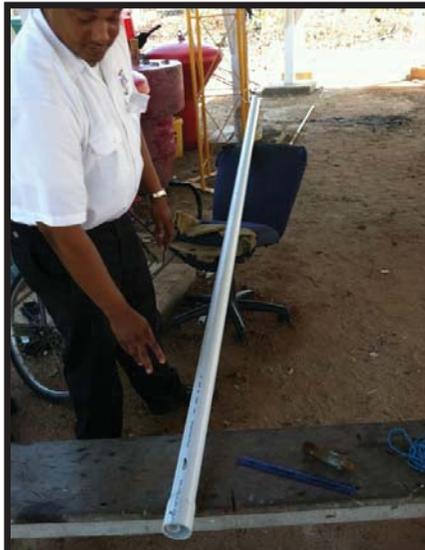
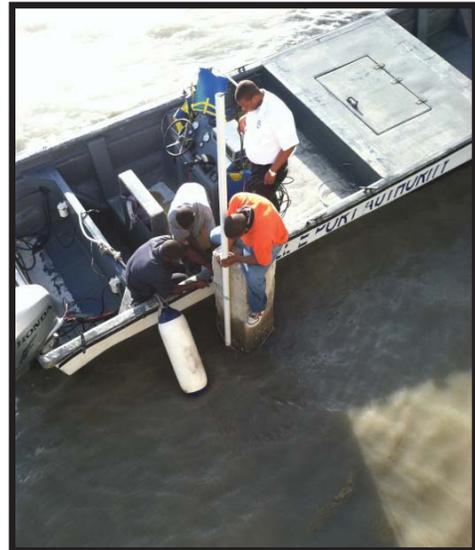
- ii. Unfortunately, although the Valeport gage operated for several months at Old Belize, it was never leveled to a benchmark network, so its relative vertical position was never monitored or recorded. That being said, the gage did collect a significant amount of data to show BPA personnel a tide pattern for the area. With the PBL Aquatrak out of commission and in order to have tide data to apply to bathymetry collected during the training period, BPA personnel installed the Valeport at PBL on a concrete piling separate from the pier. Using their previous tides training experience from 2009-2010, they successfully mounted the sensor to a PVC pipe, mounted the pipe to the piling, and properly leveled the sensor to a benchmark at PBL.

Mounting the Valeport 740 Tide Gage – Fixed to a 1-inch PVC pipe, the sensor was mounted inside a protective 3-inch PVC pipe well (left). BPA personnel strapped the well to a concrete piling near the PBL pier (right) and manually measured the distance between the sensor and top of the well to provide a leveling point to the benchmark.

- ii. Collect at least 30 days of tide data and incorporate into Phase 3 training survey data with calculation of new lowest astronomical tide level.
 - iii. Collaborate with Valeport Technical Support to test, repair, and/or replace existing Valeport 740 tide gage.

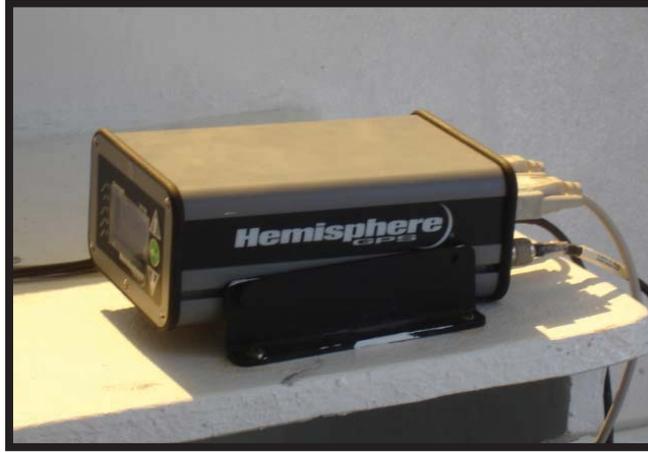
- g. **HemisphereGPS Crescent VS-100** – The GPS operated properly throughout the Phase 3 training period. However, the receiver unit is still mounted inside the cabin in a relatively unstable manner (issue identified in 2010). The unit should be held inside the vendor-provided mounting brackets with four (4) mounting screws, whereas it is currently held in place with only two (2) screws. This mounting method may result in unreliable GPS positioning and/or heading/pitch measurement. It is recommended that the GPS be mounted with four (4) screws per the VS-100 operating manual.

GPS Receiver Unit: *[picture from Phase 2 training]* The Crescent VS-100 GPS should be secured using four (4) screws, vice two, as stated in the operating manual.
