Chart action taken after the great Earthquake and the great Tsunami

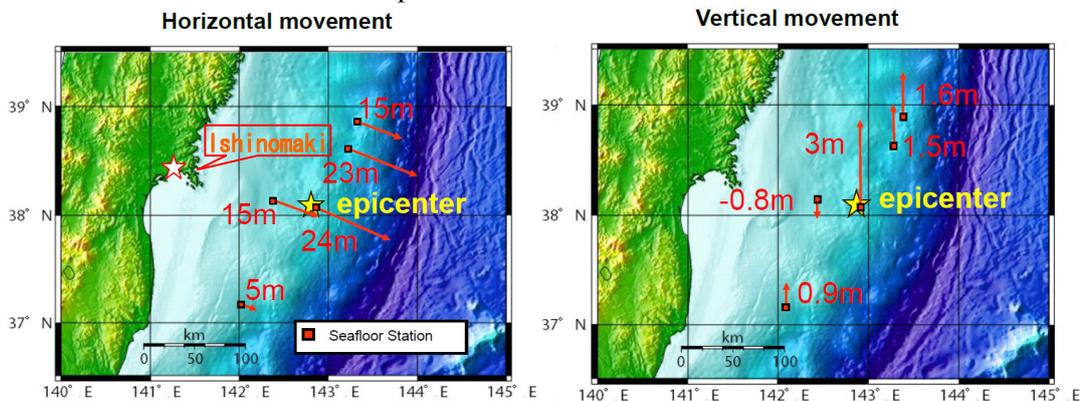
JHOD detected the maximum movement about 24m toward ESE and about 3m upward near the epicenter after the Great East Japan Earthquake. Significant subsidence of ground level has been also reported in the harbours in the east coast of Japan.

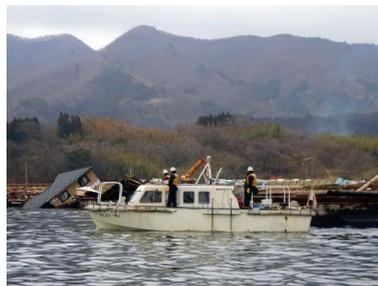
Sunken ship identified by multi-beam echo sounders

Obstacles survey

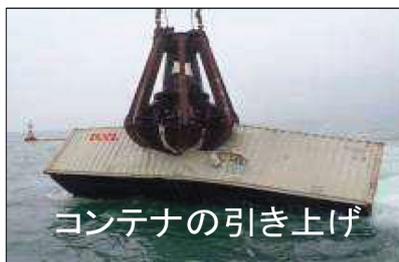
Container

Removal of the obstacles

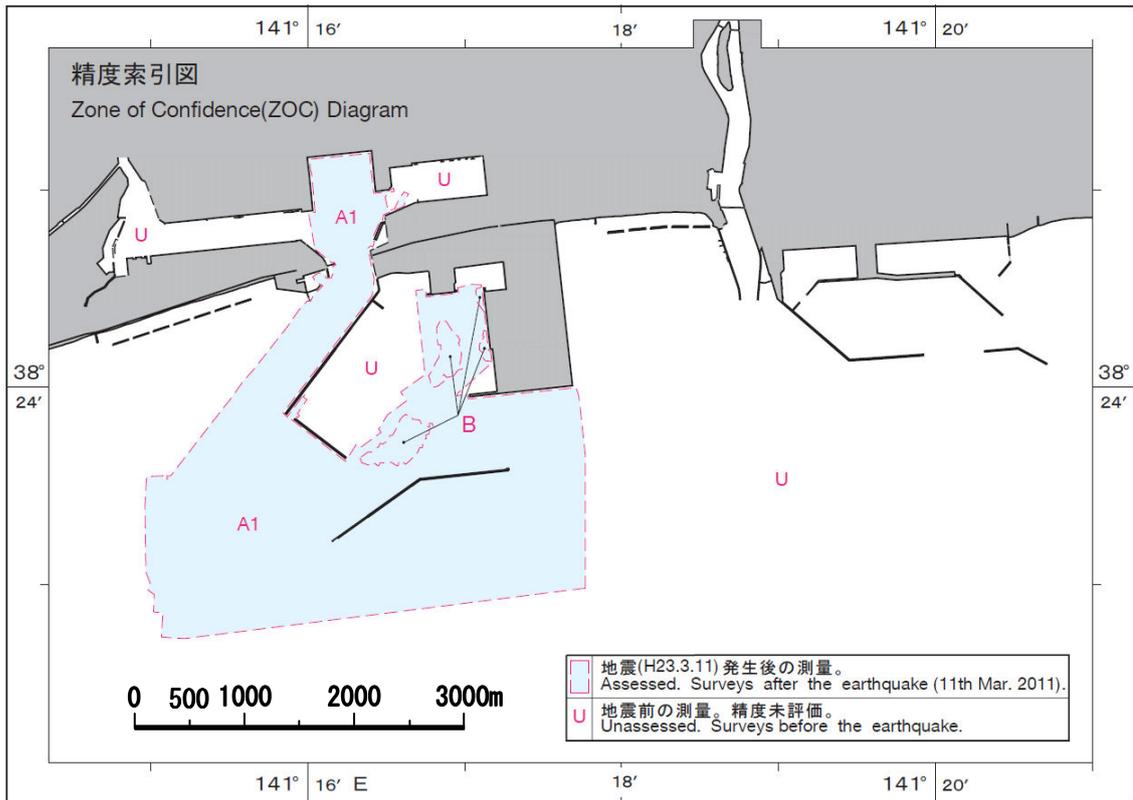
Fig. 1 ZOC Diagram of Chart W1100 "ISINOMAKI"

In a new edition of a chart, JHOD adopted the ZOC diagram. The category ZOC 'U' was assigned to unsurveyed area, because it is extremely difficult to assess the accuracy of the past surveys.

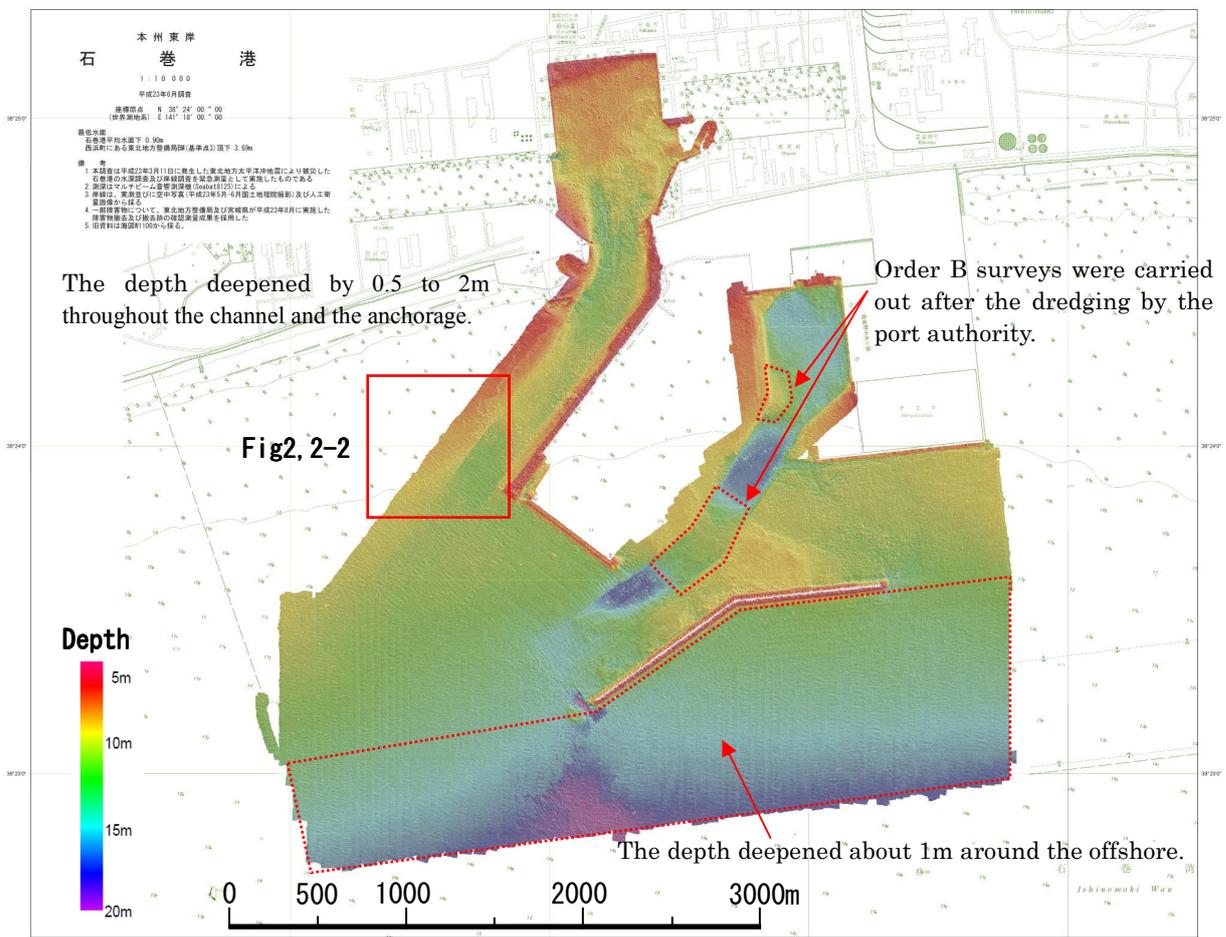
Surveyed and Unsurveyed Area (ISINOMAKI)

Fig. 1-2 Surveyed and Unsurveyed Area "ISINOMAKI"

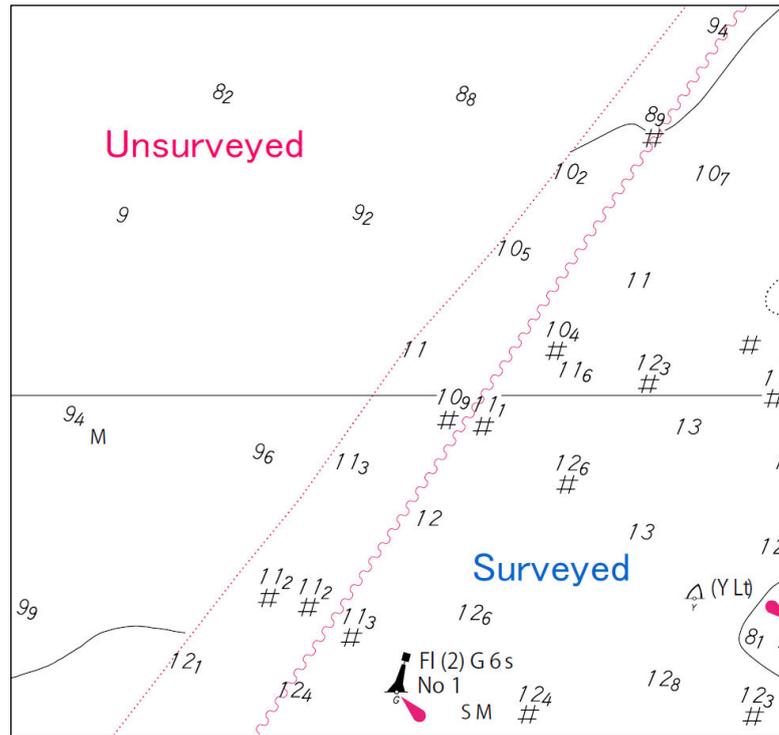
Fig. 2 Magenta dotted lines to inform limit of survey area on the chart “ISHINOMAKI”

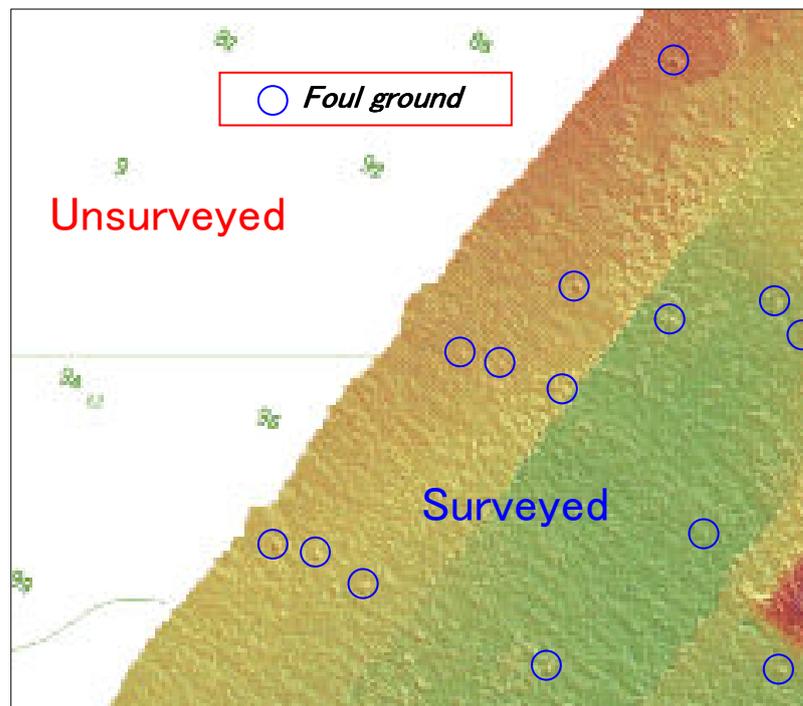
Fig. 2-2 Identified 'Foul ground' in surveyed area “ISHINOMAKI”

We observed small foul bottoms over 250 places of the surveyed area.

- 1) Water depths in all the surveying areas were changed by the crust movement.
- 2) Small foul bottoms were observed in many parts of the channels.
