# HYDROGRAPHIC COMMISSION ON ANTARCTICA

HCA9-08Ab

SURVEY PRIORITISATION WORKING GROUP  
HCA SHORT LIST

# Maritime Shipping Route Numbers: 17A & Ac

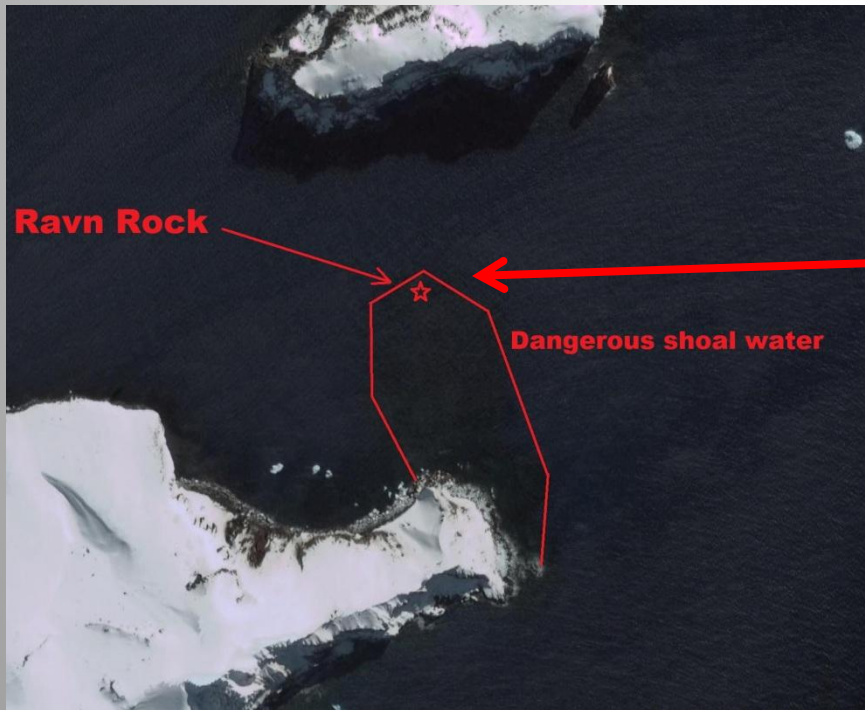
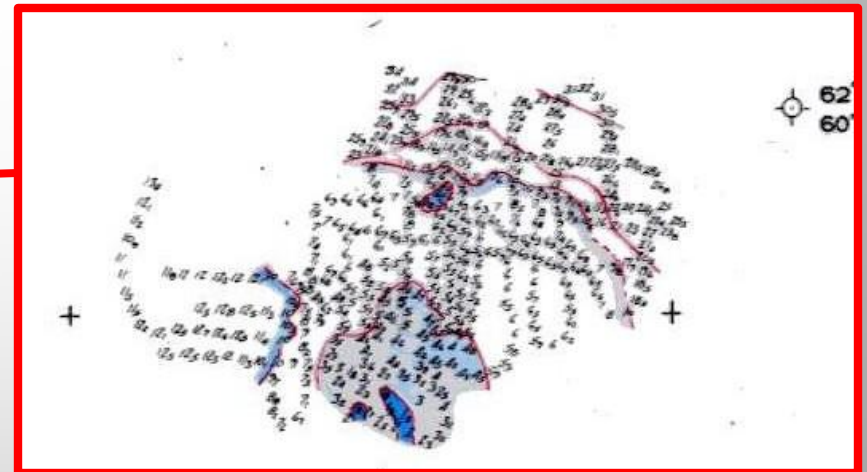
**Singlebeam survey of Ravn Rock**
