Bathymetric Measurements of the Rio Indio,
Panama, Province of Colón

**MACHC 2017
Hydrographic Awareness
November 2017
Cuba**

The purpose of this project was to carry out bathymetric measurements from the mouth of the Rio Indio to a distance approximately 30 km inland along the river. These data will be useful for assessing the river's environmental flow, navigational capacity, pollution prevention, flood control and other relevant geo-hydrological studies.

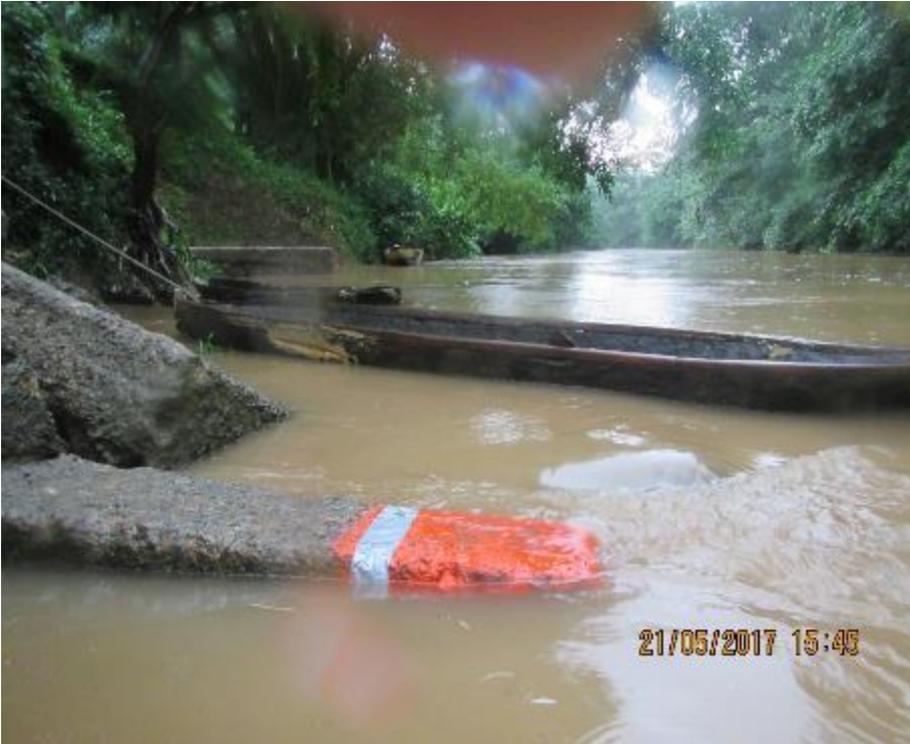
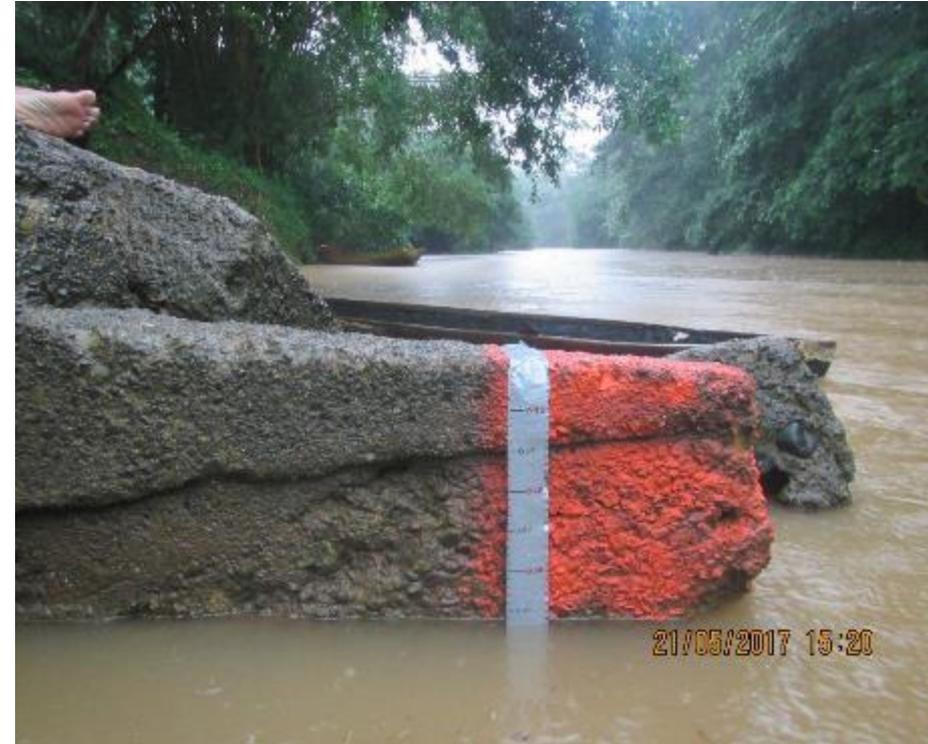
Priority 1: Santa Rosa

Water level measured relative to spray painted concrete slab. Used duct tape with graduations for tide staff. Water went from 0.4 m below to level in 20 minutes, then to 1.5 m above in another 30 minutes. This occurred after a significant rain event

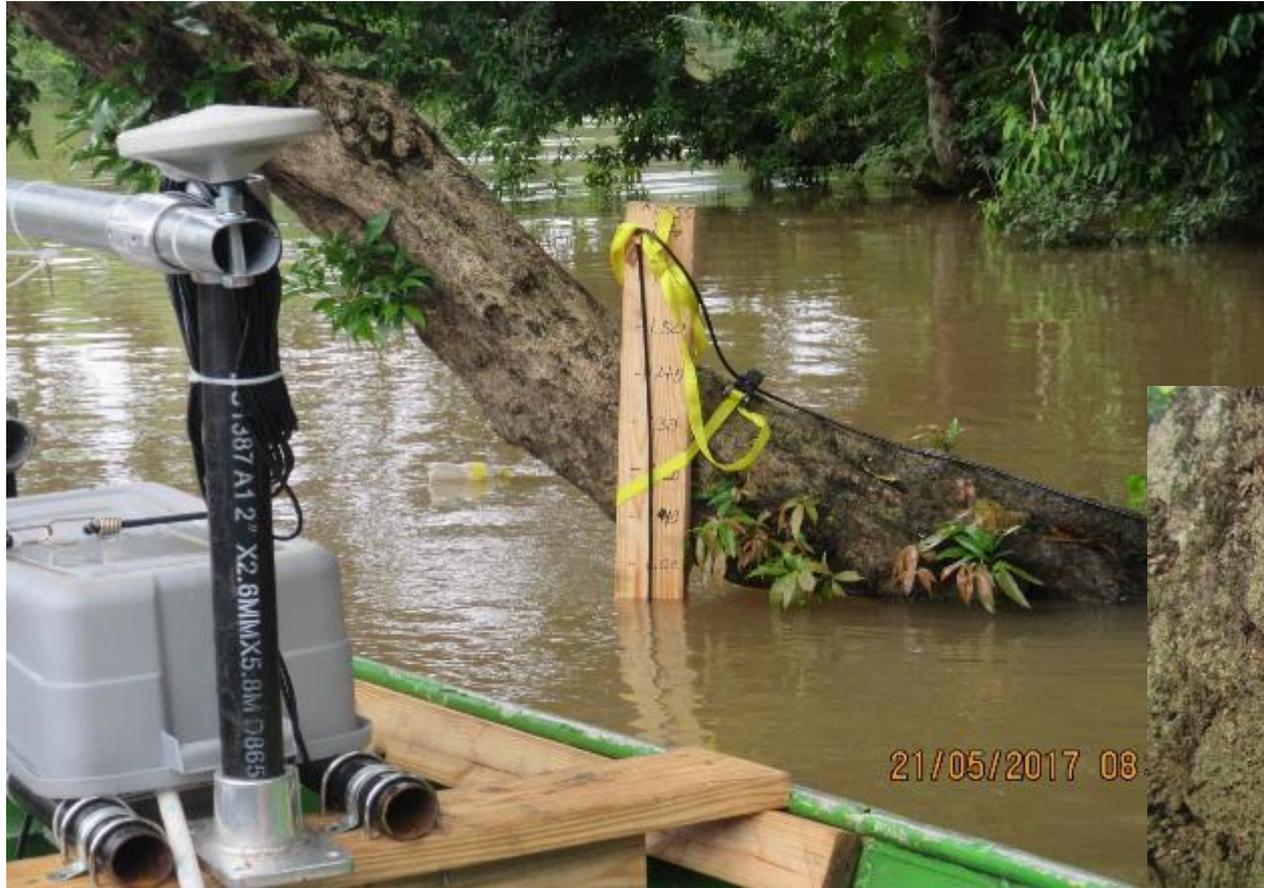
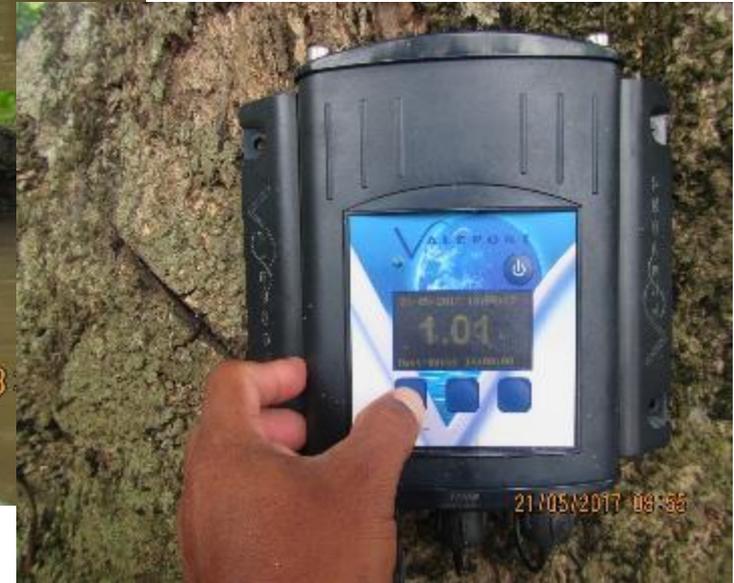
Priority 1: Chilar

Tide staff strapped to tree. Water level gauge transducer on the bottom.

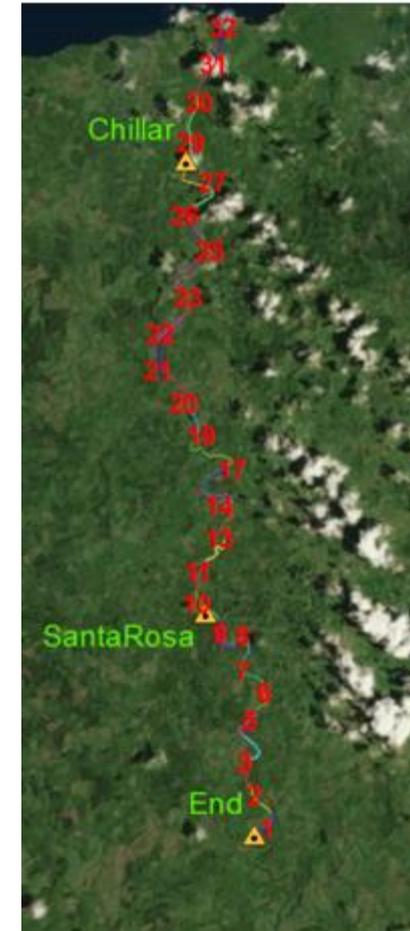
Priority 1: Santa Rosa and Chilar

Chilar and Santa Rosa water level measurements, relative to PLD

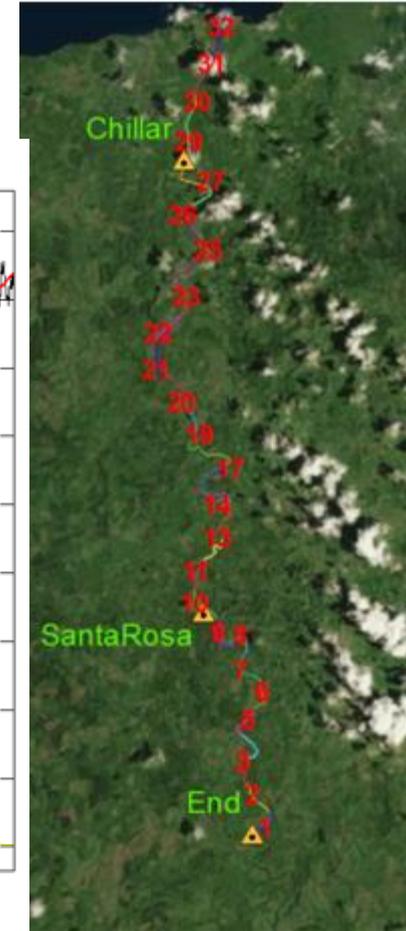
GNSS check at Chilar Water Level

GNSS heights at the vessel, translated to PLD
(when high-accuracy GNSS results were good enough)

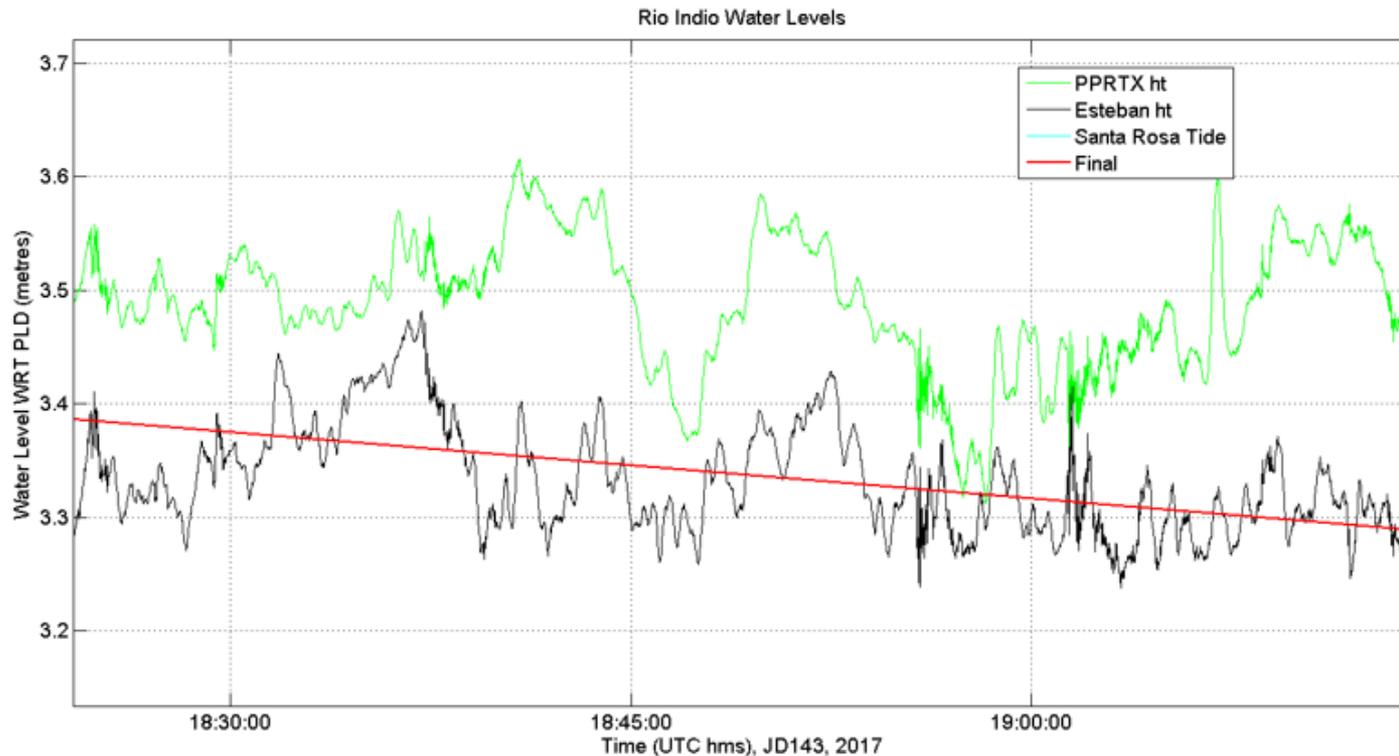
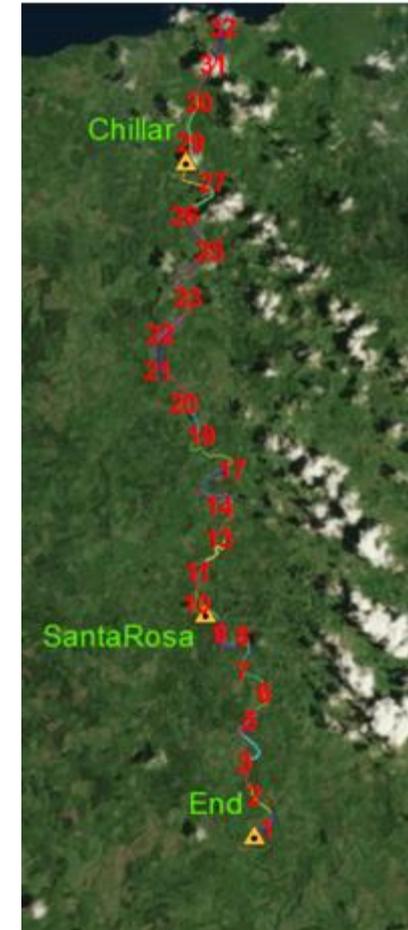
GNSS checks at Santa Rosa Water Level

GNSS heights at the vessel, translated to PLD
(when high-accuracy GNSS results were good enough)

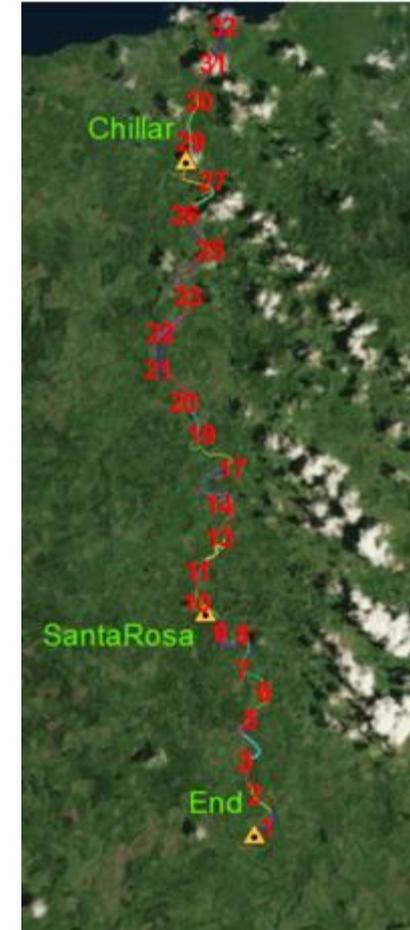
Priority 3: Topo Lidar water level

Topo LiDAR water level interpolation, relative to PLD
