Paper for Consideration by NCWG
Marine Incidents: Grounding of “Nova Cura”

Submitted by:	Netherlands Hydrographic Office
Executive Summary:	Lessons learned from the grounding of the Nova Cura
Related Documents:	Report Dutch Safety Board
Related Projects:

Digital navigation: old skills in new technology

Lessons from the grounding of the Nova Cura

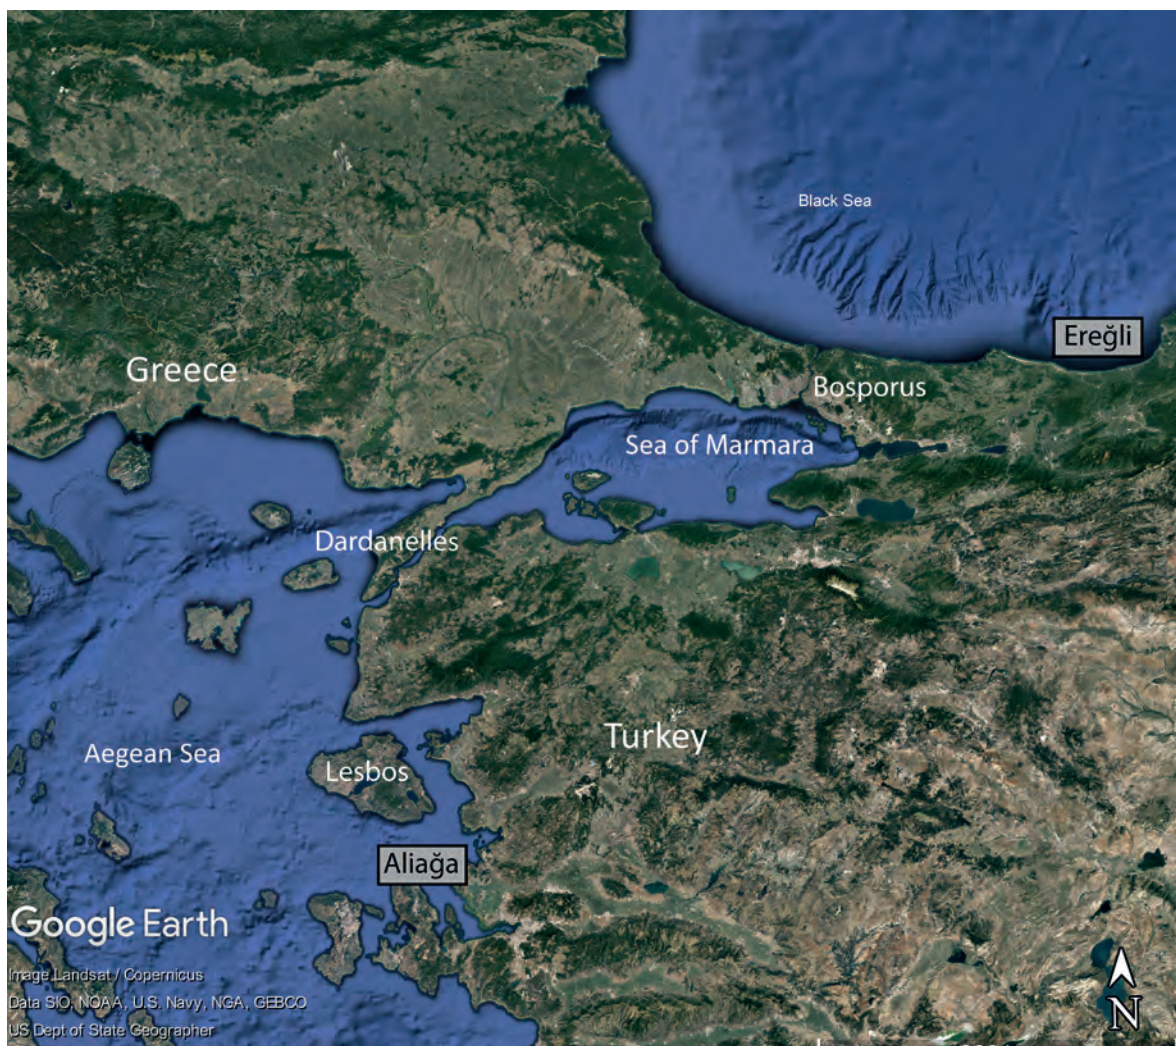
Figure 2: Overview of the planned route. Source: Google Earth

Ereğli is at the Black Sea. To go to Aliaga the Nova Cura had to pass the Bosphorus to the Sea of Marmara and afterwards via the Dardanelles to the Aegean Sea (see figure 2). The passage planning had been done by the second mate before departure. A so-called Electronic Chart Display and Information System (ECDIS, see blue box) was being used on the Nova Cura for navigation.

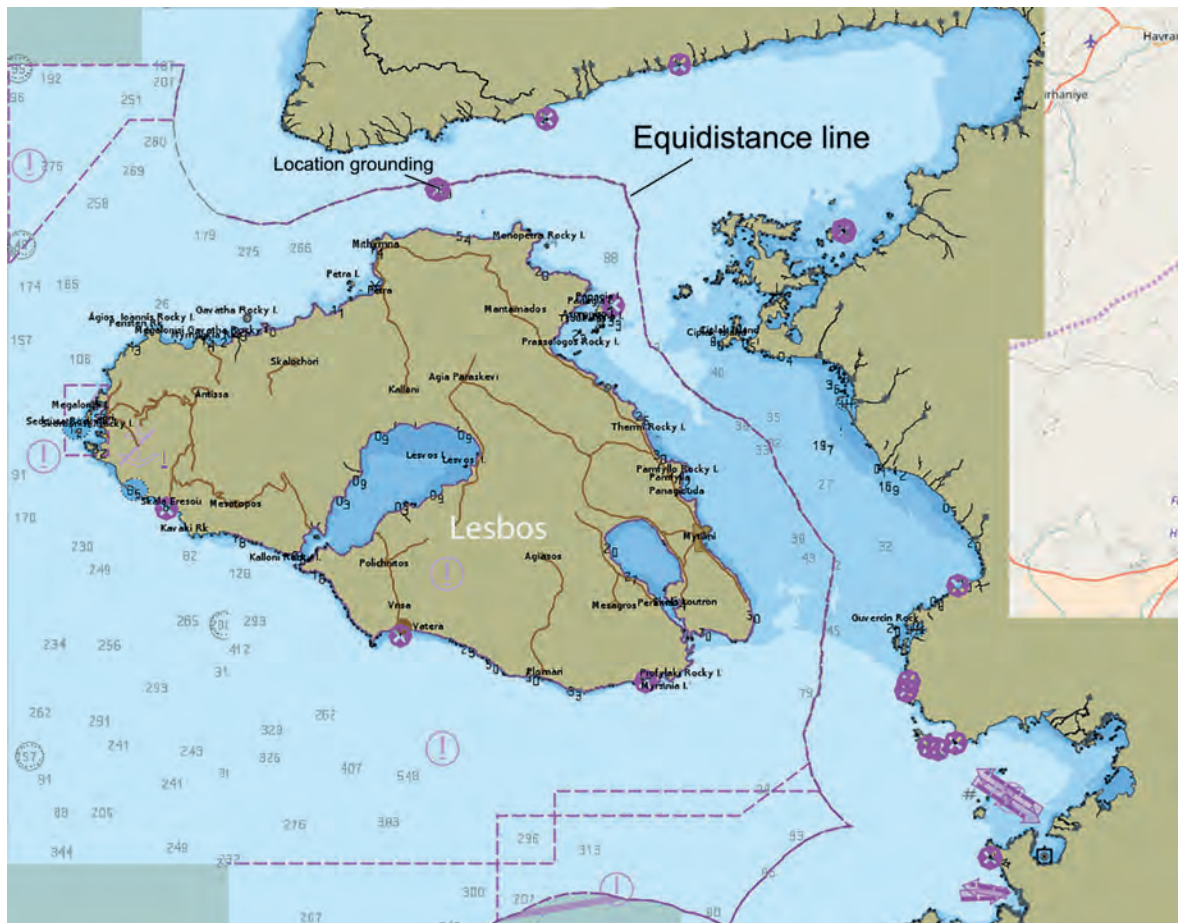
The Nova Cura was certified to use the ECDIS³ alone for navigation, so for that reason it only needed a small portfolio of paper charts on board. The original destination of the Nova Cura was Izmir (Turkey). First of all, the second mate checked which digital charts he required and whether any updates were available in the ECDIS. Then he read the Pilots for the next port, volume 6⁴ of the Admiralty List of Radio Signals (ALRS), and assessed the relevance of the Navtex messages. The Navtex messages were digitised and the temporary and preliminary messages were automatically included. Following this, he roughly plotted the route in the ECDIS first, after which he zoomed in to plan it in more detail. On 19 April 2016 the second mate plotted the route in the ECDIS and had earlier already ordered the digital charts required for the route. The plotted route ran along the west of the island of Lesbos (Greece), see the black line in Figure 3.

less sailing. In response the captain altered the route, so that container could be loaded in Aliaga that same day. He did not redo the passage planning for this new route. A new chart in ECDIS was not required, because the most suitable chart (GR4APP01) was already available in the ECDIS.

Figure 3: Route to Aliaga north of Lesbos (red), route to Izmir west of Lesbos (black). Source: GR4APP01

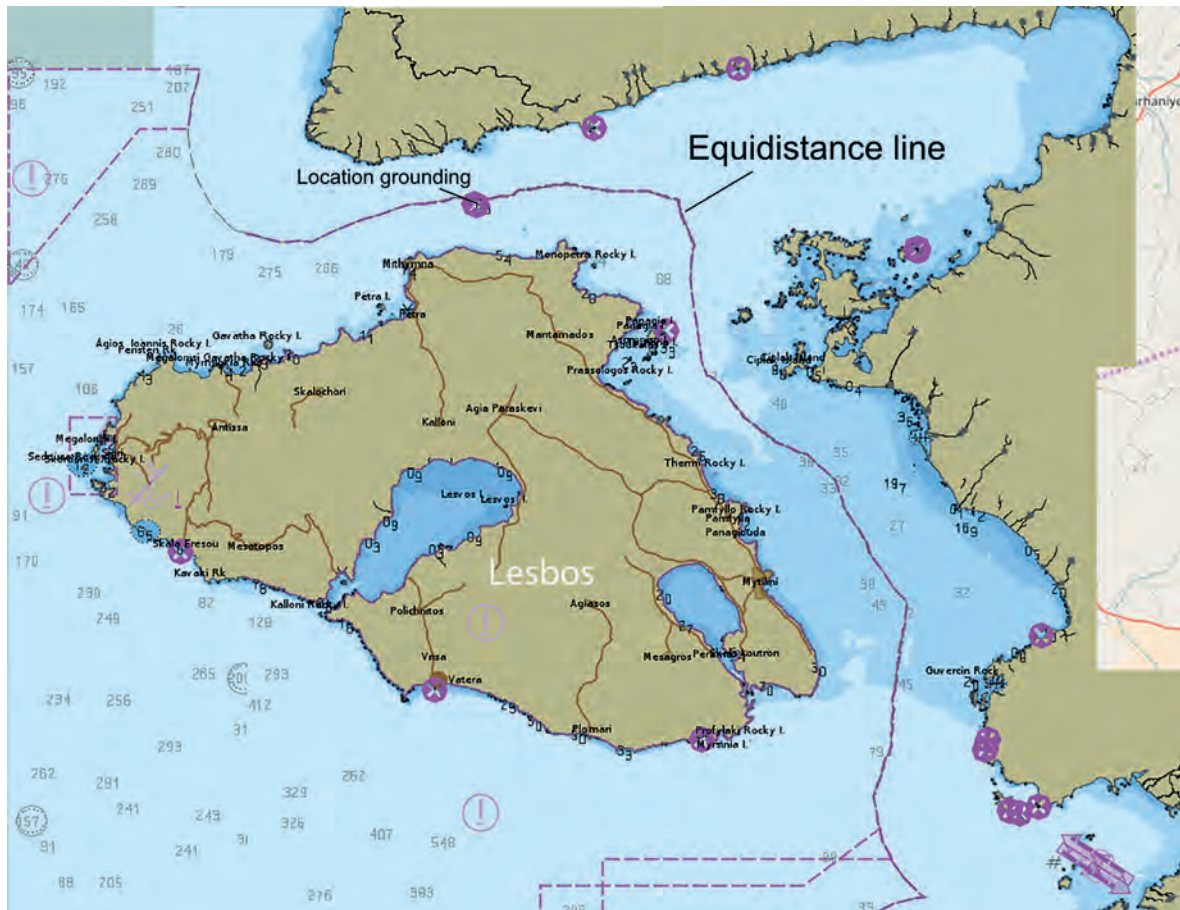
Lamnas Reef is a shallow area located in Mytilini Strait. Mytilini Strait is a waterway that forms the border between Turkey and Greece (near the Greek island of Lesbos), see Figure 6. Lamnas Reef is located partly in Greek waters and partly in Turkish waters.

Figure 6: Border between Greece and Turkey in Mytilini Strait. Source: GR4APP01

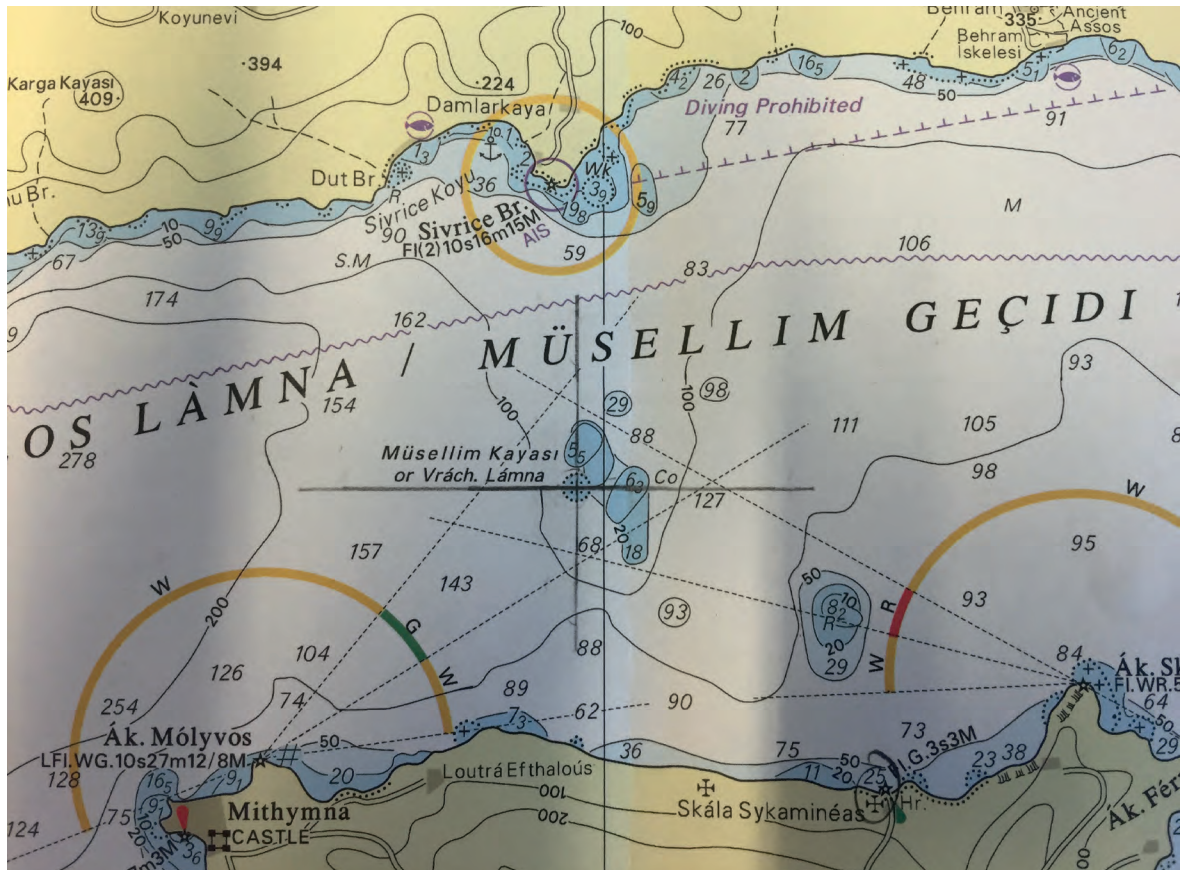
The UKHO publishes paper nautical charts in the British Admiralty Series through Admiralty Maritime Products & Services. The UKHO copied the Greek paper nautical chart supplemented with the information known to them and published it under number 1061. The chart number is BA1061. The UKHO has satellite images of Mytilini Strait, among other things, and incorporated this information in BA1061, see Figure 9.

Figure 9: Lamnas Reef in BA1061.

The Admiralty Vector Chart Service¹⁰ (AVCS, the digital Admiralty charts) in 2013 created an Admiralty Information Overlay (AIO)¹¹ containing the differences between the BA1061 and the Greek ENC GR 4APP01. The availability of the above AIO in ECDIS depends on the Value Added Reseller (VAR) where the ENCs are purchased. The AIO was not available on board the Nova Cura.
