ECDIS Display and Alarm Issues

Tim Lewis, Head of International Partnering (America)
XII th MACHC - BASSETERRE, ST.KITTS & NEVIS
Dec 2011

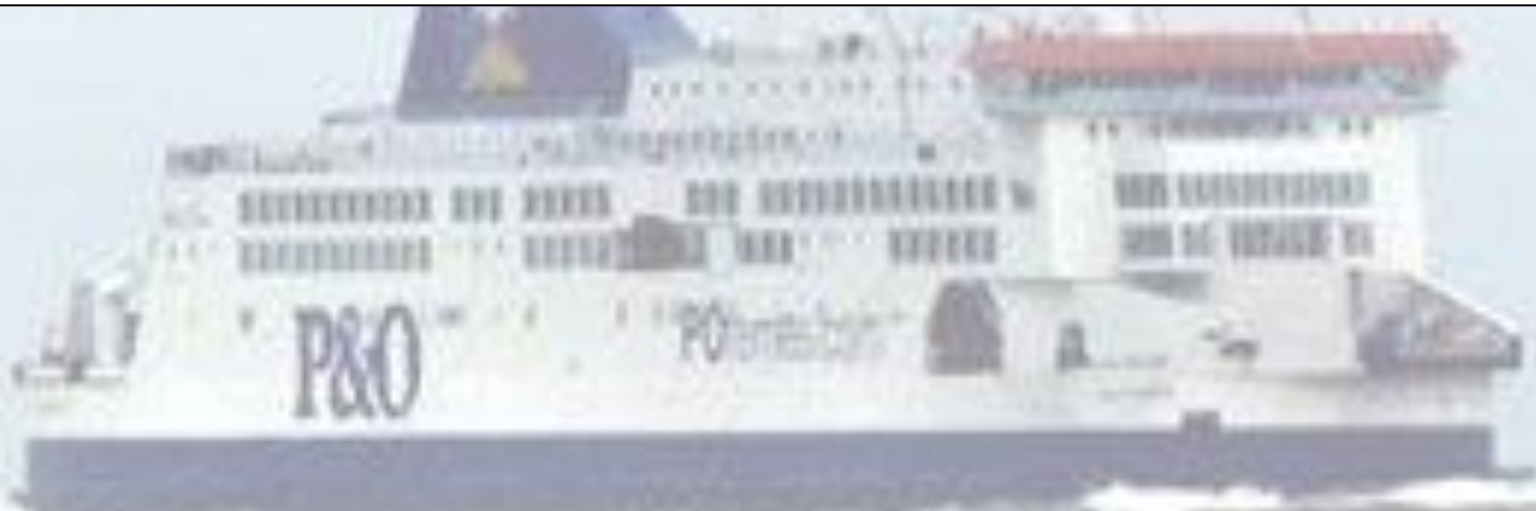
ISSUE 1 – DOES NOT DISPLAY BUT DOES ALARM

Wreck coincident with a depth contour

- This example came to light in January 2009 as a result of an enquiry from IHB regarding the encoding of a 1.8m wreck on a GB ENC.
- The enquiry was prompted by the MAIB report on the grounding of P&O ferry “Pride of Canterbury” off the Kent coast in January 2008.

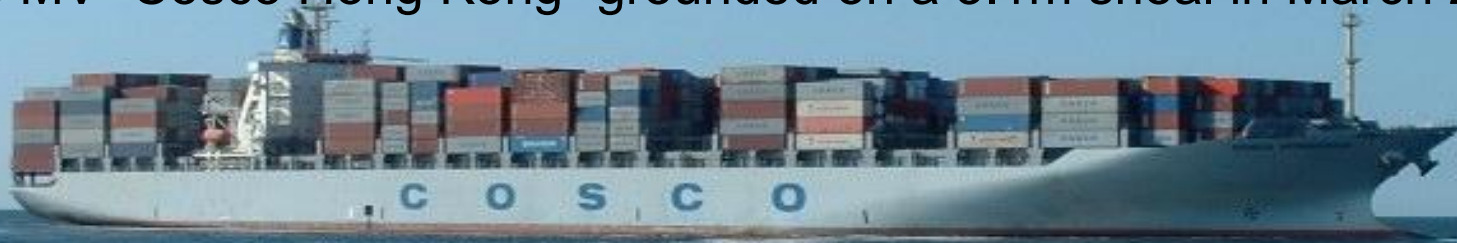
ISSUE 2 – DOES NOT DISPLAY OR ALARM

Soundings with EXPSOU=2

- This example came to light during a visit by MAIB in January 2010.
- MAIB chose to look at an area in the approaches to Hong Kong where the MV “Cosco Hong Kong” grounded on a 3.1m shoal in March 2009.
