2nd NCWG MEETING
Monaco 26-29 April 2016

Paper for Consideration by the Nautical Cartography Working Group (NCWG)
Showing Virtual AIS Aids to Navigation Out of Position on Paper Charts

Submitted by:	Australia
Executive Summary:	There is no specification for paper charts for the depiction of Virtual AIS Aids to Navigation where they are positioned over a navigational danger.
Related Documents:	S-4 – B-489.2.
Related Projects:	None

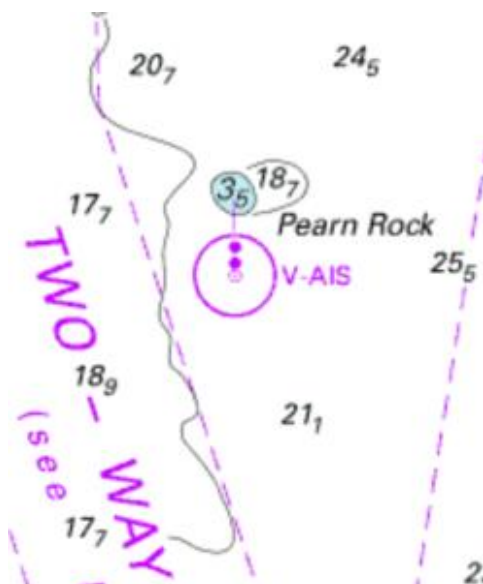
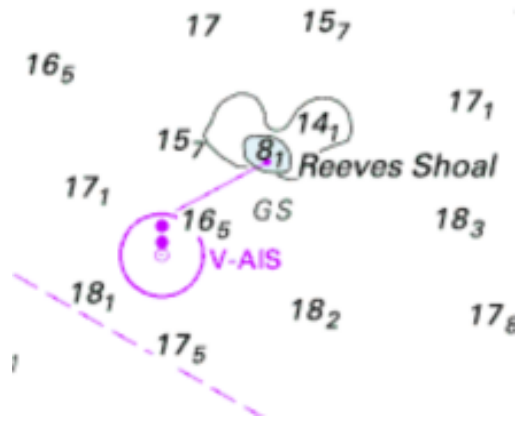
Australia’s solution for the situation where a V-AIS is positioned directly over a navigational danger was to offset the V-AIS symbol from the danger, and use a magenta version of the “pointer” as specified for a sounding out of position at B-412.2 to show the actual “position” of the V-AIS. For example:

Where a V-AtoN is positioned directly over a submerged danger to navigation, the danger should be shown in its true position as normal. The V-AtoN should be offset from the danger, with a short magenta ‘pointer’, similar to that used for soundings (see B-412.2) used to mark the actual position of the V-AtoN. For example:
